## **Geotechnical Assessment**

**Project:** Alterations & Additions  
65 Hillside Road, Newport NSW

**REF: AG 21418**  
9 December 2021

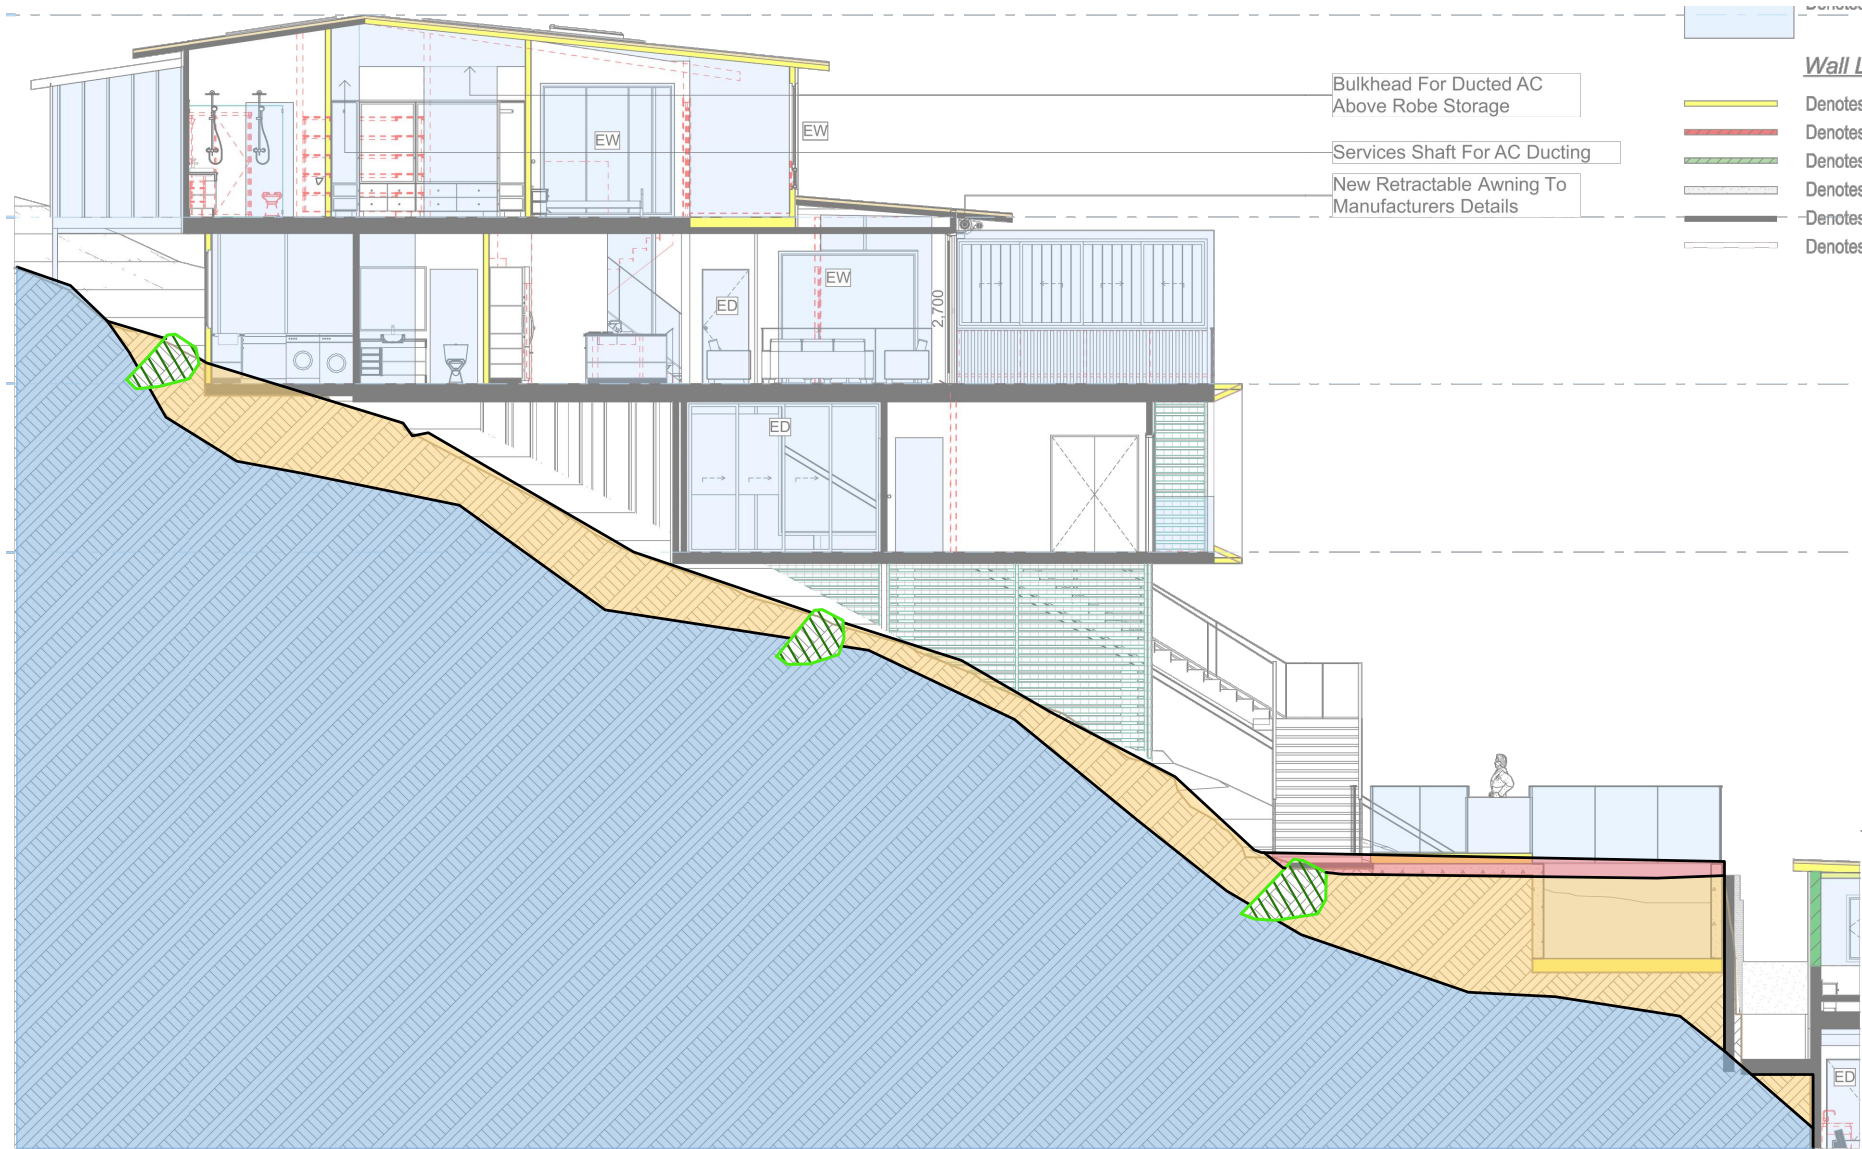
**INFERRED GEOLOGICAL SECTION**  
SCALE NTS

The soil profile consists of shallow uncontrolled sandy fill and sandy topsoil (O & A Horizons), overlying clayey sand (B Horizon) and weathered bedrock (C Horizon). Small to medium sized sandstone floaters are present in the upper profile. Based on our observations and the results of testing on site, we would expect weathered sandstone bedrock to be found within 0.5 – 3.35 metres below current surface levels across the area of the proposed works.
