Geotechnical Assessment

Project: Alterations & Additions
2/1 Lister Avenue, Seaforth NSW

Prepared for:
Mr & Mrs Vescio

Ref: AG 25134
9 April 2025

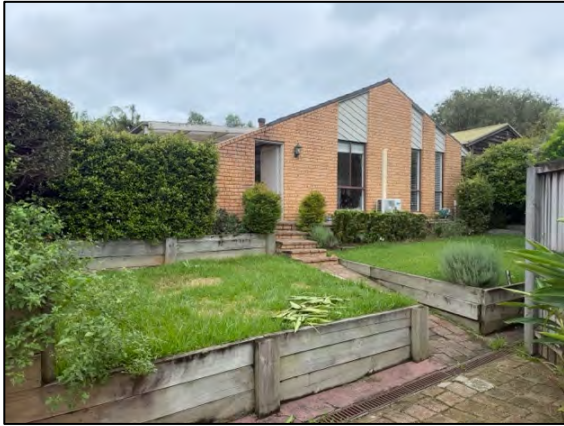
Photo 1: Front of residence and location of plunge pool.

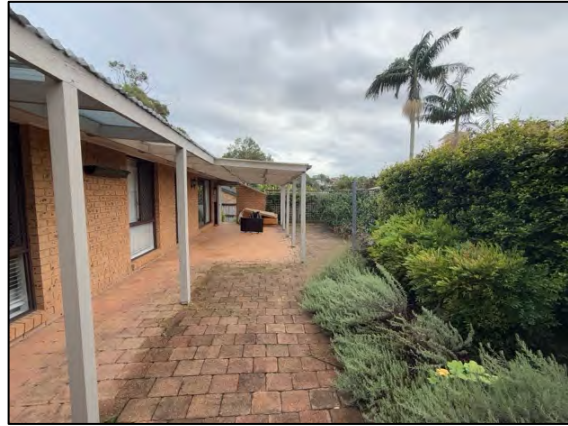
Photo 2: Patioed side yard.

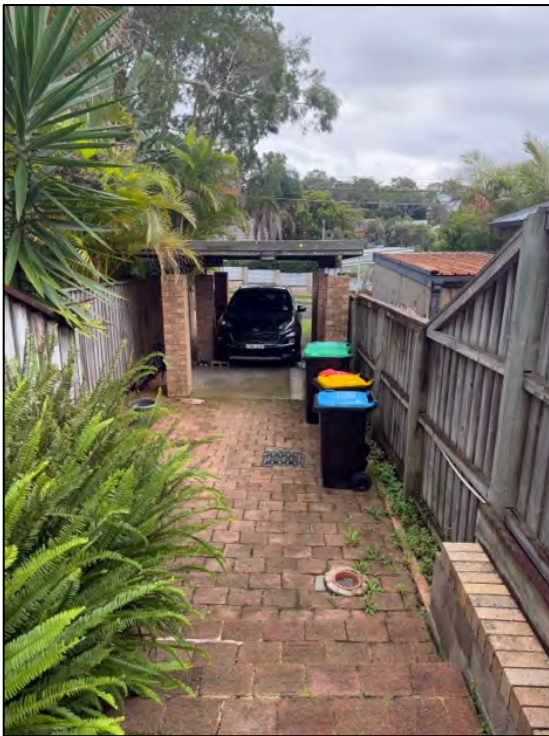
Photo 3: Patioed carport area.

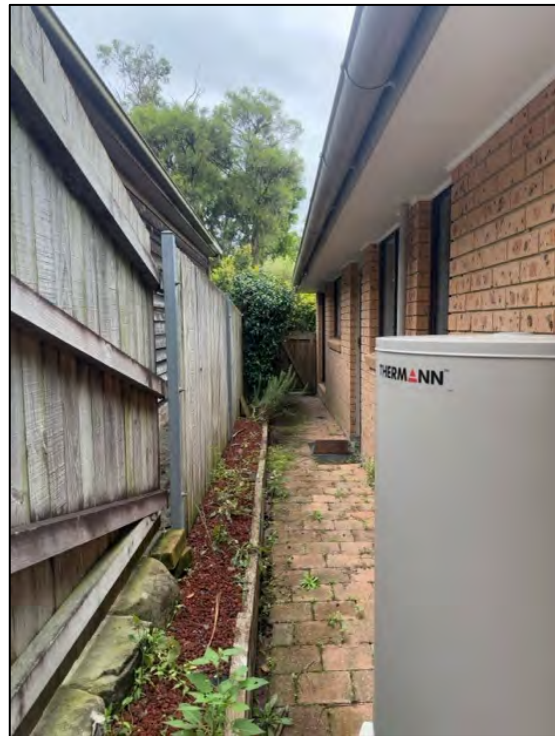
Photo 4: Western boundary.
