Geotechnical Assessment

Project: New Internal Driveway
201 McCarrs Creek Road, Church Point NSW

REF: AG 21200
21 June 2021

For New Internal Driveway at
201 McCarrs Creek Road, Church Point NSW

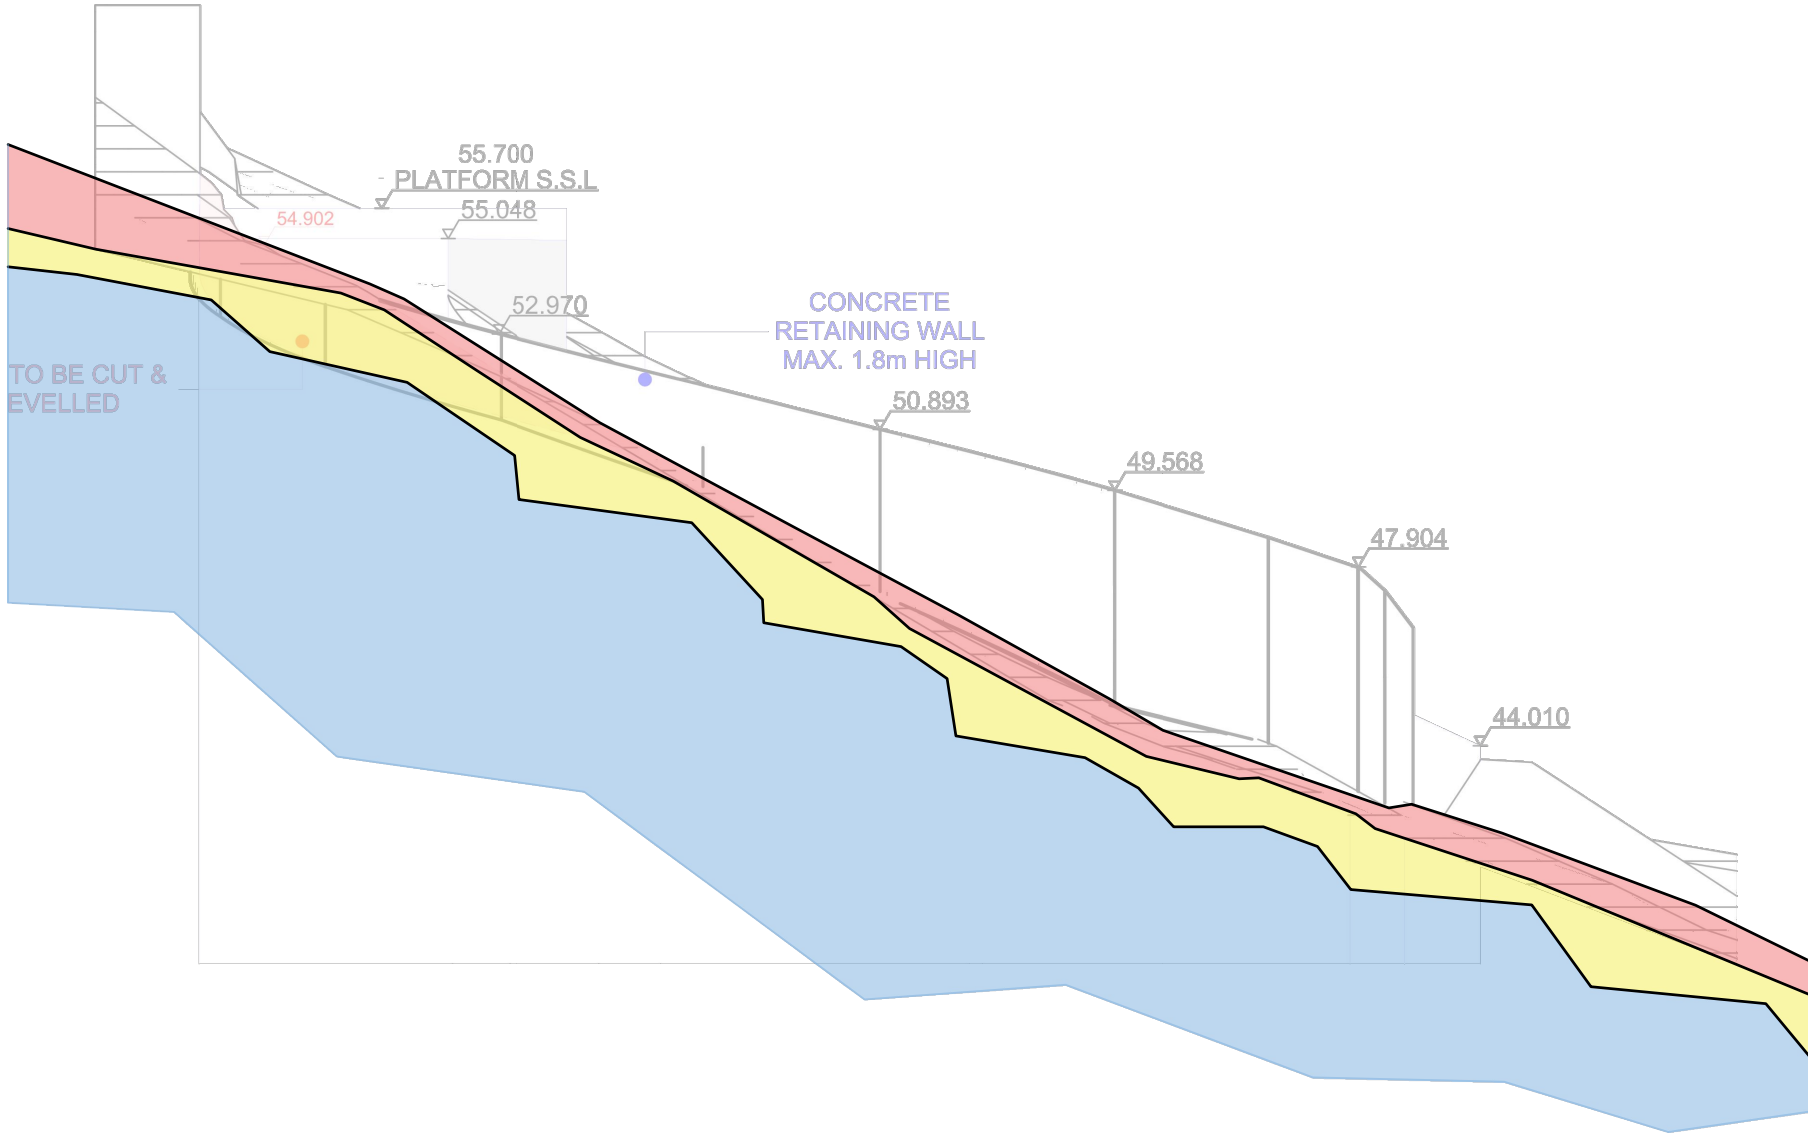
INFERRED GEOLOGICAL SECTION

INTERPRETED SUBSURFACE SECTION ONLY.
ACTUAL GROUND CONDITIONS MAY VARY.

- UNCONTROLLED FILL/SILTY TOPSOIL
- SILTY CLAY
- NEWPORT FORMATION INTERBEDDED SHALE/SANDSTONE
