Date: 25 June 2024
No. Pages: 4
Project No.: 2024-091

Preliminary Landslip Assessment for 22 Abernathy Street, Seaforth, NSW.

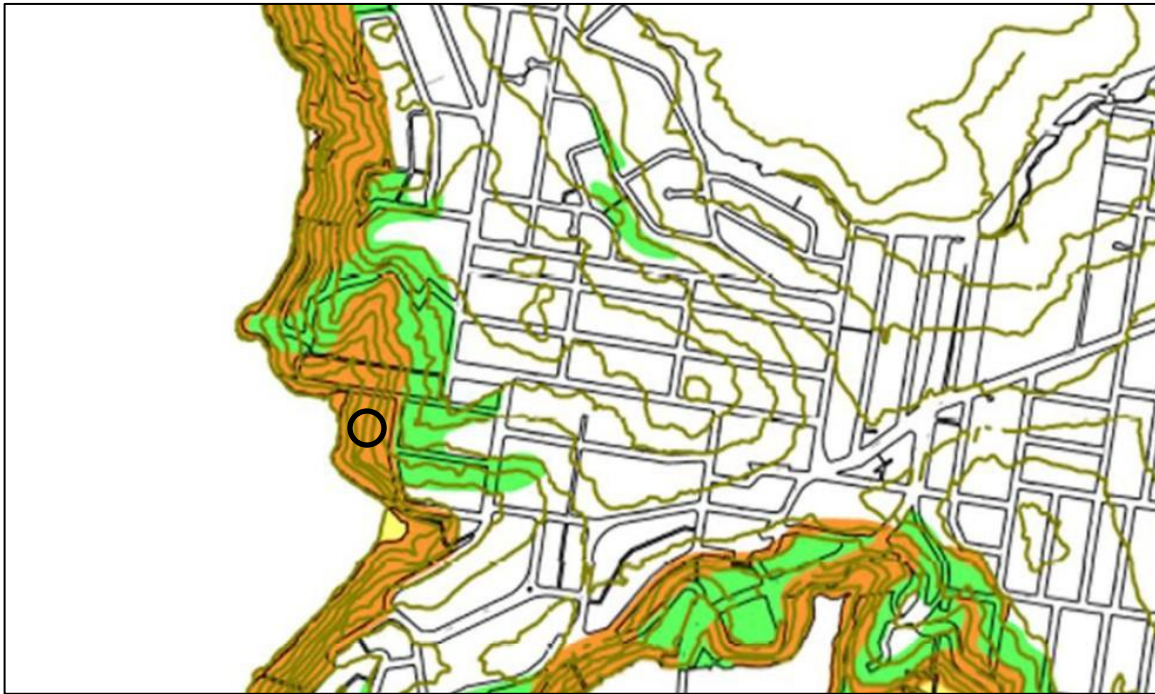
The site is located within Landslip Risk Class “G1” as identified within Northern Beaches (Manly) Councils, Development Control Plan 2013 – Schedule 1, Map ‘C’, being ‘Steeper Slopes generally near coastal or harbourside areas typically >25°’ (See Figure 1).

Figure 1: Landslip Risk within Site location (outlined black)

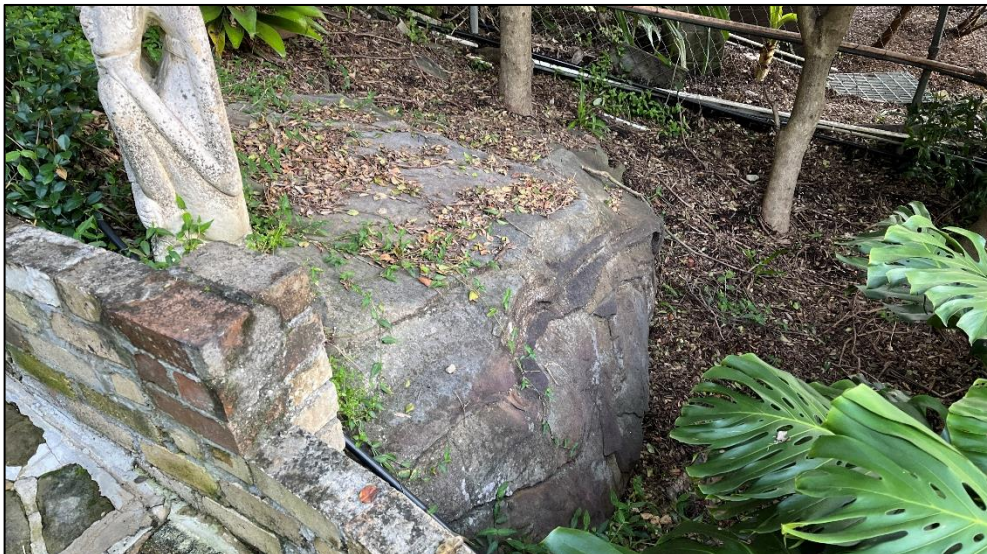
Bedrock outcrops were observed within the front of the site and comprised low to medium strength sandstone which did not display adverse defects or clay seams (See Photograph 1).

Photograph 1: Bedrock outcrop within the site

Based on the above checklist it is considered that a detailed Site Stability (Geotechnical) Report is not required for this Development. However, care is required for any excavation works within bedrock as potential damage can result from excavation machinery therefore it is recommended that geotechnical inspection occur prior to bulk excavation.
