Geotechnical Assessment

Project: Alterations & Additions
5 Roosevelt Avenue, Allambie Heights NSW

Prepared for:
Aaron Hawkins

Ref: AG 24350
6 September 2024

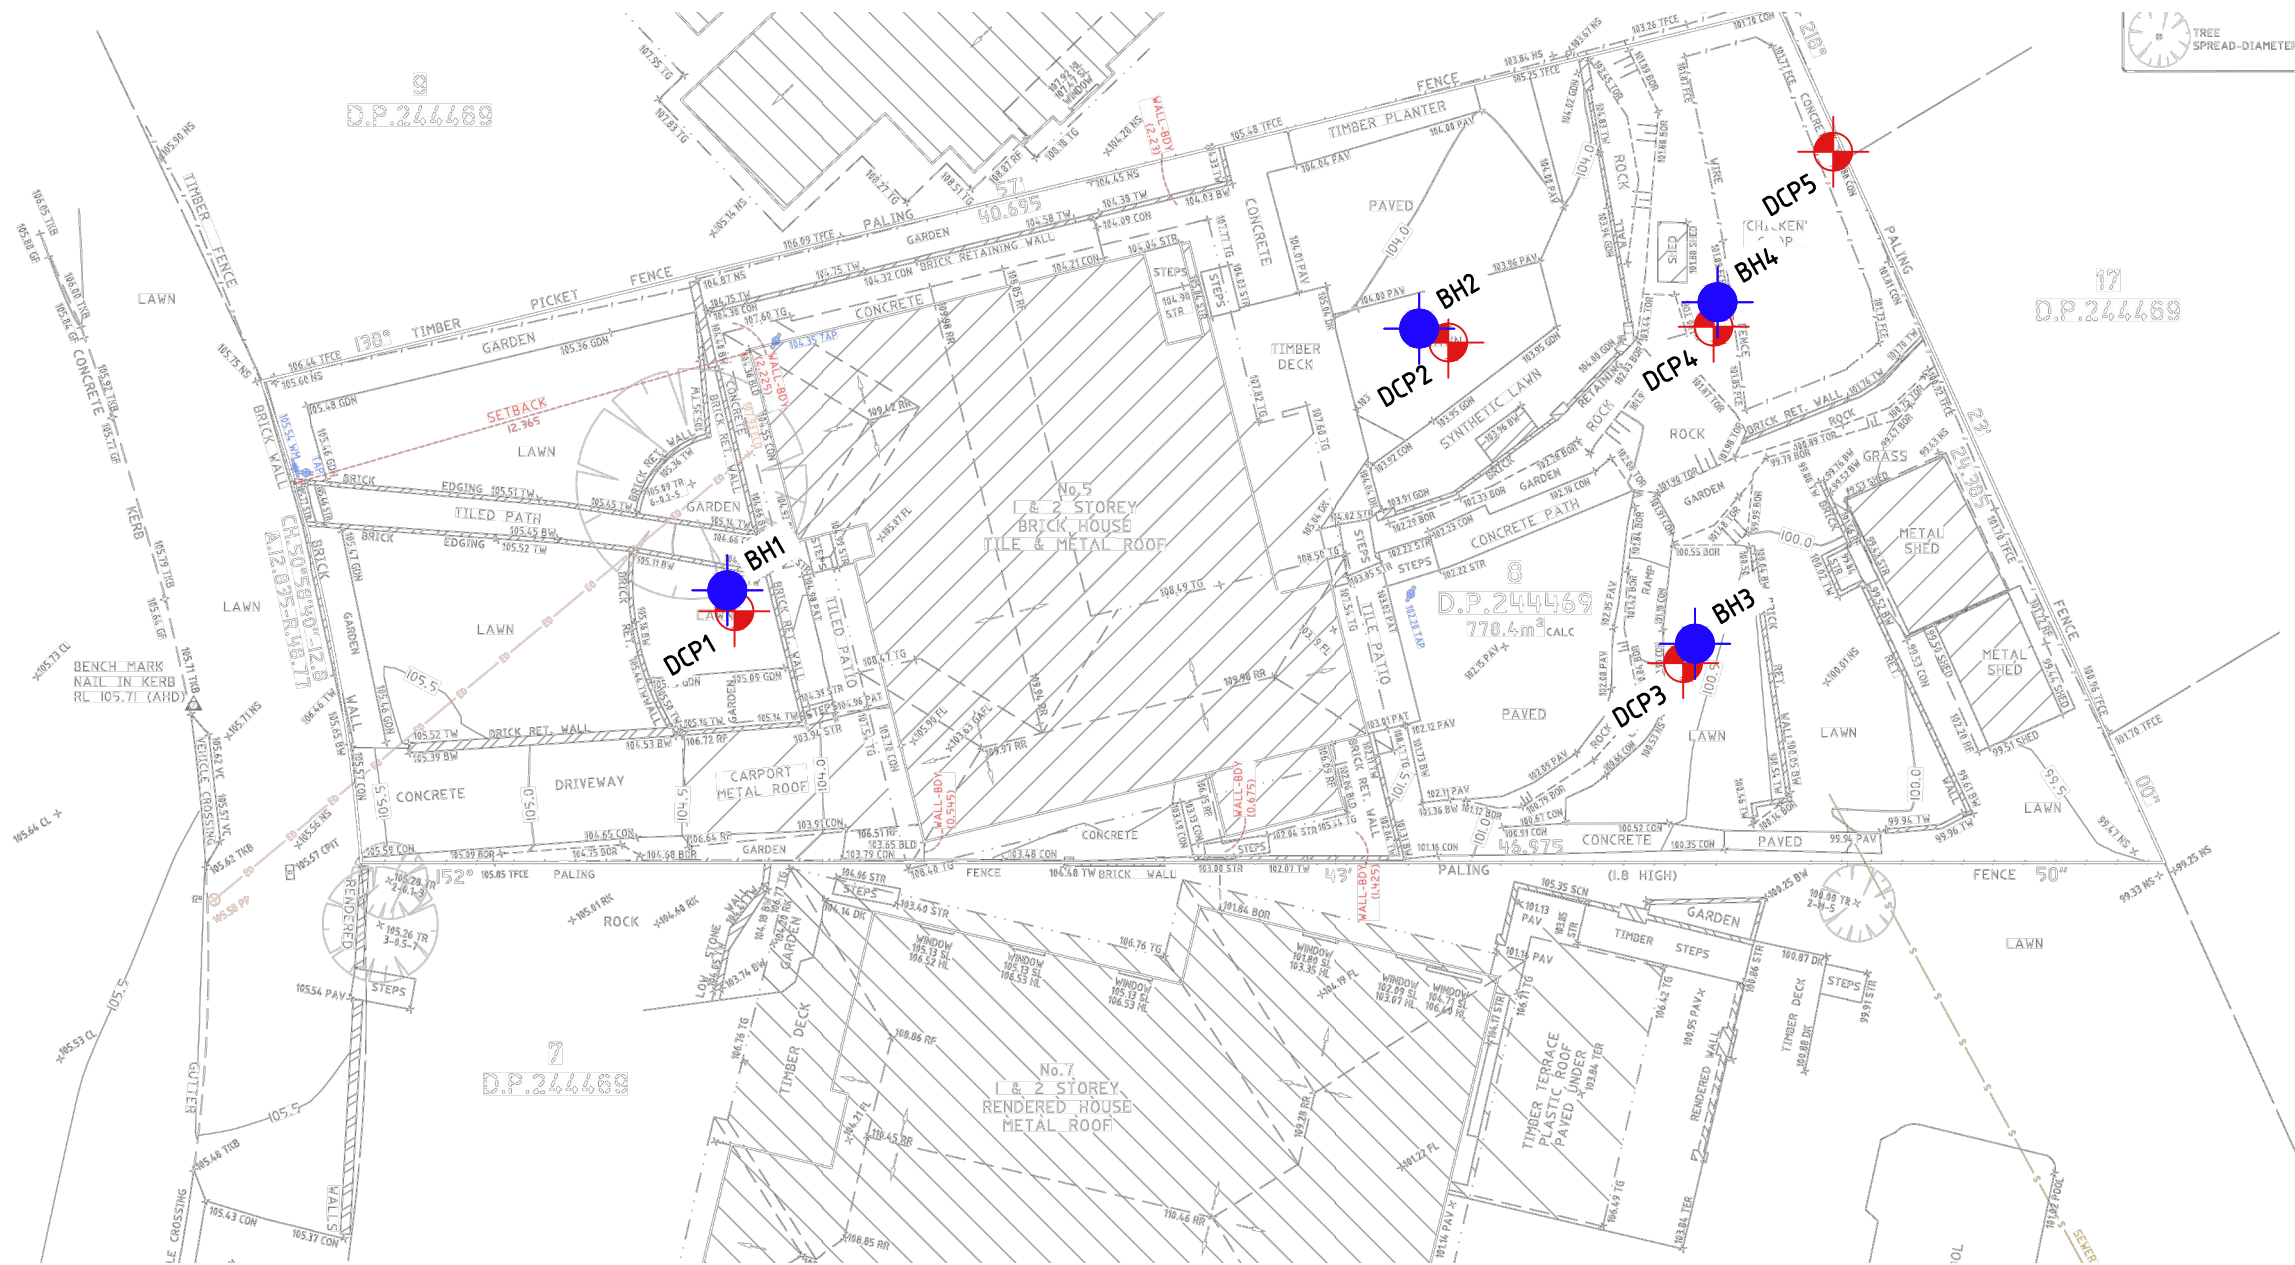
SITE PLAN/GROUND TEST LOCATIONS
SCALE NTS

Test	DCP 1	DCP 2
Summary	Refusal @ 0.6m Double Bouncing on bedrock. Brown sand on moist tip.	Refusal @ 0.3m Double Bouncing on bedrock. Brown sand on moist tip.
Test	DCP 3	DCP 4
Summary	Refusal @ 0.1m Double Bouncing on bedrock. Brown sand on moist tip.	Refusal @ Surface Level Double Bouncing on bedrock. Clean tip.
Test	DCP 5	-
Summary	Refusal @ Surface Level Double Bouncing on bedrock. Clean tip.	-

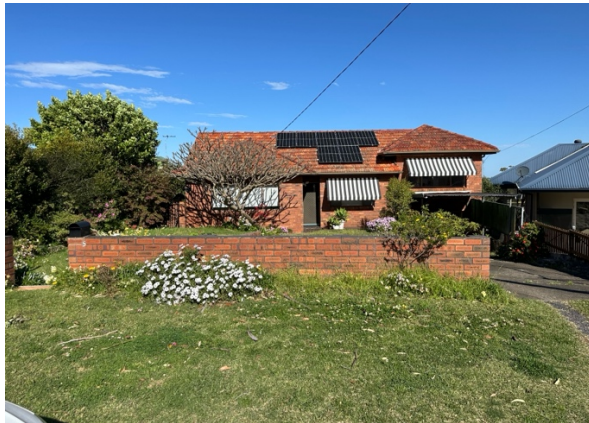
Photo 1: Site frontage, looking south-east.

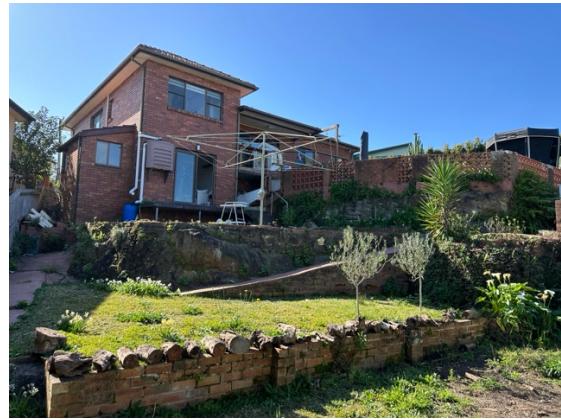
Photo 2: Southern corner of site looking north-east.

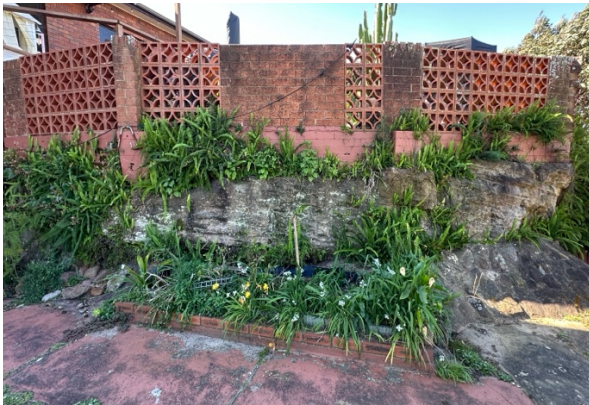
The existing building at the site is a single storey brick house with garage underneath, a grassed front yard and larger grassed backyard areas. The rear yard has sandstone outcropping visible at multiple locations with sections of undercutting observed. Neighbouring buildings are mostly single and double storey dwellings.

Photo 3: Sandstone outcropping, Middle of rear yard looking east.

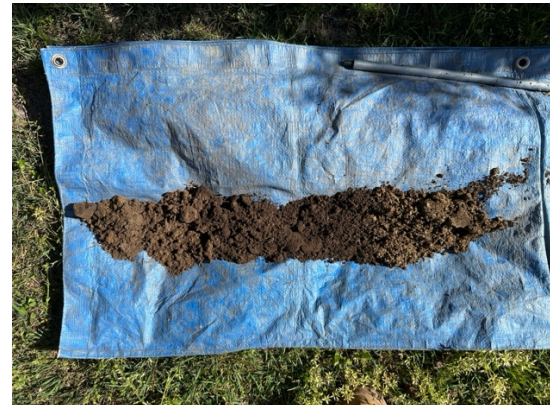
Photo 4: Subsurface soil profile of BH01.

Depth (m)	Water	Drilling Method	Testing	Graphic Log	Material Description	Classification Code	Consistency	Moisture	DCP graph
					Fill Topsoil Silty SAND SM: dark brown, fine to coarse grained, trace fine to coarse sized gravel, moist.	SM		M	
					Natural Silty SAND SM: medium dense, dark brown, fine to coarse grained, trace fine sized gravel, moist.	SM	MD		
1					BH1 refusal at 0.6m (Auger teeth grinding on sandstone bedrock)				
2
