# *Arboriculture Assessment & Management Statement*

April 2020

**Site:** Lot 1 in DP 588372  
9 Bate Avenue  
ALLAMBIE HEIGHTS, NSW|

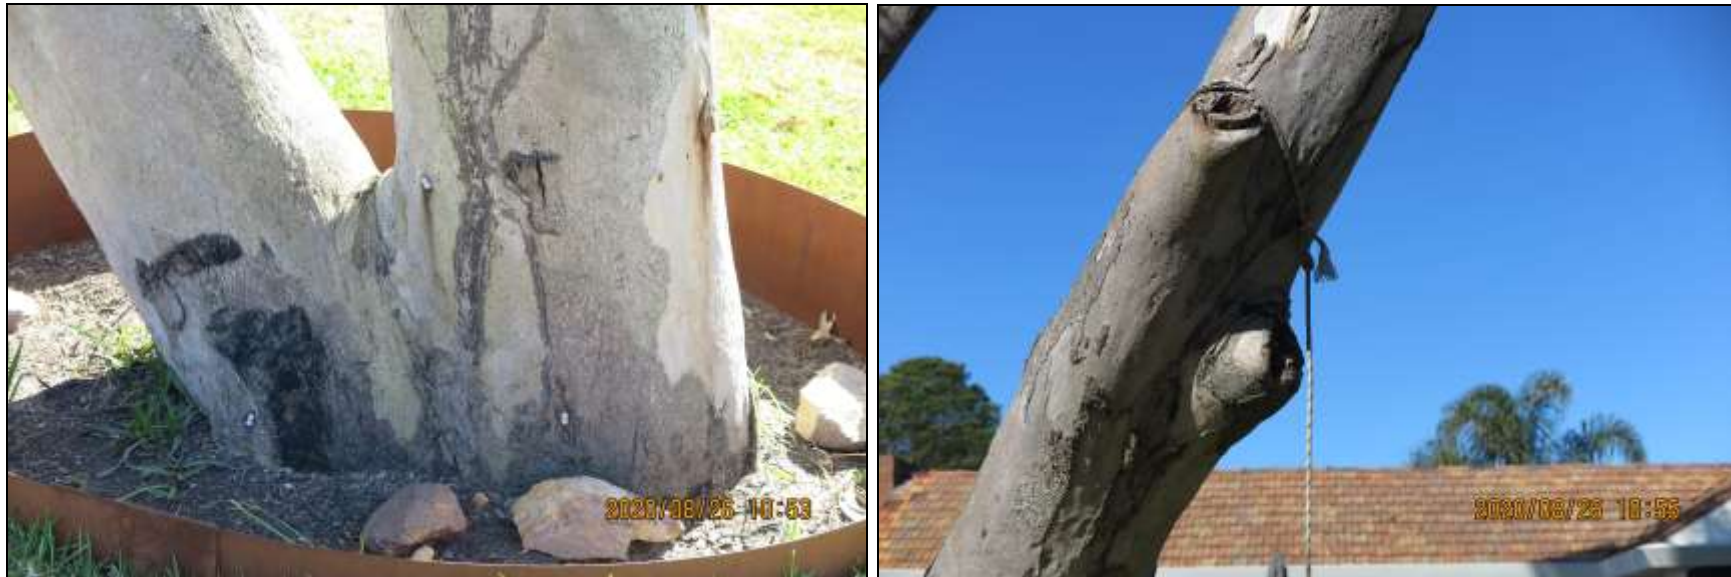
Figure 3: Left illustrates the location of the tree, note changed soil levels/retaining wall. Right illustrates one of multiple old termite transport galleries.

The discussed tree in the previous short term (i.e. around twelve (12) months has been subjected to a change of natural (previously existing) soil levels. Whilst not of concern at the time of assessment this may compromise its Useful Life Expectancy (from herein ULE) over time. As discussed onsite, the tree appears to display better character relative to health & vigour in recent months, most likely a consequence of back to normal (even greater than normal) natural rainfall patterns.

- (i) Any formal surfacing of the existing compacted bare soil surface driveway within the TPZ radial of 8.76m from the tree trunk centre be constructed using 'tree root friendly' materials. Simply, permeable or pervious pavers/materials.

- (ii) Any construction of a permanent structure, e.g. a secondary dwelling within the TPZ radial of 8.76m from the tree trunk centre be constructed by suspending the structure so as to reduce ground level disturbance within its total TPZ surface area (241.08m<sup>2</sup>).  
Excavation within this area would need to be completed 'manually'. Any significant diameter 'live woody root' greater than 50mm (0.050m) in diameter exposed would ideally be avoided by simply moving the 'footing/pier site'. This is very common best Arboriculture Practice & is supported by both the engineering & building fraternities.

- (iii) The discussed tree would be isolated from any future works by the installation of temporary metal mesh fencing panels with above ground supports as to the as calculated TPZ radial distance of 8.76m.

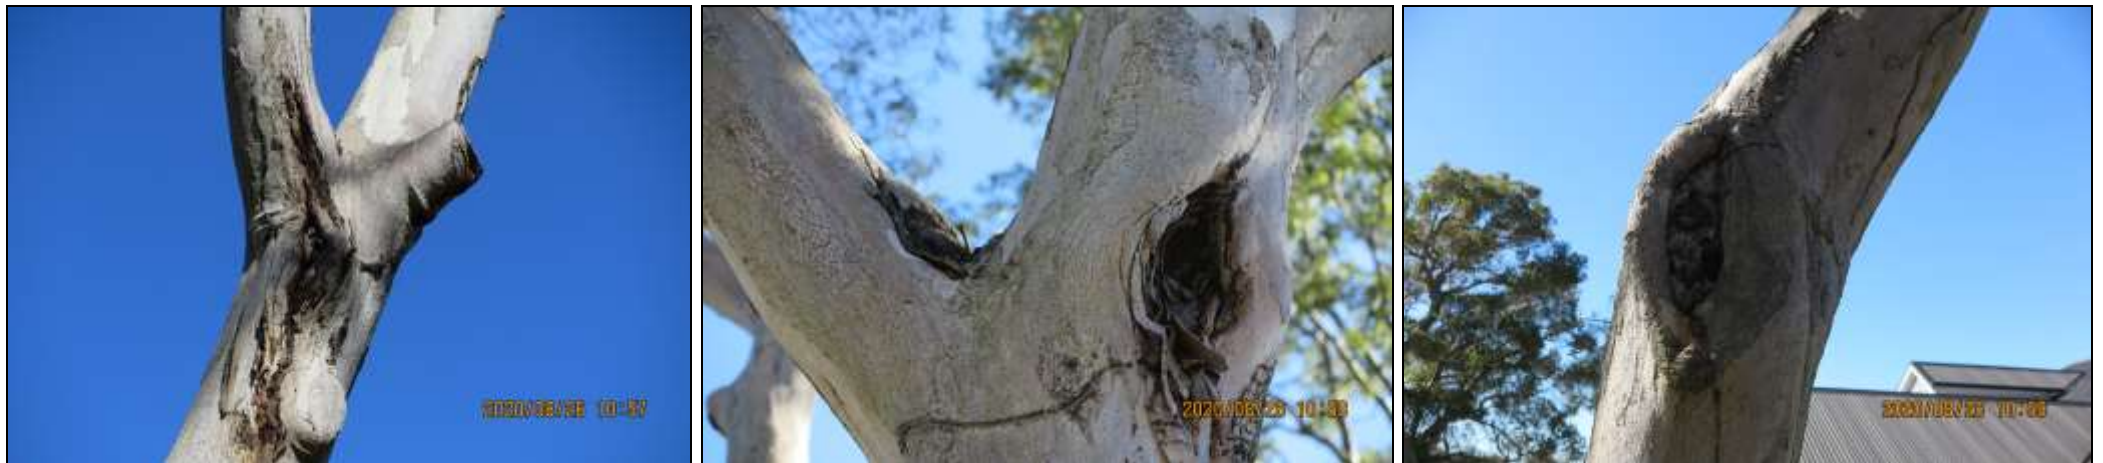
This document will specify the tree be monitored for any signs of active termite activity & change in appearance of its canopy. Multiple 'trunk/stem open wound sites display previous termite damage plus the likely presence of decay pathogen (fungal) organism damage. Monitor these wound sites for the appearance of 'fruiting bodies', commonly referred to as 'Bracket Fungi'. Should these appear the tree would likely require more in-depth assessment, i.e. Resistograph® of Sonic Tomograph (e.g. Picus® or Arbortom®) to quantify the presence of functional verses dysfunctional supporting wood tissues. (This is an expensive process & would not be undertaken unless council or consultant arborist specification to do so.)

Figure 4: Clockwise from top left, confirms altered soil levels/termite treatment sites, numerous open/sealed old wound sites with termite damage as well as decay pathogen damage, bottom middle & left illustrates likely 'fruiting body' emergence sites.

- *Document in writing with supporting photographic evidence any excavation process required.*
- *Reassess the tree relative to its Health & Vigour at least every 3 years, more often if still day 'live branch failures' occur or the tree can be visibly seen to be in a state of accelerated decline.*

- *The discussed tree is specified to be pruned on an as required basis, simply only removing dead/dying branches greater than 30mm in diameter. (See AS4373-2007 Pruning of amenity trees. See Chapter 7, Sections 7.1, 7.2 (plus subclauses) & 7.3 (plus subclauses).*
