# Hazardous Materials Survey

Proposed Stella Maris College Extension  
48-50 Eurobin Avenue  
Manly NSW 2095

**Project No. 22246**  
Version 2

9 December 2022

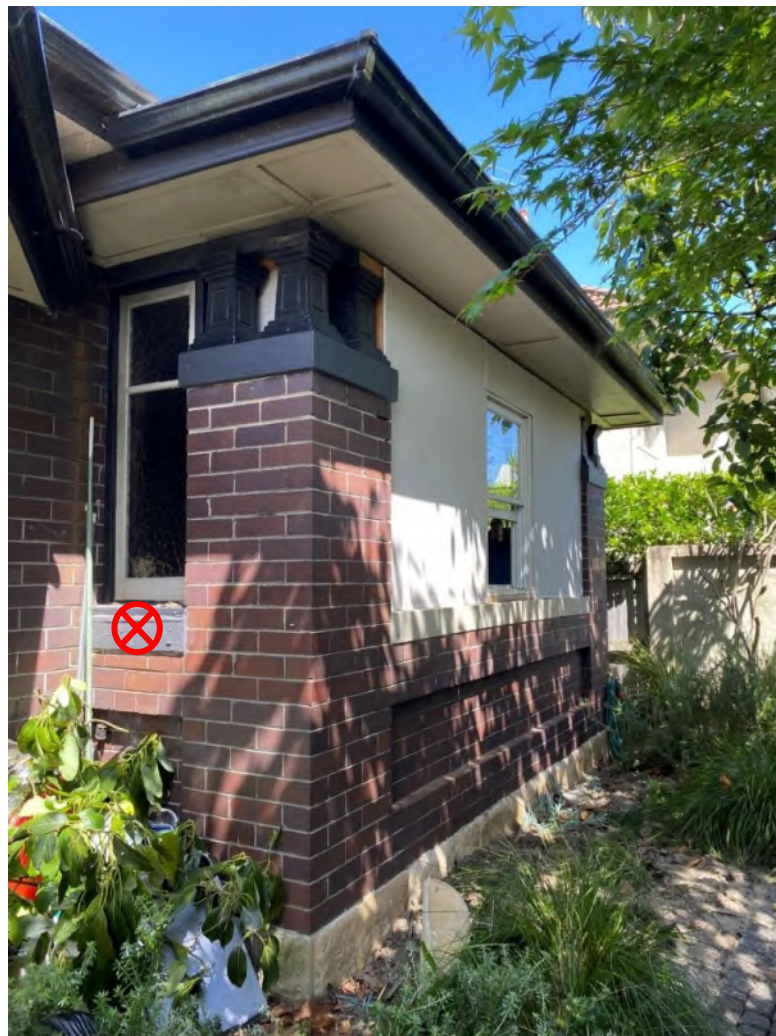
ITEM	DESCRIPTION
<b>Location(s)</b>	48 Eurobin Avenue - External windowsill
<b>Material Type</b>	Dark grey/blue paint
<b>Material Condition</b>	Poor
<b>Sample ID</b>	48-PS3
<b>Approximate Extent</b>	10m <sup>2</sup>
<b>Laboratory Results</b>	Lead in paint (%w/w) = 6.7%  <b>Exceeds 1% w/w criteria for Lead in Paint.</b>

(Sample location within red circle)

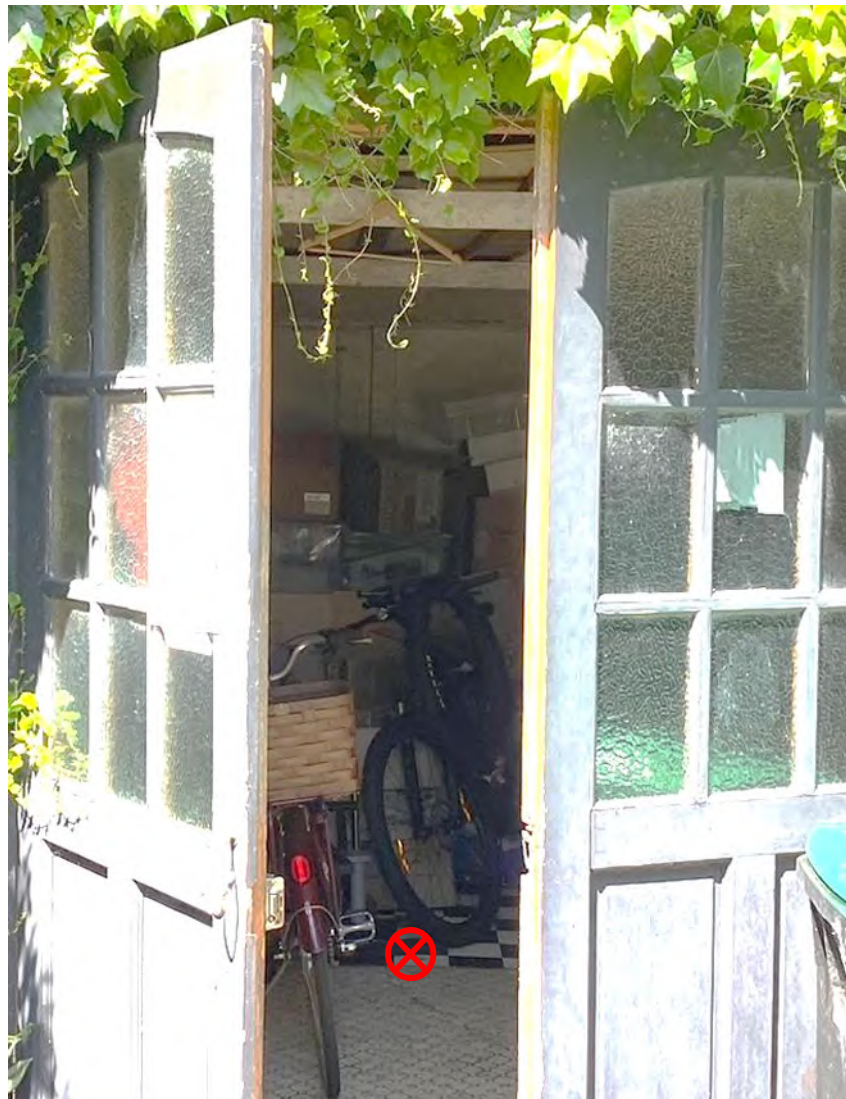
ITEM	DESCRIPTION
<b>Location(s)</b>	48 Eurobin Avenue - shed
<b>Material Type</b>	Black and white check pattern vinyl sheet
<b>Material Condition</b>	Fair
<b>Sample ID</b>	48-MS4
<b>Approximate Extent</b>	10m <sup>2</sup>
<b>Laboratory Results</b>	<b>Synthetic mineral fibres detected</b>

(Sample location within red circle)

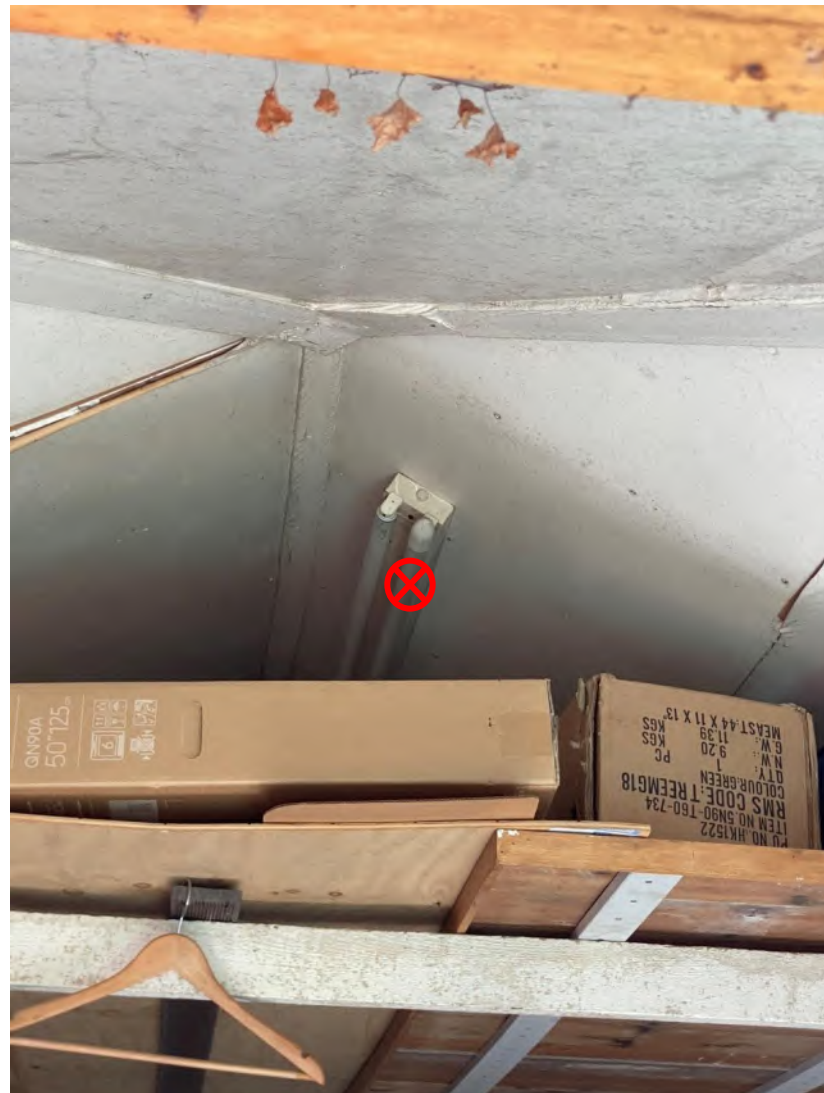
ITEM	DESCRIPTION
<b>Location(s)</b>	48 Eurobin Avenue – roof of shed
<b>Material Type</b>	Fluorescent light fixture
<b>Material Condition</b>	Good
<b>Sample ID</b>	N/A
<b>Approximate Extent</b>	1m <sup>2</sup>
<b>Laboratory Results</b>	<b>Not sampled - Potentially PCB containing fluorescent light fixture</b>

(Identified hazardous material within red circle)

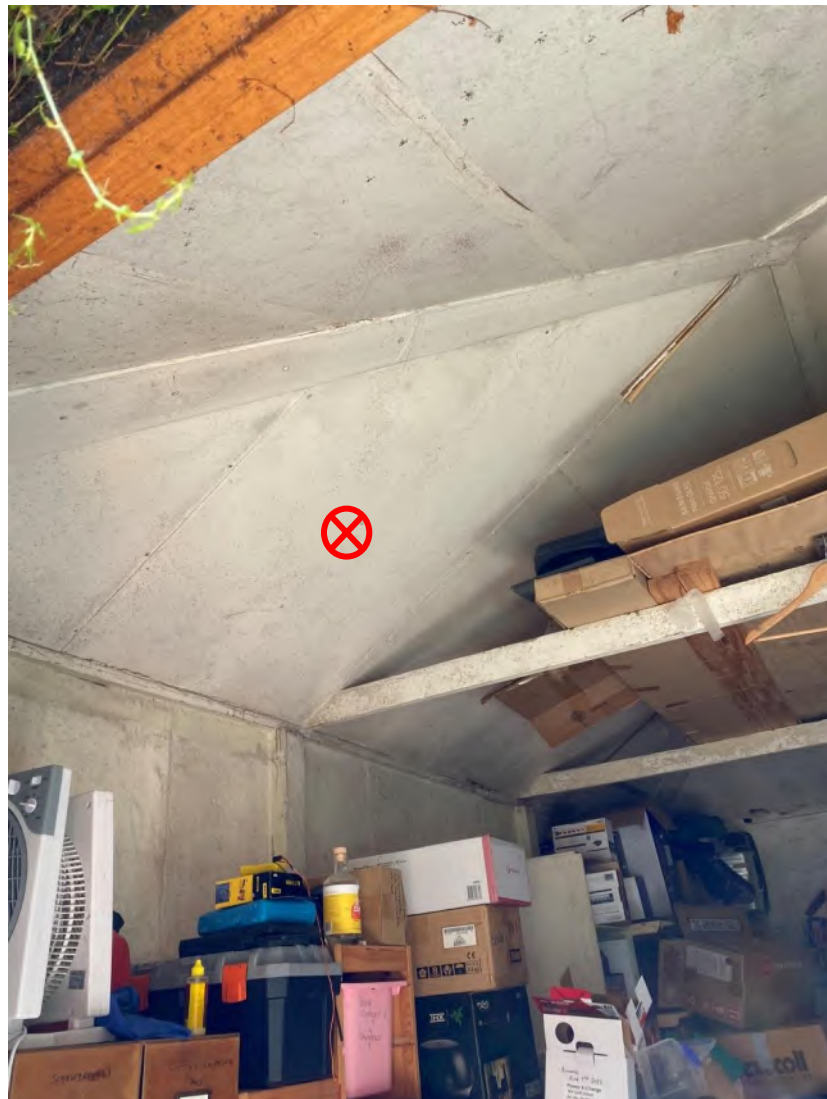
ITEM	DESCRIPTION
<b>Location(s)</b>	48 Eurobin Avenue – roof of shed
<b>Material Type</b>	Fibrous cement sheeting
<b>Material Condition</b>	Fair
<b>Sample ID</b>	N/A
<b>Approximate Extent</b>	20m <sup>2</sup>
<b>Laboratory Results</b>	<b>Not sampled - Potentially asbestos containing fibrous cement sheeting</b>

(Identified material within red circle)

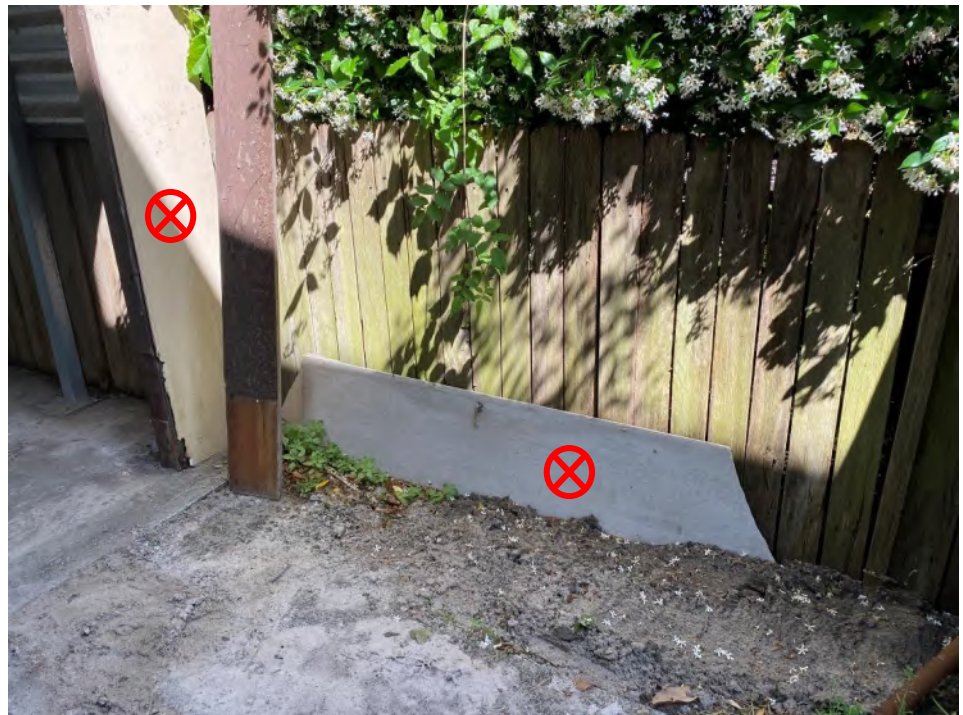
ITEM	DESCRIPTION
<b>Location(s)</b>	50 Eurobin Avenue – Unit 1, in car port
<b>Material Type</b>	Fibrous cement sheeting (dimpled)
<b>Material Condition</b>	Fair
<b>Sample ID</b>	N/A
<b>Approximate Extent</b>	2m <sup>2</sup>
<b>Laboratory Results</b>	<b>Presumed asbestos containing fibrous cement sheeting – asbestos fibres visible in cross section</b>

(Sample location within red circle)

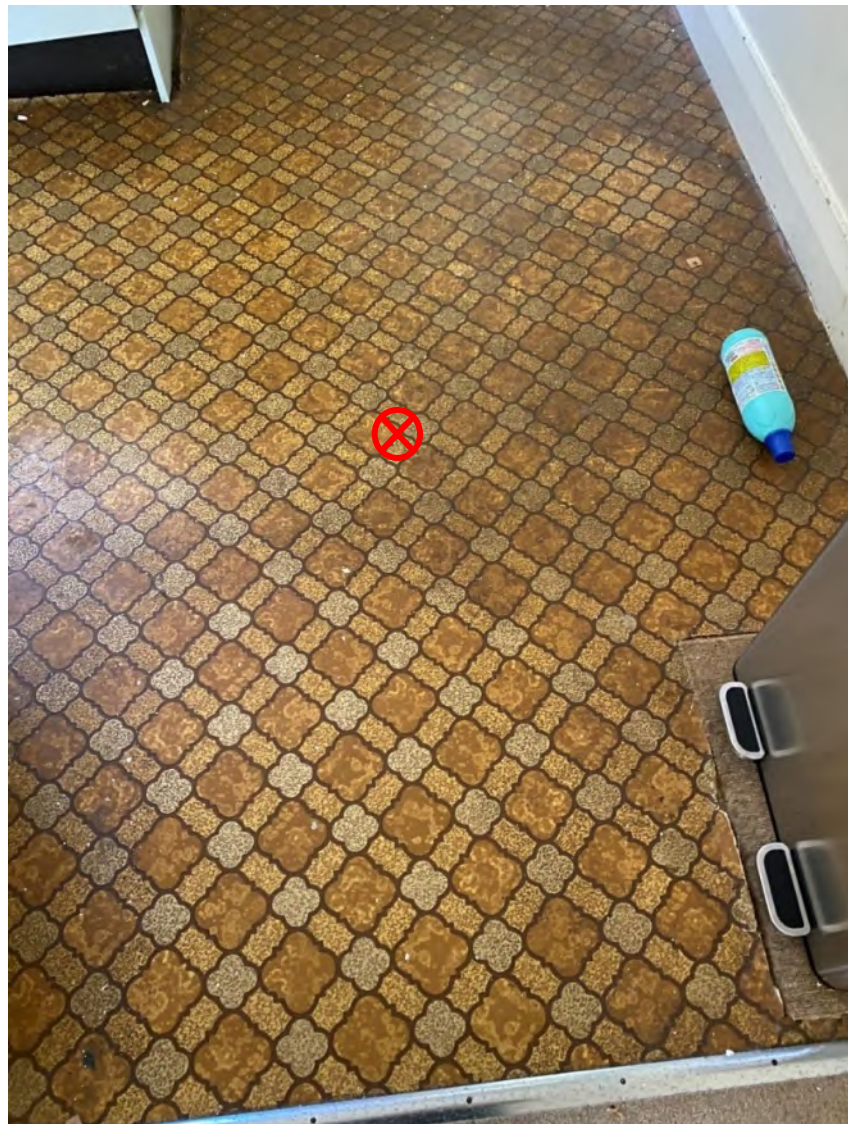
ITEM	DESCRIPTION
<b>Location(s)</b>	50 Eurobin Avenue – Unit 2 – Kitchen floor
<b>Material Type</b>	Beige geometric pattern vinyl sheet
<b>Material Condition</b>	Fair
<b>Sample ID</b>	50/2-MS1
<b>Approximate Extent</b>	10m <sup>2</sup>
<b>Laboratory Results</b>	<b>Chrysotile asbestos detected</b>

(Sample location  
within red circle)

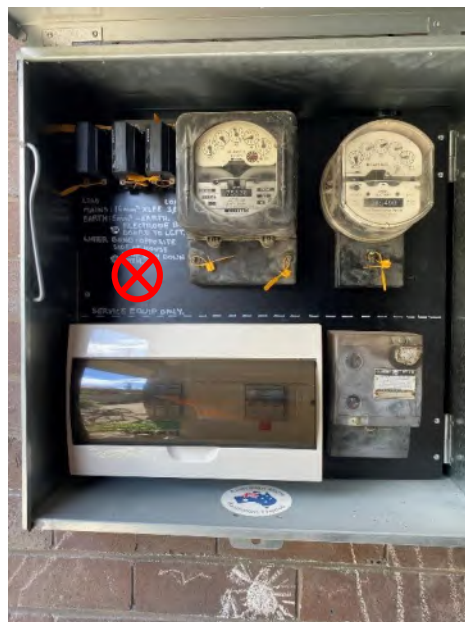
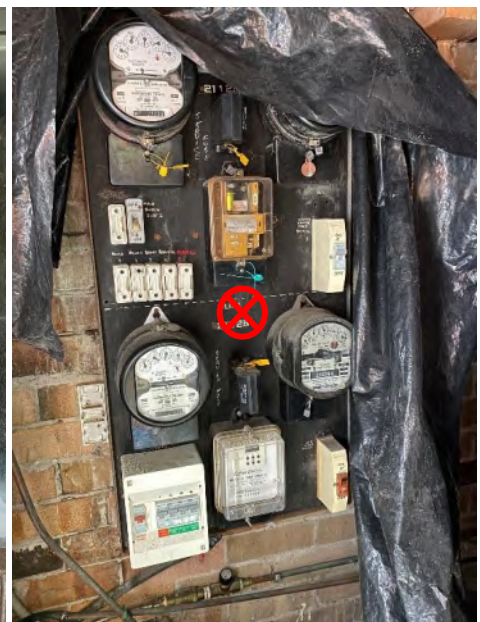
ITEM	DESCRIPTION
<b>Location(s)</b>	48 Eurobin – Fusebox on external of house near entrance 50 Eurobin – Unit 1 – Fusebox within fusebox room towards front of premises.
<b>Material Type</b>	Potentially asbestos containing backboard
<b>Material Condition</b>	Good
<b>Sample ID</b>	N/A
<b>Approximate Extent</b>	2m <sup>2</sup>
<b>Laboratory Results</b>	<b>Not sampled – Presumed to contain asbestos</b>

(Identified material within red circle)

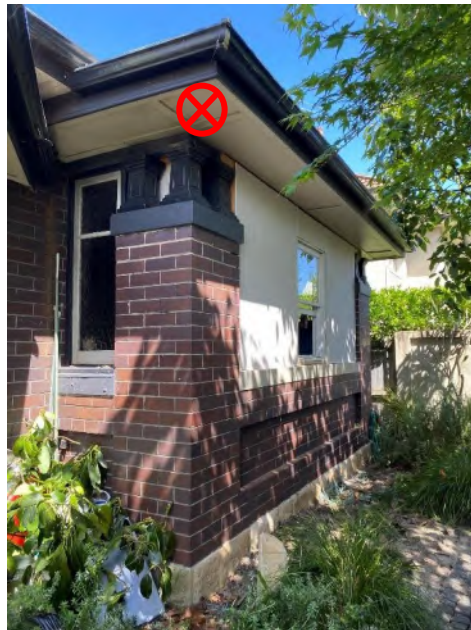
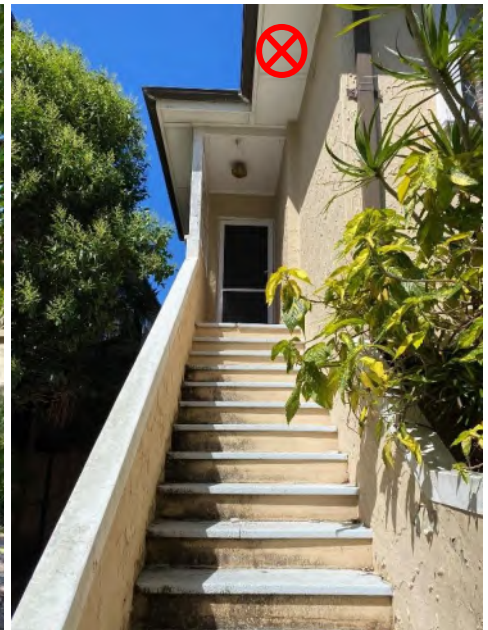
ITEM	DESCRIPTION
<b>Location(s)</b>	External eaves on both properties
<b>Material Type</b>	Potentially asbestos containing fibrous cement sheeting
<b>Material Condition</b>	Fair
<b>Sample ID</b>	N/A
<b>Approximate Extent</b>	50m <sup>2</sup>
<b>Laboratory Results</b>	<b>Not sampled – Presumed to contain asbestos</b>

(Identified material within red circle)
