Geotechnical Assessment

Project: Residential Development
1955 Pittwater Road, Bayview, NSW.

REF: AG 19015
30th January, 2019

For Residential Development at
1955 Pittwater Road, Bayview, NSW

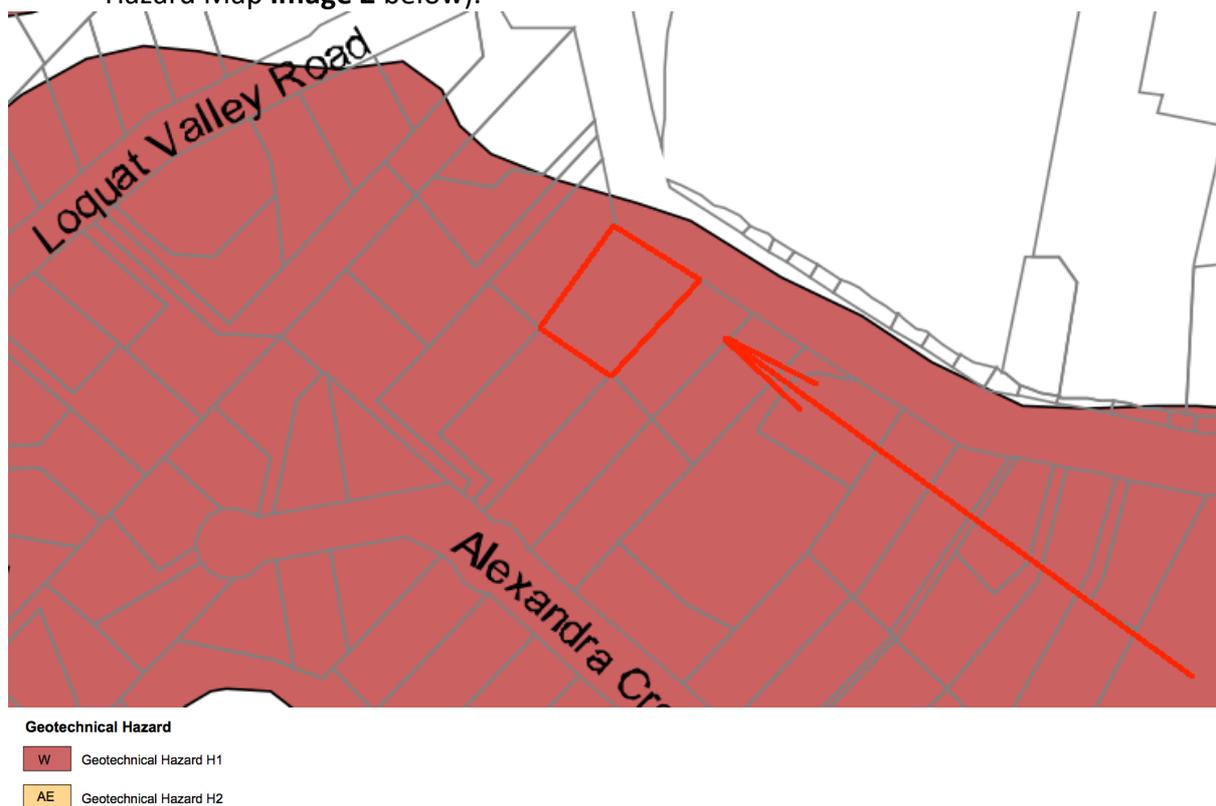
- The property is classified Geotechnical Hazard H1 (W) with reference to Northern Beaches Council PLEP Geotechnical Hazard Map Sheet GTH_011 (PLEP Geotechnical Hazard Map **Image 2** below).

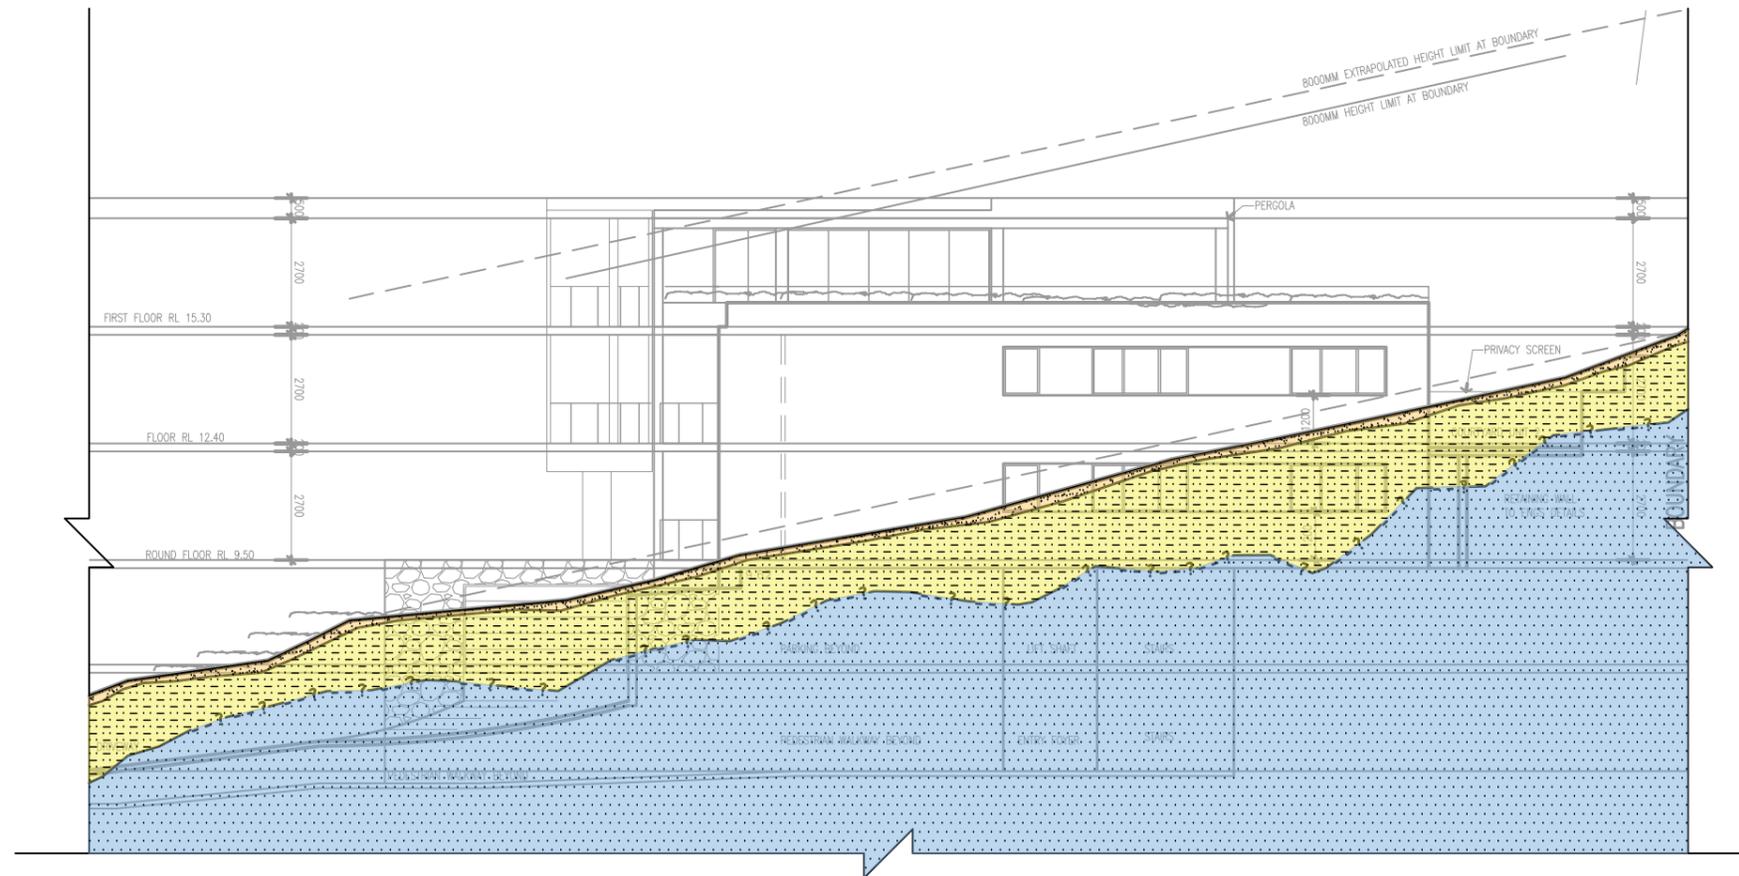
INFERRED GEOLOGICAL TYPE SECTION

INTERPRETED SUBSURFACE SECTION ONLY.
ACTUAL GROUND CONDITIONS MAY VARY.

DEPTH TO AND COMPOSITION OF BEDROCK
GEOLOGY TO BE CONFIRMED BY MECHANICAL
DRILLING.
