Marine Habitat Survey

Address | 187 Riverview Road, Avalon Beach

Survey Date | 24 July 2023

Job Number 23-061-08

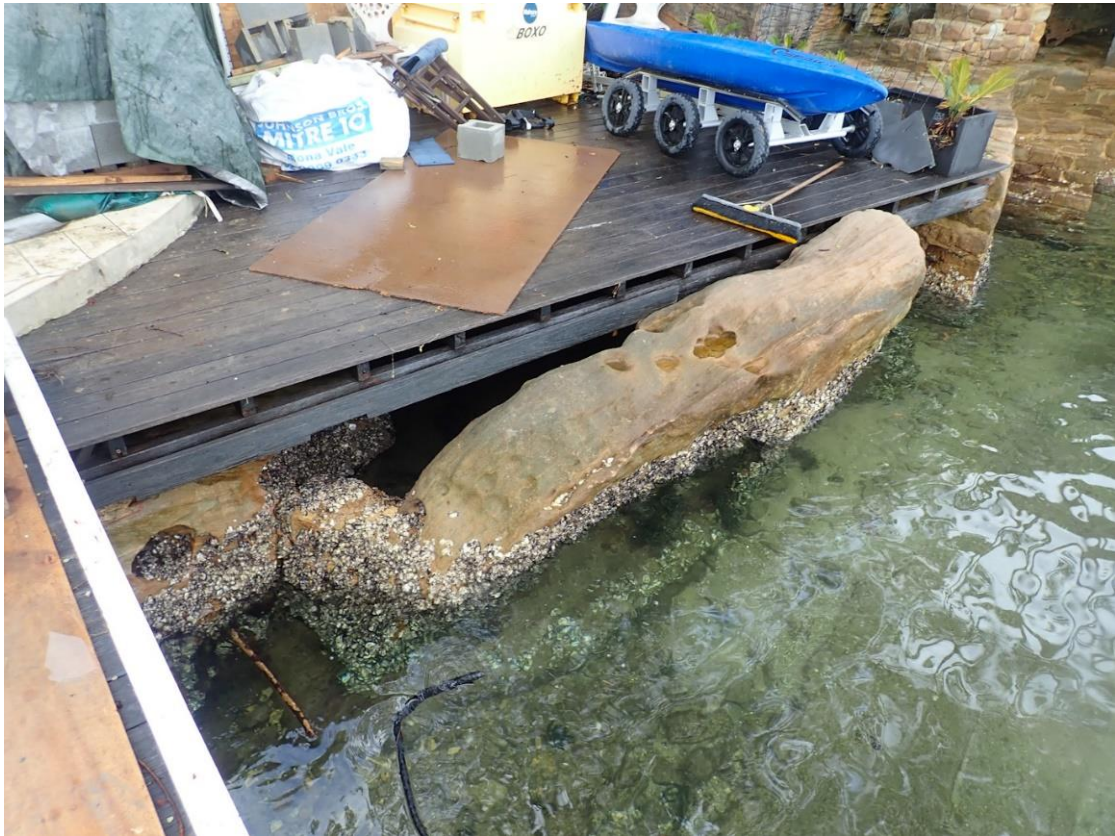
The unauthorised timber deck sat atop an area of natural rock which was colonised by high density cover of oysters (Photo 1) off the front of the deck and in areas of rock that were visible under the decking. The oyster habitat on this area of rock did not appear to be impacted by the installation of the unauthorised deck.

The unauthorised timber deck has had no observable negative impacts on the oyster habitat on the underlying area of natural intertidal rock.

Photo 1. The unauthorised timber deck on the southern edge of The Property, sitting atop the natural rock colonised by oysters.

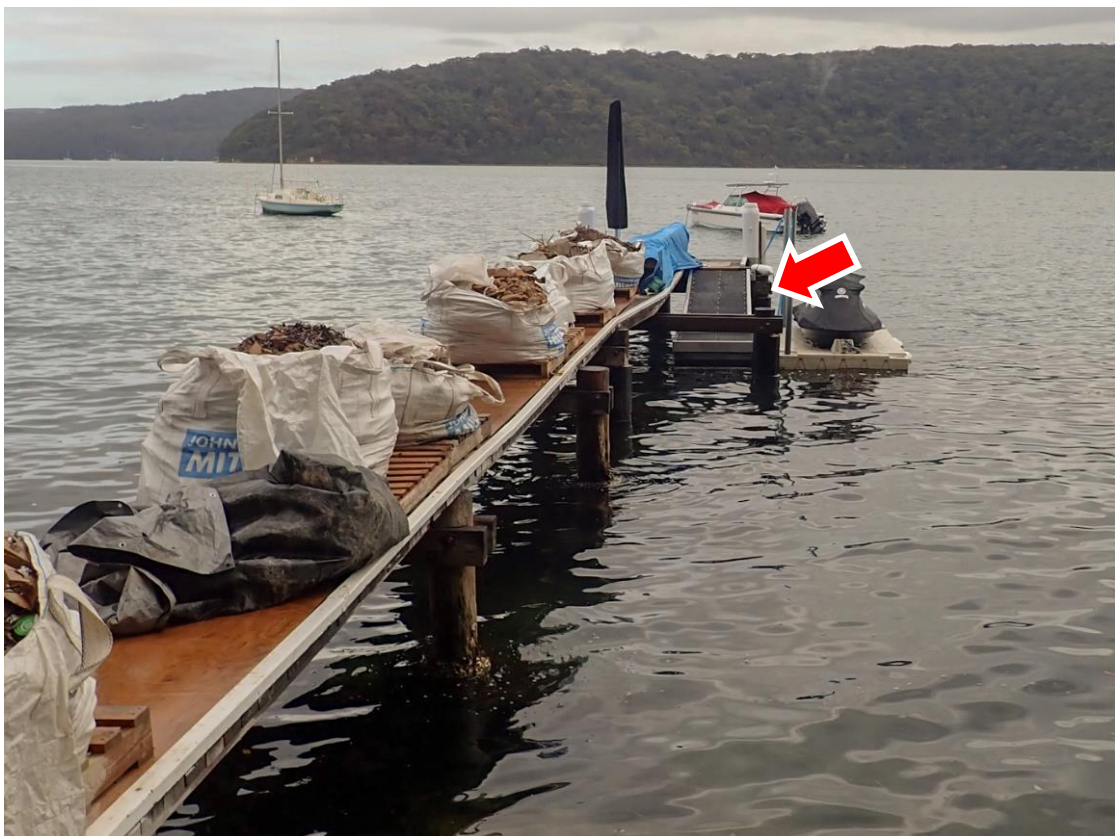
The unauthorised mesh landing ramp and small mesh pontoon was located almost entirely over an area of subtidal boulders (Photos 7 - 8), with almost no sand available in its footprint for seagrass to colonise. The rocky substratum and attached biota did not appear to be harmed by the unauthorised mesh landing ramp and small mesh pontoon.

There was no seagrass present in the footprint of the unauthorised mesh landing ramp and small mesh pontoon, as nearly all the seabed in this area was rocky and therefore not an available habitat for seagrass to colonise.

Photo 2. The authorised timber jetty, with the red arrow indicating the unauthorised mesh landing ramp and small mesh pontoon.

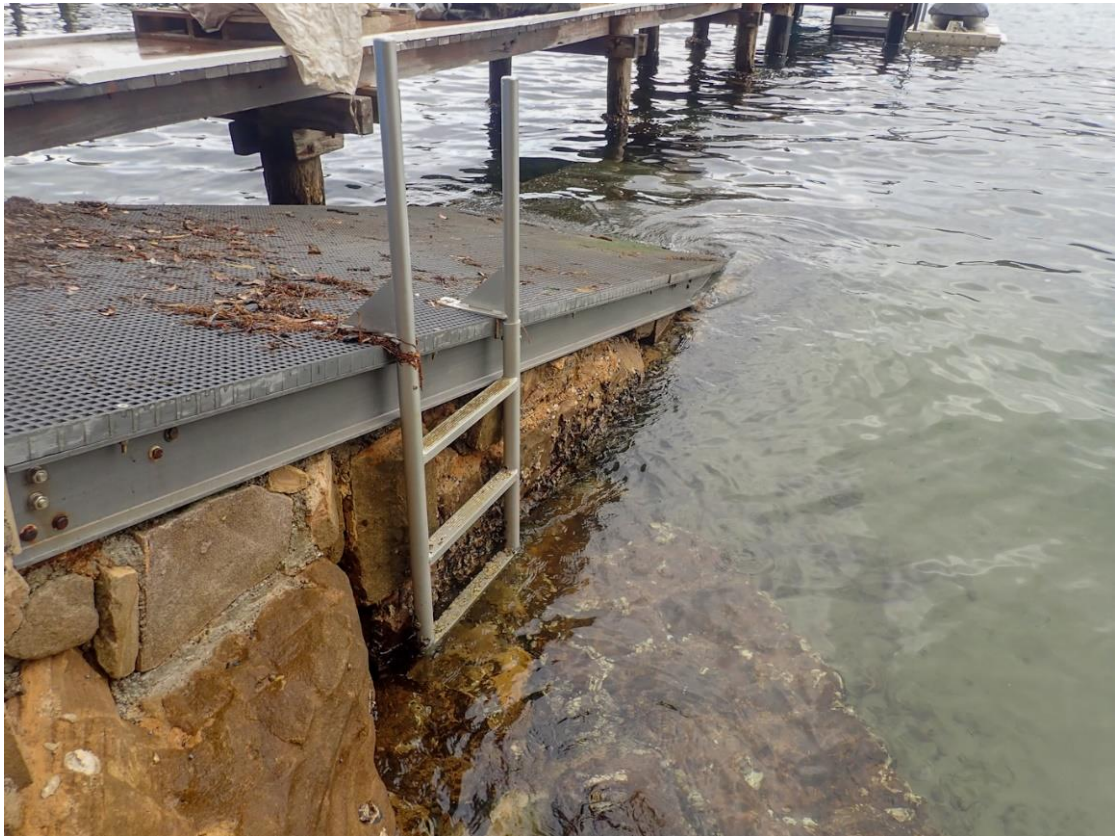
The unauthorised stone ramp was installed on top of the intertidal sand area (Photo 4). This area of intertidal sand would most likely have been unvegetated prior to the installation of the stone ramp, as the sand the same distance offshore on the northern side of The Property is currently unvegetated. The exposed sandstone blocks on the side of the stone

The unauthorised stone ramp has had no observable negative impacts on the intertidal sand area. This area of intertidal sand would most likely have been unvegetated prior to the installation of the stone ramp, as the sand the same distance offshore on the northern side of The Property is currently unvegetated. The exposed sandstone blocks on the side of the stone ramp have proved to be beneficial by providing a new artificial intertidal habitat at The Property which has been colonised by oysters and periwinkles.

Photo 3. The unauthorised stone ramp covered with a mesh ramp on the northern side of the jetty.

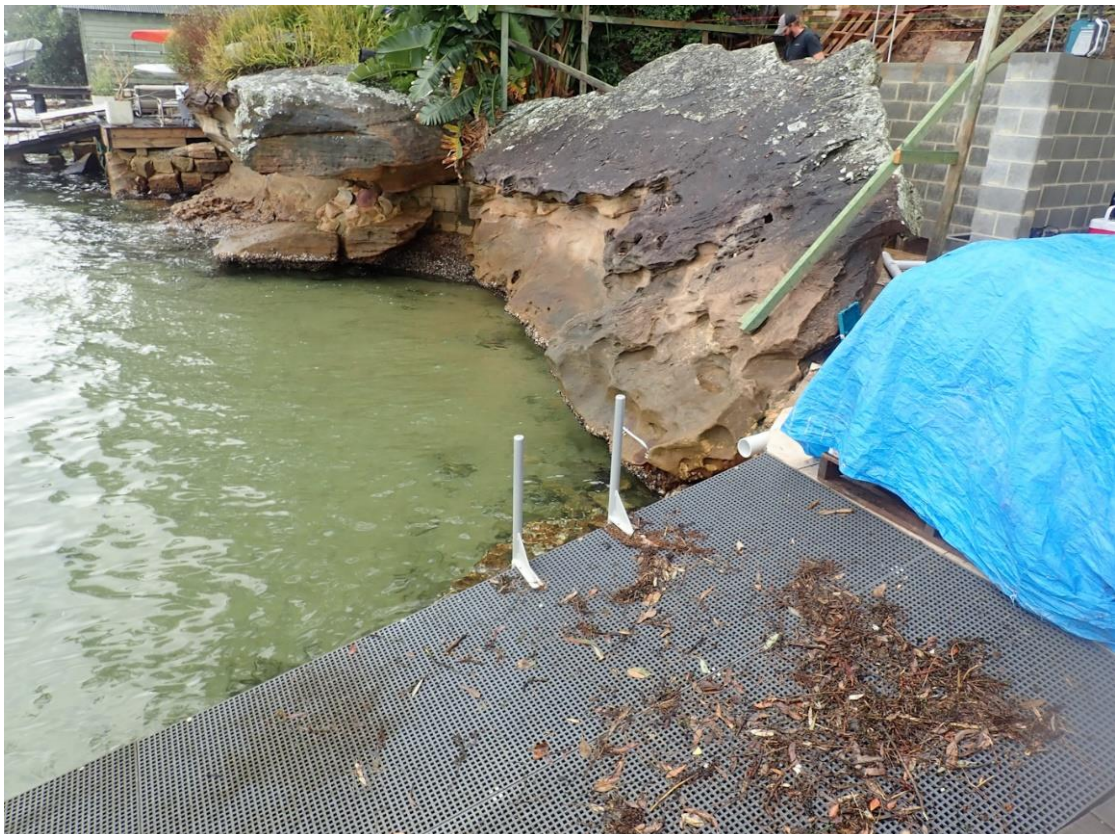
The intertidal zone within the on-site survey area of The Property consisted of artificial and natural habitats. There was a low natural sandstone rock face that extended across the width of The Property (Photos 1 and 4). The rock face was fronted by an approximately 4 m wide area of sand on the northern side of the jetty (Plate 4) and by a 4 m wide flat rock shelf on the southern side of the jetty and offshore of the unauthorised deck. The sandstone block sides of the unauthorised stone ramp and the timber jetty piers provided artificial intertidal habitat.

The base of the natural rock face (Photos 1 and 4) was colonised by a narrow, high density cover of Sydney rock oysters (*Saccostrea glomerata*), along with scattered periwinkles (*Bembicium auratum*). The timber jetty piers were colonised by a medium density cover of oysters.

Photo 4. The natural rock face fronted by intertidal bare sand on the northern side of the unauthorised stone ramp.

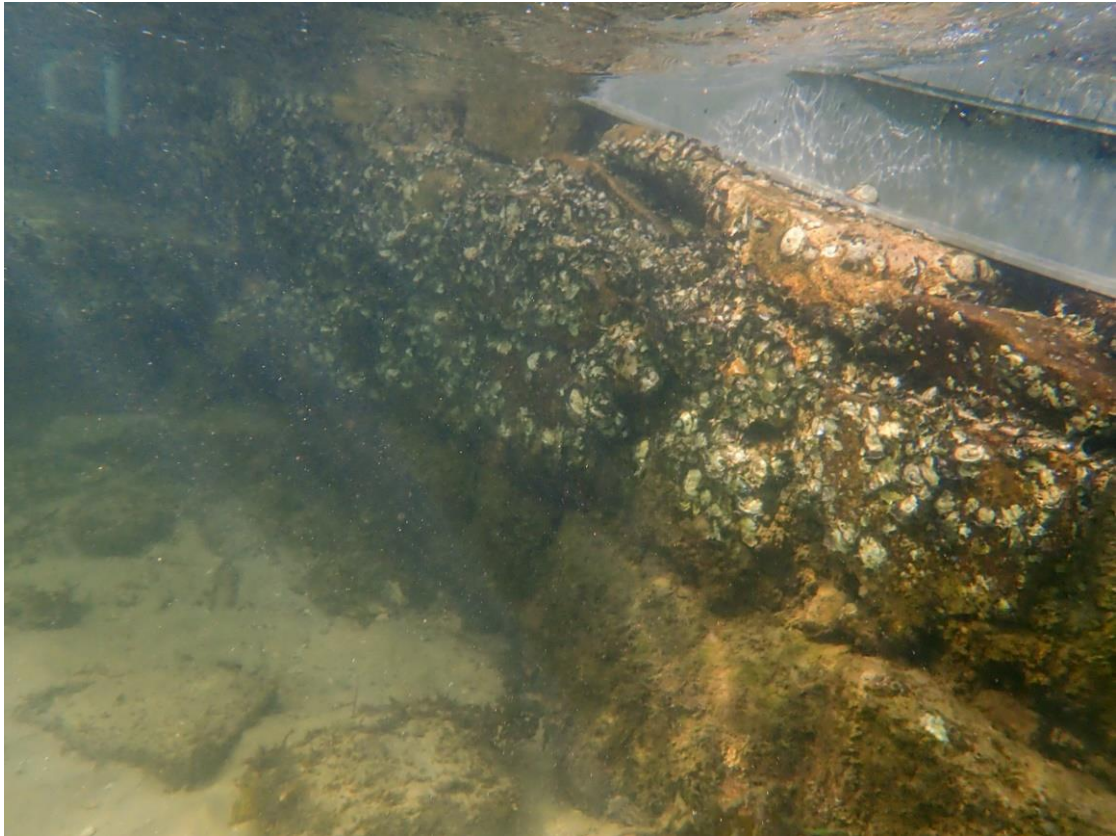
ramp provided artificial intertidal habitat for a high density cover of oysters (Photo 5) and scattered periwinkles (*Bembicium auratum*).

Photo 5. The intertidal cover of oysters on the submerged side blocks of the stone ramp.

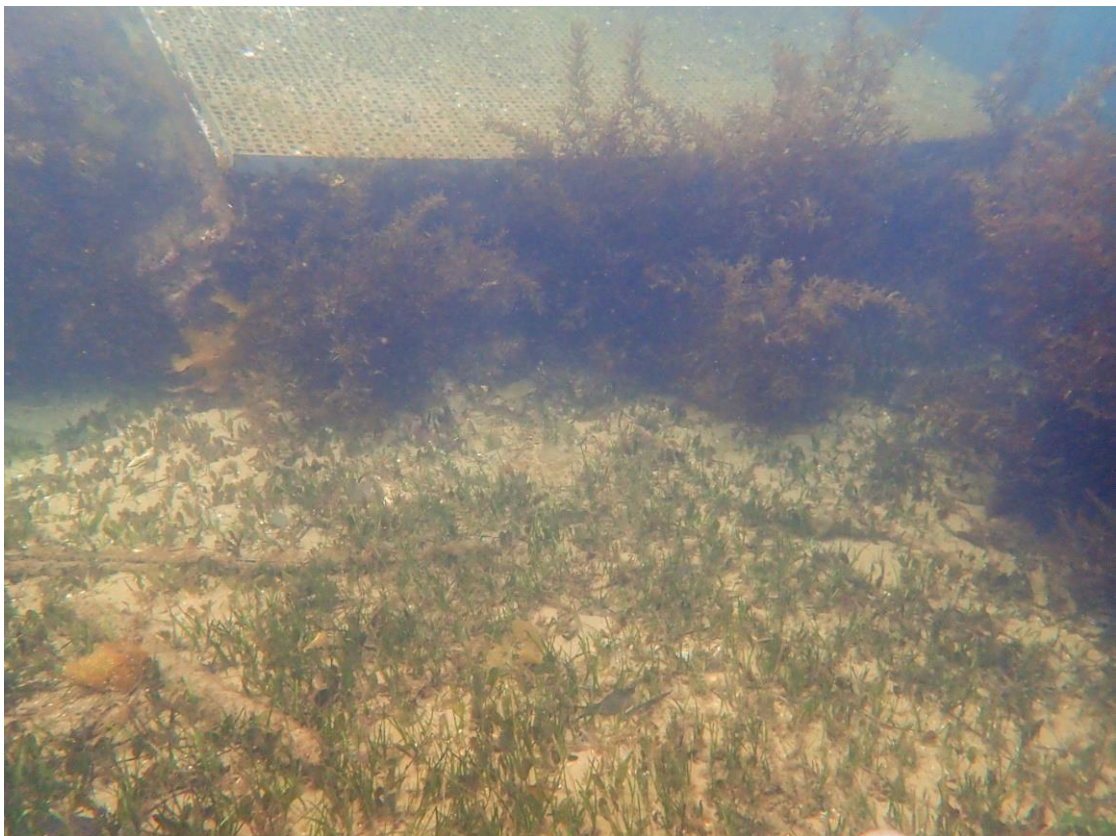
A non-continuous, medium density bed of mixed *Zostera* and *Halophila* seagrass (ZosC2M/HalC2L; Photo 6) colonised much of the sandy seabed, where available in amongst areas of rocks and boulders (see seagrass map in Appendix B). The inshore margin of the bed wrapped around the end of the unauthorised stone ramp (Photo 6). There was no seagrass present in the footprint of the unauthorised mesh landing ramp and small mesh pontoon, as nearly all the seabed in this area was rocky (Photos 7 - 8).

Photo 6. The inshore margin of the mixed *Zostera* and *Halophila* (ZosC2M/HalC2L) seagrass bed off the front of the unauthorised stone ramp.

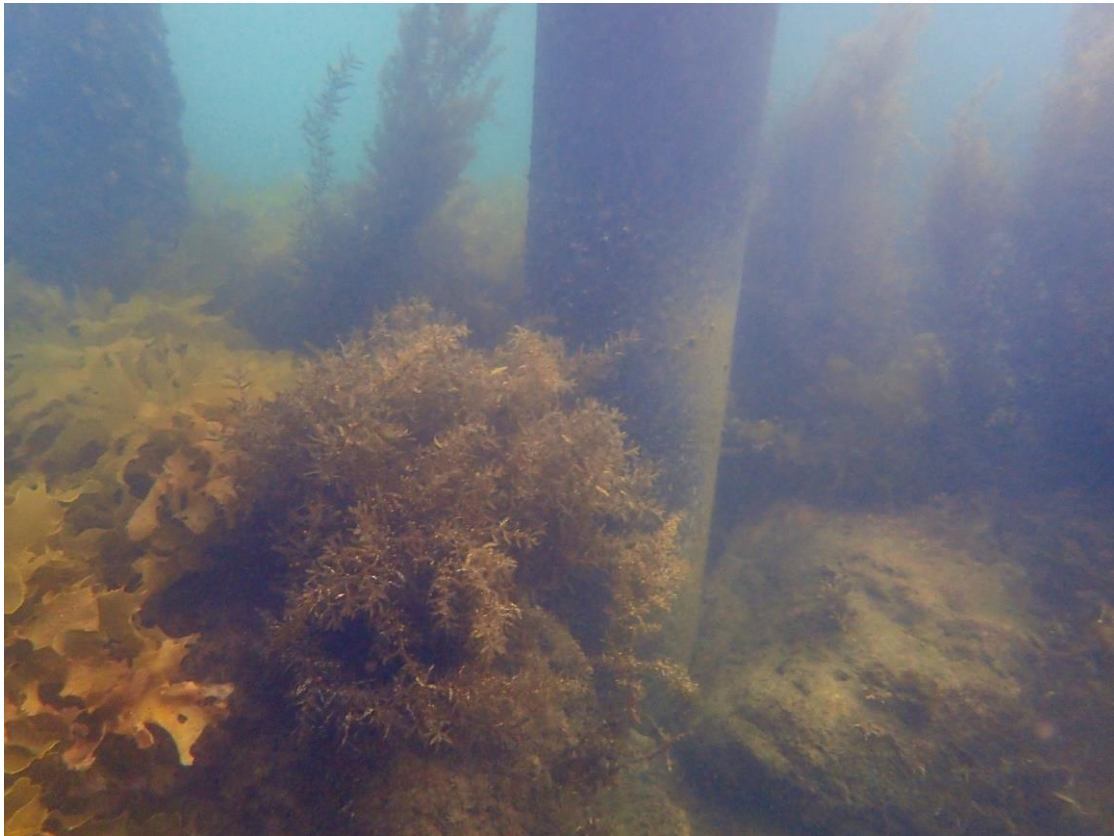
Photo 7. Subtidal rocky substrata under the unauthorised mesh ramp, colonised by bubbleweed and kelp.

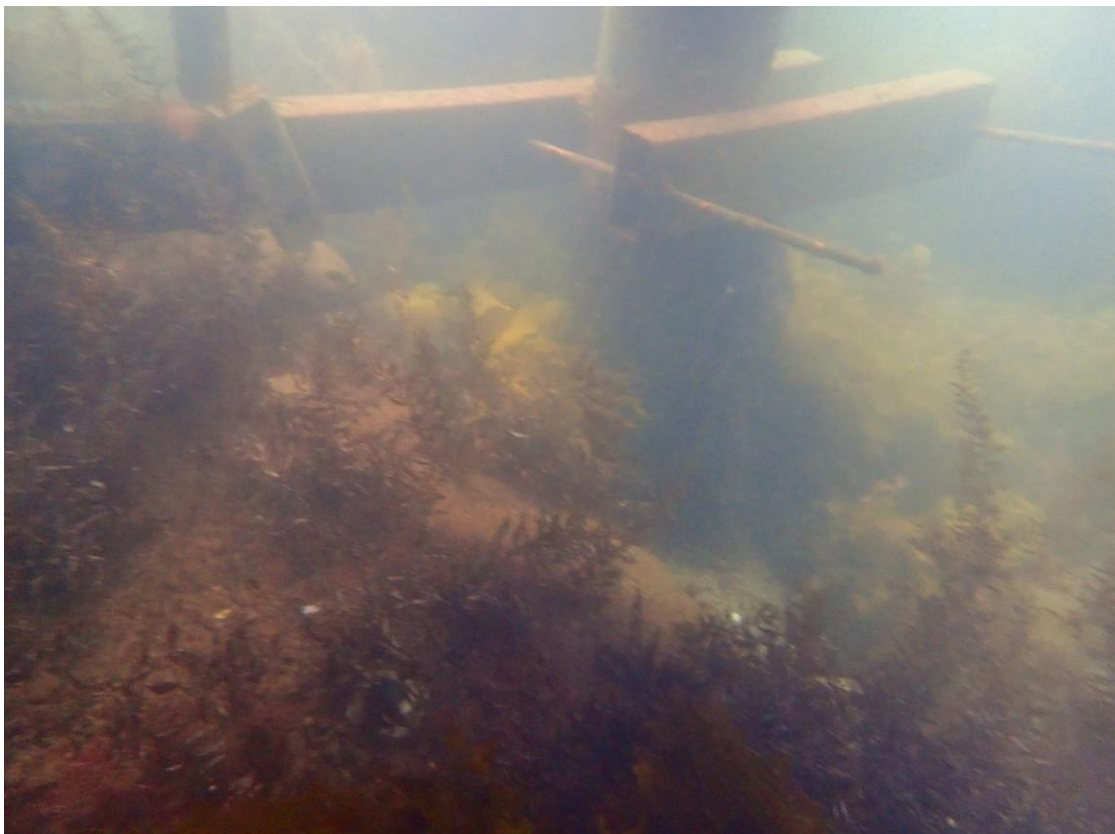
Photo 8. Subtidal rocky substrata under the unauthorised mesh pontoon, colonised by bubbleweed and kelp.
