GEOTECHNICAL INVESTIGATION:

New Garage and Alterations and Additions at **6 Hillcrest Place, North Manly**

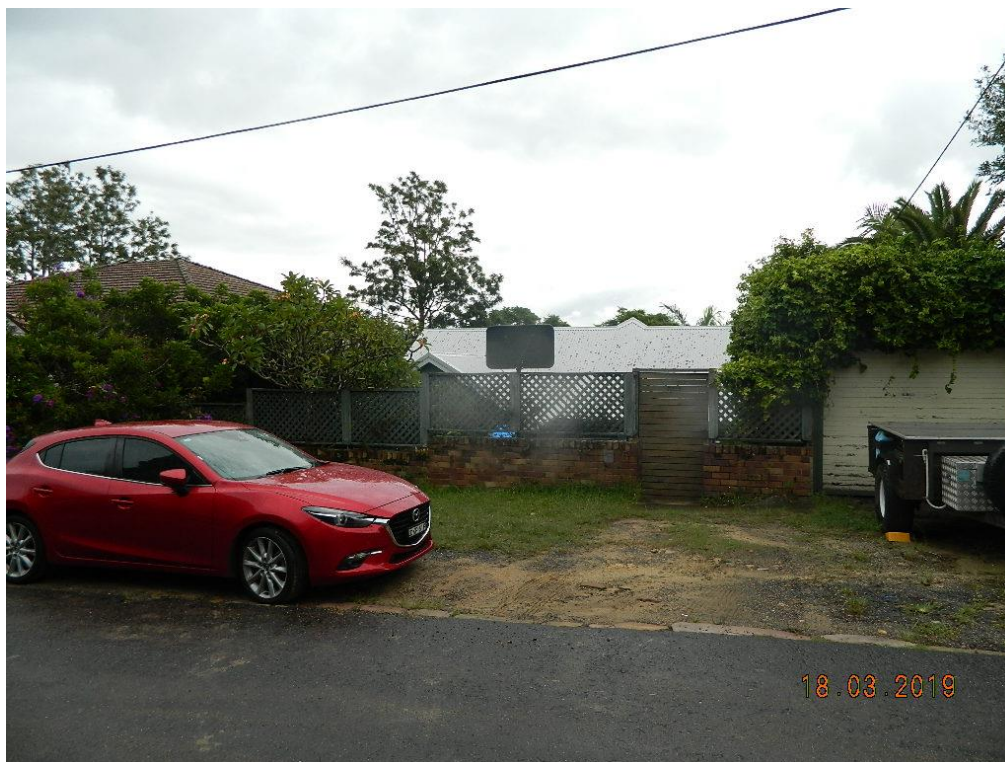
Photo 1

- 2.3** At the road frontage, an excavation has been made in the slope to level an area for a lawn and deck on the uphill side of the house (Photo 1). The excavation is supported by a stable brick wall that will be rebuilt as part of the proposed works (Photo 2). Medium Strength Sandstone is exposed at the surface along Hillcrest Place and at the base of the brick retaining wall (Photo 3). An old brick garage on the N side

of the road frontage has been constructed on top of Medium Strength Sandstone and will be demolished as part of the proposed works (Photo 1). The part two-storey brick house is supported on brick walls and brick piers (Photo 4). No significant signs of movement were observed in the supporting brick walls and the supporting brick piers stand vertical (Photo 5). Competent Medium Strength Sandstone was observed outcropping in the foundation space (Photo 6). A well-vegetated slope falls from the downhill side of the house before easing to the lower boundary (Photo 7). The slope is broken up by a stack rock retaining wall reaching a maximum height of ~0.5m. The wall is old but, from what could be observed, is in a stable condition (Photo 8). Large dislodged sandstone joint blocks sit partially embedded in the slope directly below the house (Photos 9 & 10). They appear to be in a stable position and have been in place for some time. No significant signs of movement were observed on the property. No geotechnical hazards that could impact on the subject property were observed on the neighbouring properties as seen from the subject property and the road.

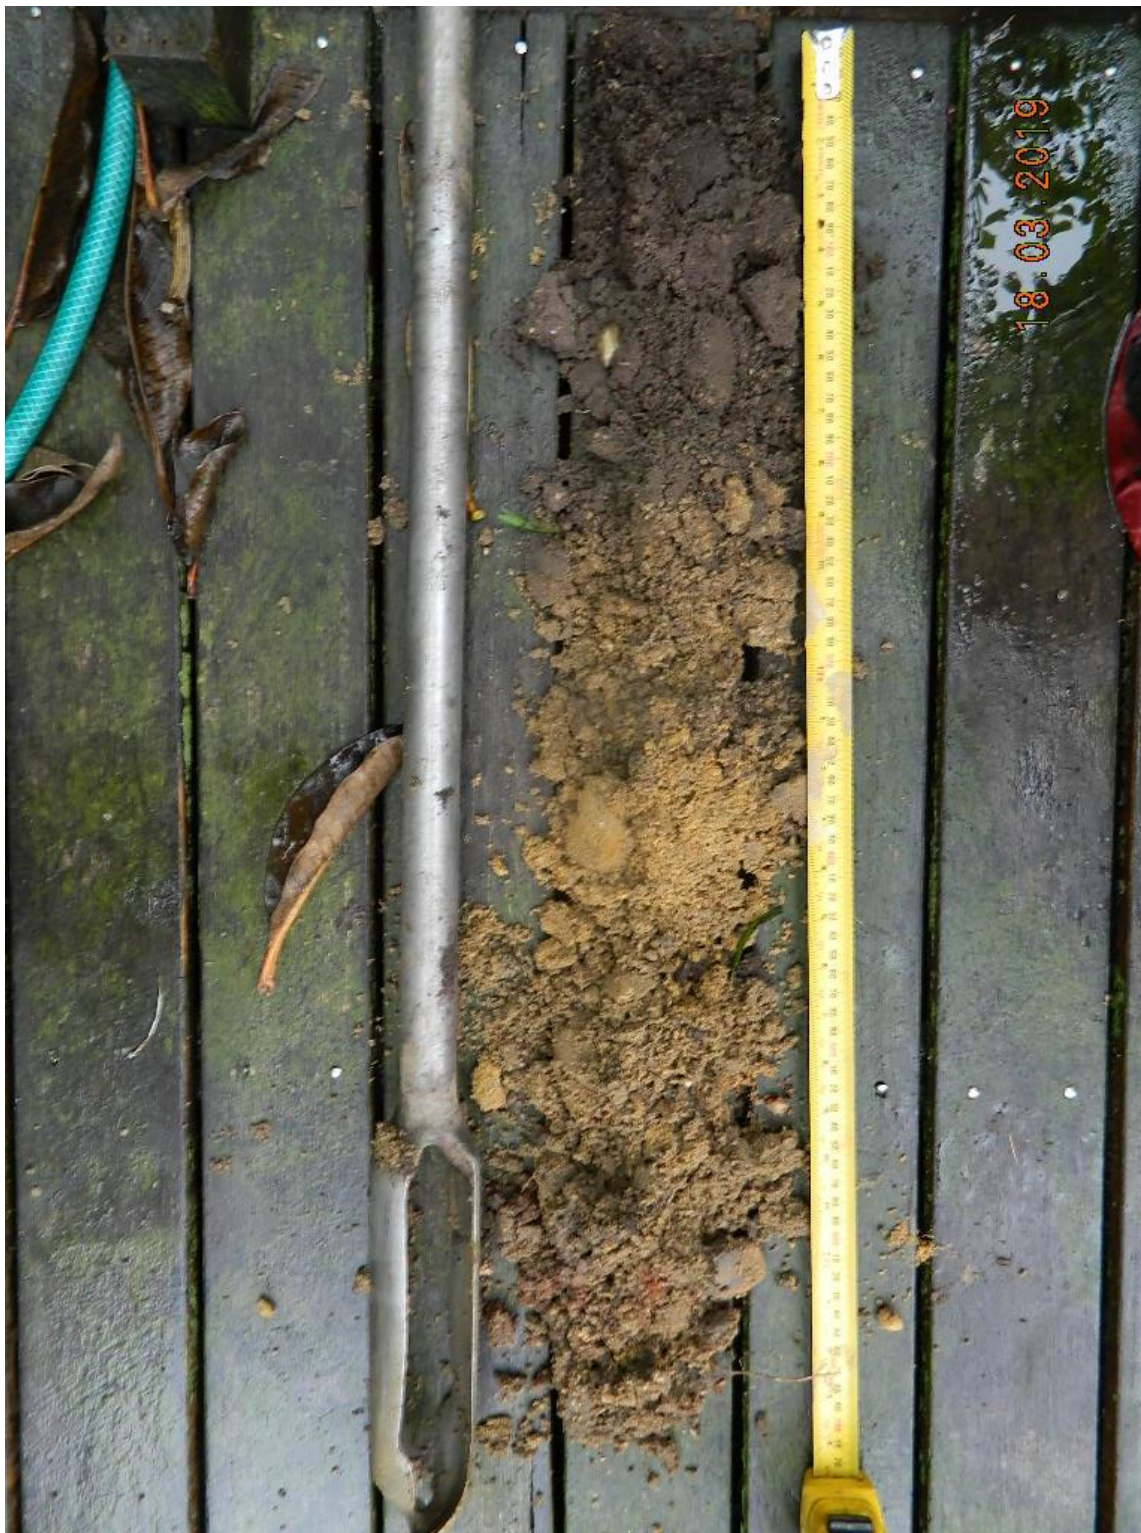
AUGER HOLE 1 (~RL15.4) – AH1 (Photo 11)

Depth (m)	Material Encountered
0.0 to 0.2	SANDY SOIL , brown, loose, soft, organic matter, fine to medium grained, dry.
0.2 to 0.7	SILTY SAND , weathered sandstone, yellowish brown, sugary texture, loose, rock fragments throughout, red mottling, clay inclusions, damp.

Refusal @ 0.7m in silty sand. No watertable encountered.

Photo 11: Auger Hole 1, base of hole at base of image
