GEOTECHNICAL INVESTIGATION:

New Pool at 10 Beverly Place, Curl Curl

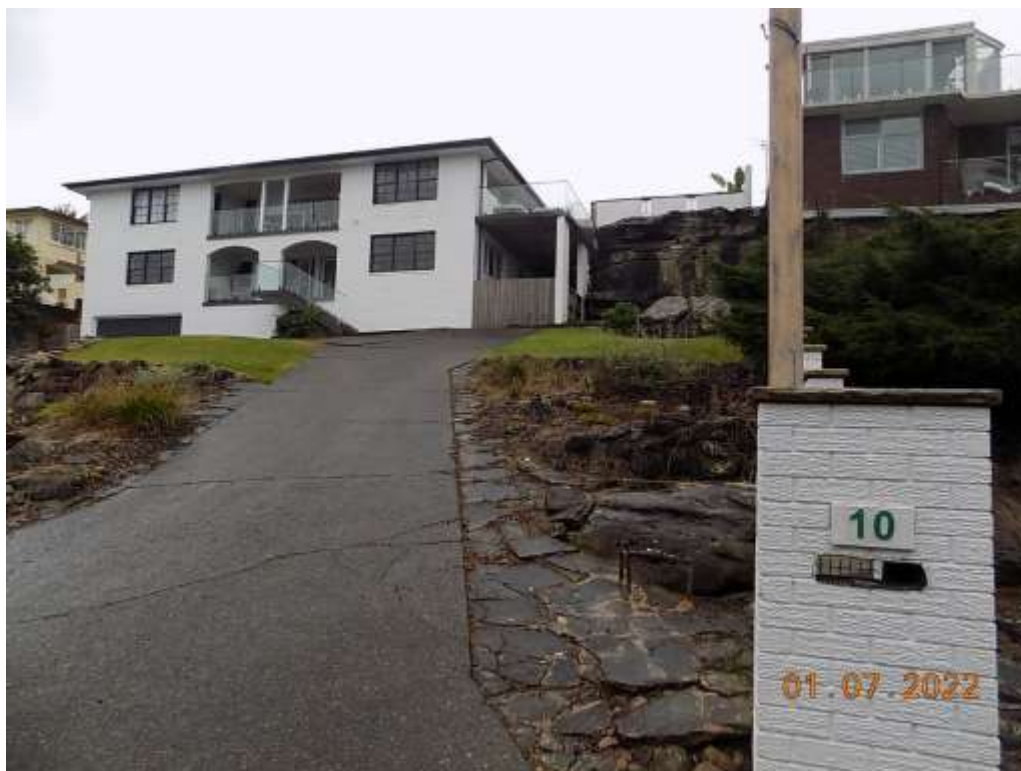
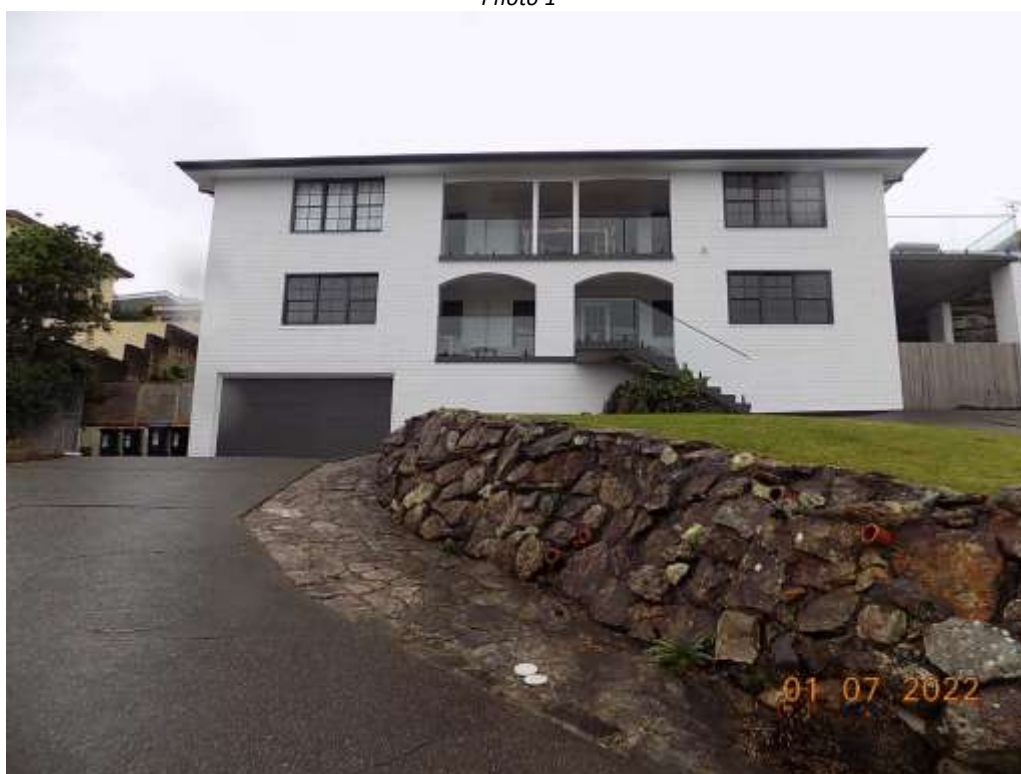
- 2.3** At the road frontage, a concrete driveway runs to a garage and carport underneath the downhill side of the house (Photos 1 & 2). A fill for a lawn area in between the lower common boundary and the house is lined by a ~2.0m high sandstone flagging wall. The two-storey rendered brick house is supported on external brick walls. The external brick walls show no significant signs of movement. The cut to create the level platform for the house has been taken through Competent Medium Strength Sandstone (Photo 3). A ~4.0m high rock face steps up the N side of the property (Photo 4 & 5). The outcrop was observed to be slightly undercut on the E face but is considered stable. There is a cavity on the S side of the rock face that is

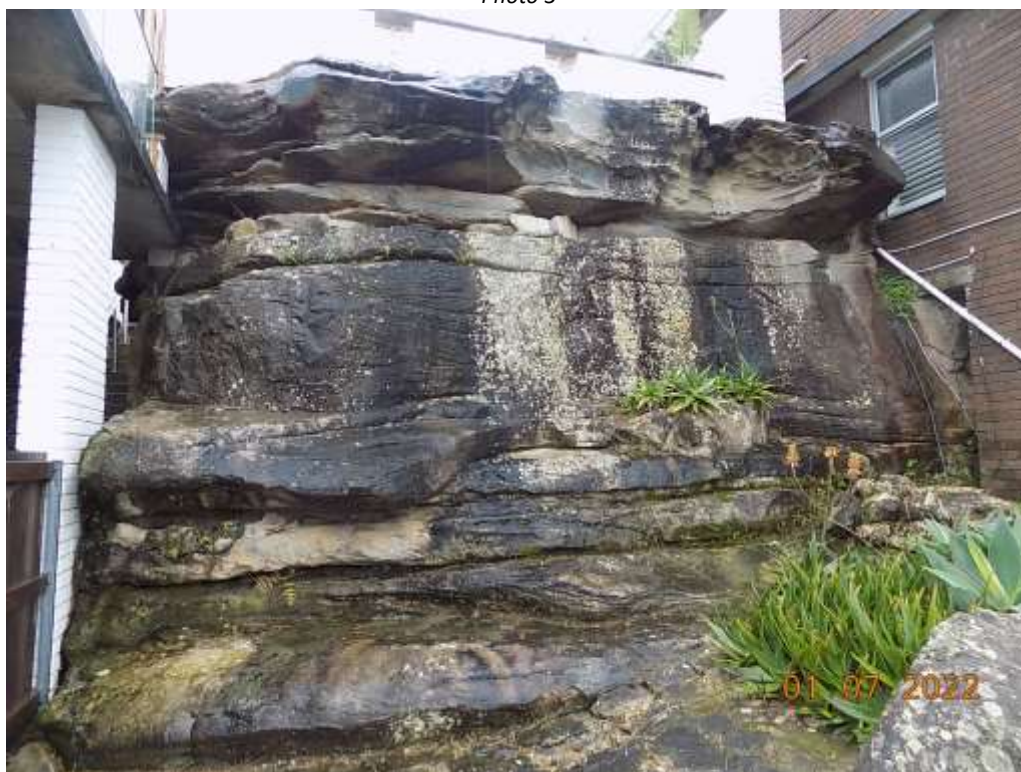
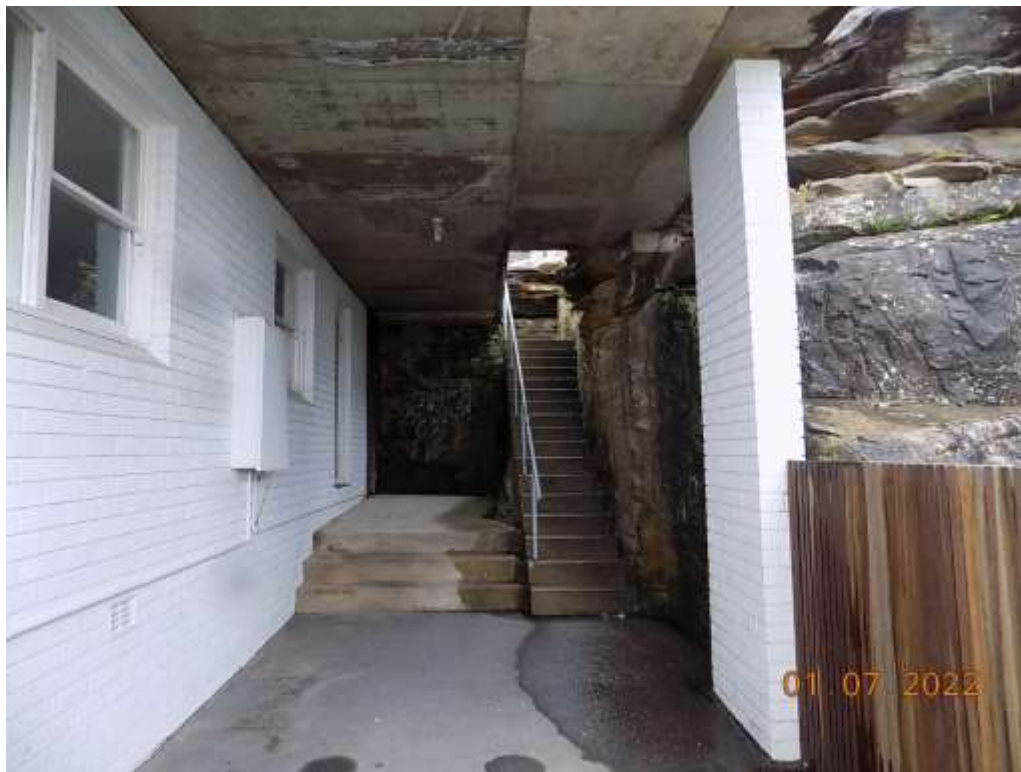
HAZARDS	Hazard One	Hazard Two
TYPE	The moderate to steep slope that rises across the property and continues above and below failing and impacting on the proposed works.	The sandstone face that steps ~4.0m up the slope failing and impacting on the proposed works (Photo 4 & 5).
LIKELIHOOD	'Unlikely' (10^{-4})	'Unlikely' (10^{-4})
CONSEQUENCES TO PROPERTY	'Medium' (12%)	'Medium' (25%)
RISK TO PROPERTY	'Low' (2×10^{-5})	'Low' (2×10^{-5})
RISK TO LIFE	8.3×10^{-7} /annum	2.9×10^{-7} /annum
COMMENTS	This level of risk is 'ACCEPTABLE'.	This level of risk is 'ACCEPTABLE'.

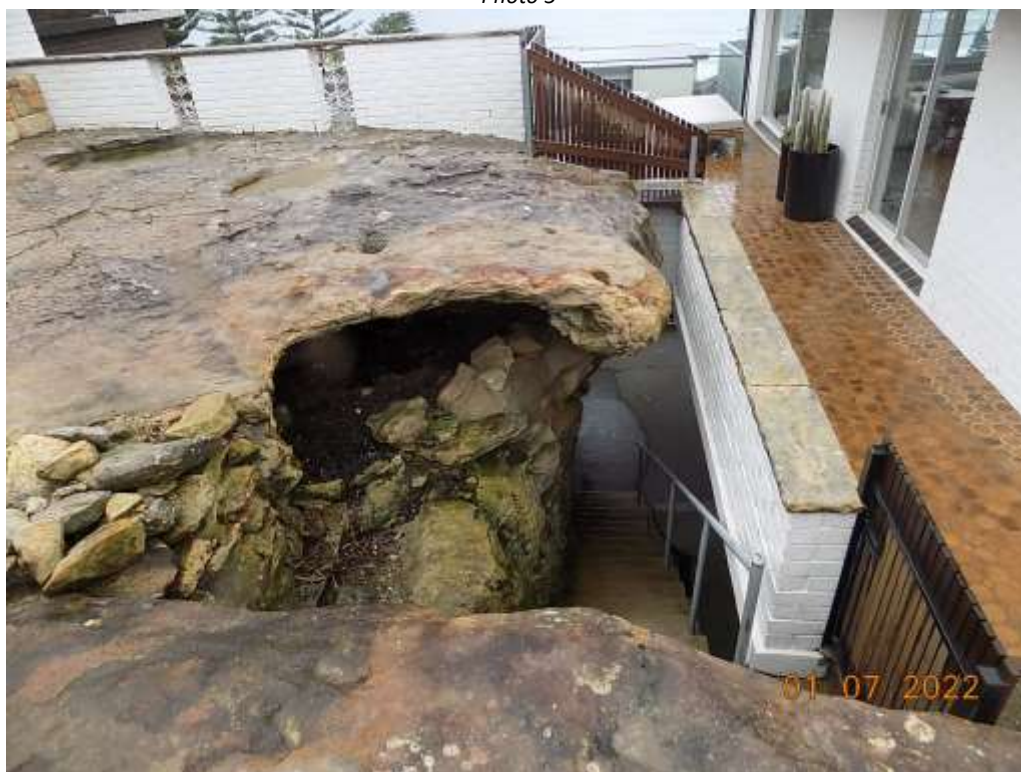
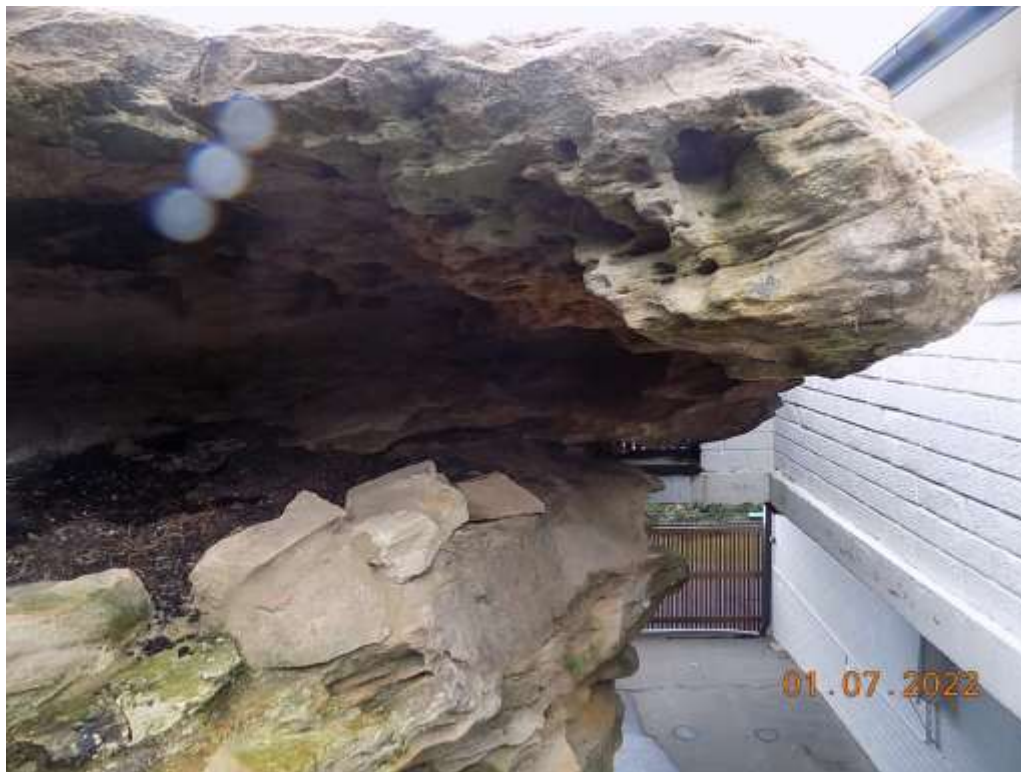
undercut to ~1.5m and overhangs ~0.5m from the bulk rock face below (Photos 6 & 7). The cavity is bridged on both sides and considered currently stable however the overhang will likely need to be removed as part of the proposed excavation works. Competent Medium Strength Sandstone outcrops above the house and extends to a ~1.3m high stable stack rock retaining wall that lines the upper common boundary (Photo 8). A ~stable 0.6m high sandstone block retaining wall supports a fill for a level lawn area in the upper NE corner of the property (Photo 9).

The cavity and overhang (Photos 6 & 7) on the S side of the excavation are likely to be destabilised during the excavation. As such, the overhanging portion of the rock is to be cut with rock saws and demolished prior to the commencement of the pool excavation. See site plan for location of overhanging rock to be removed.

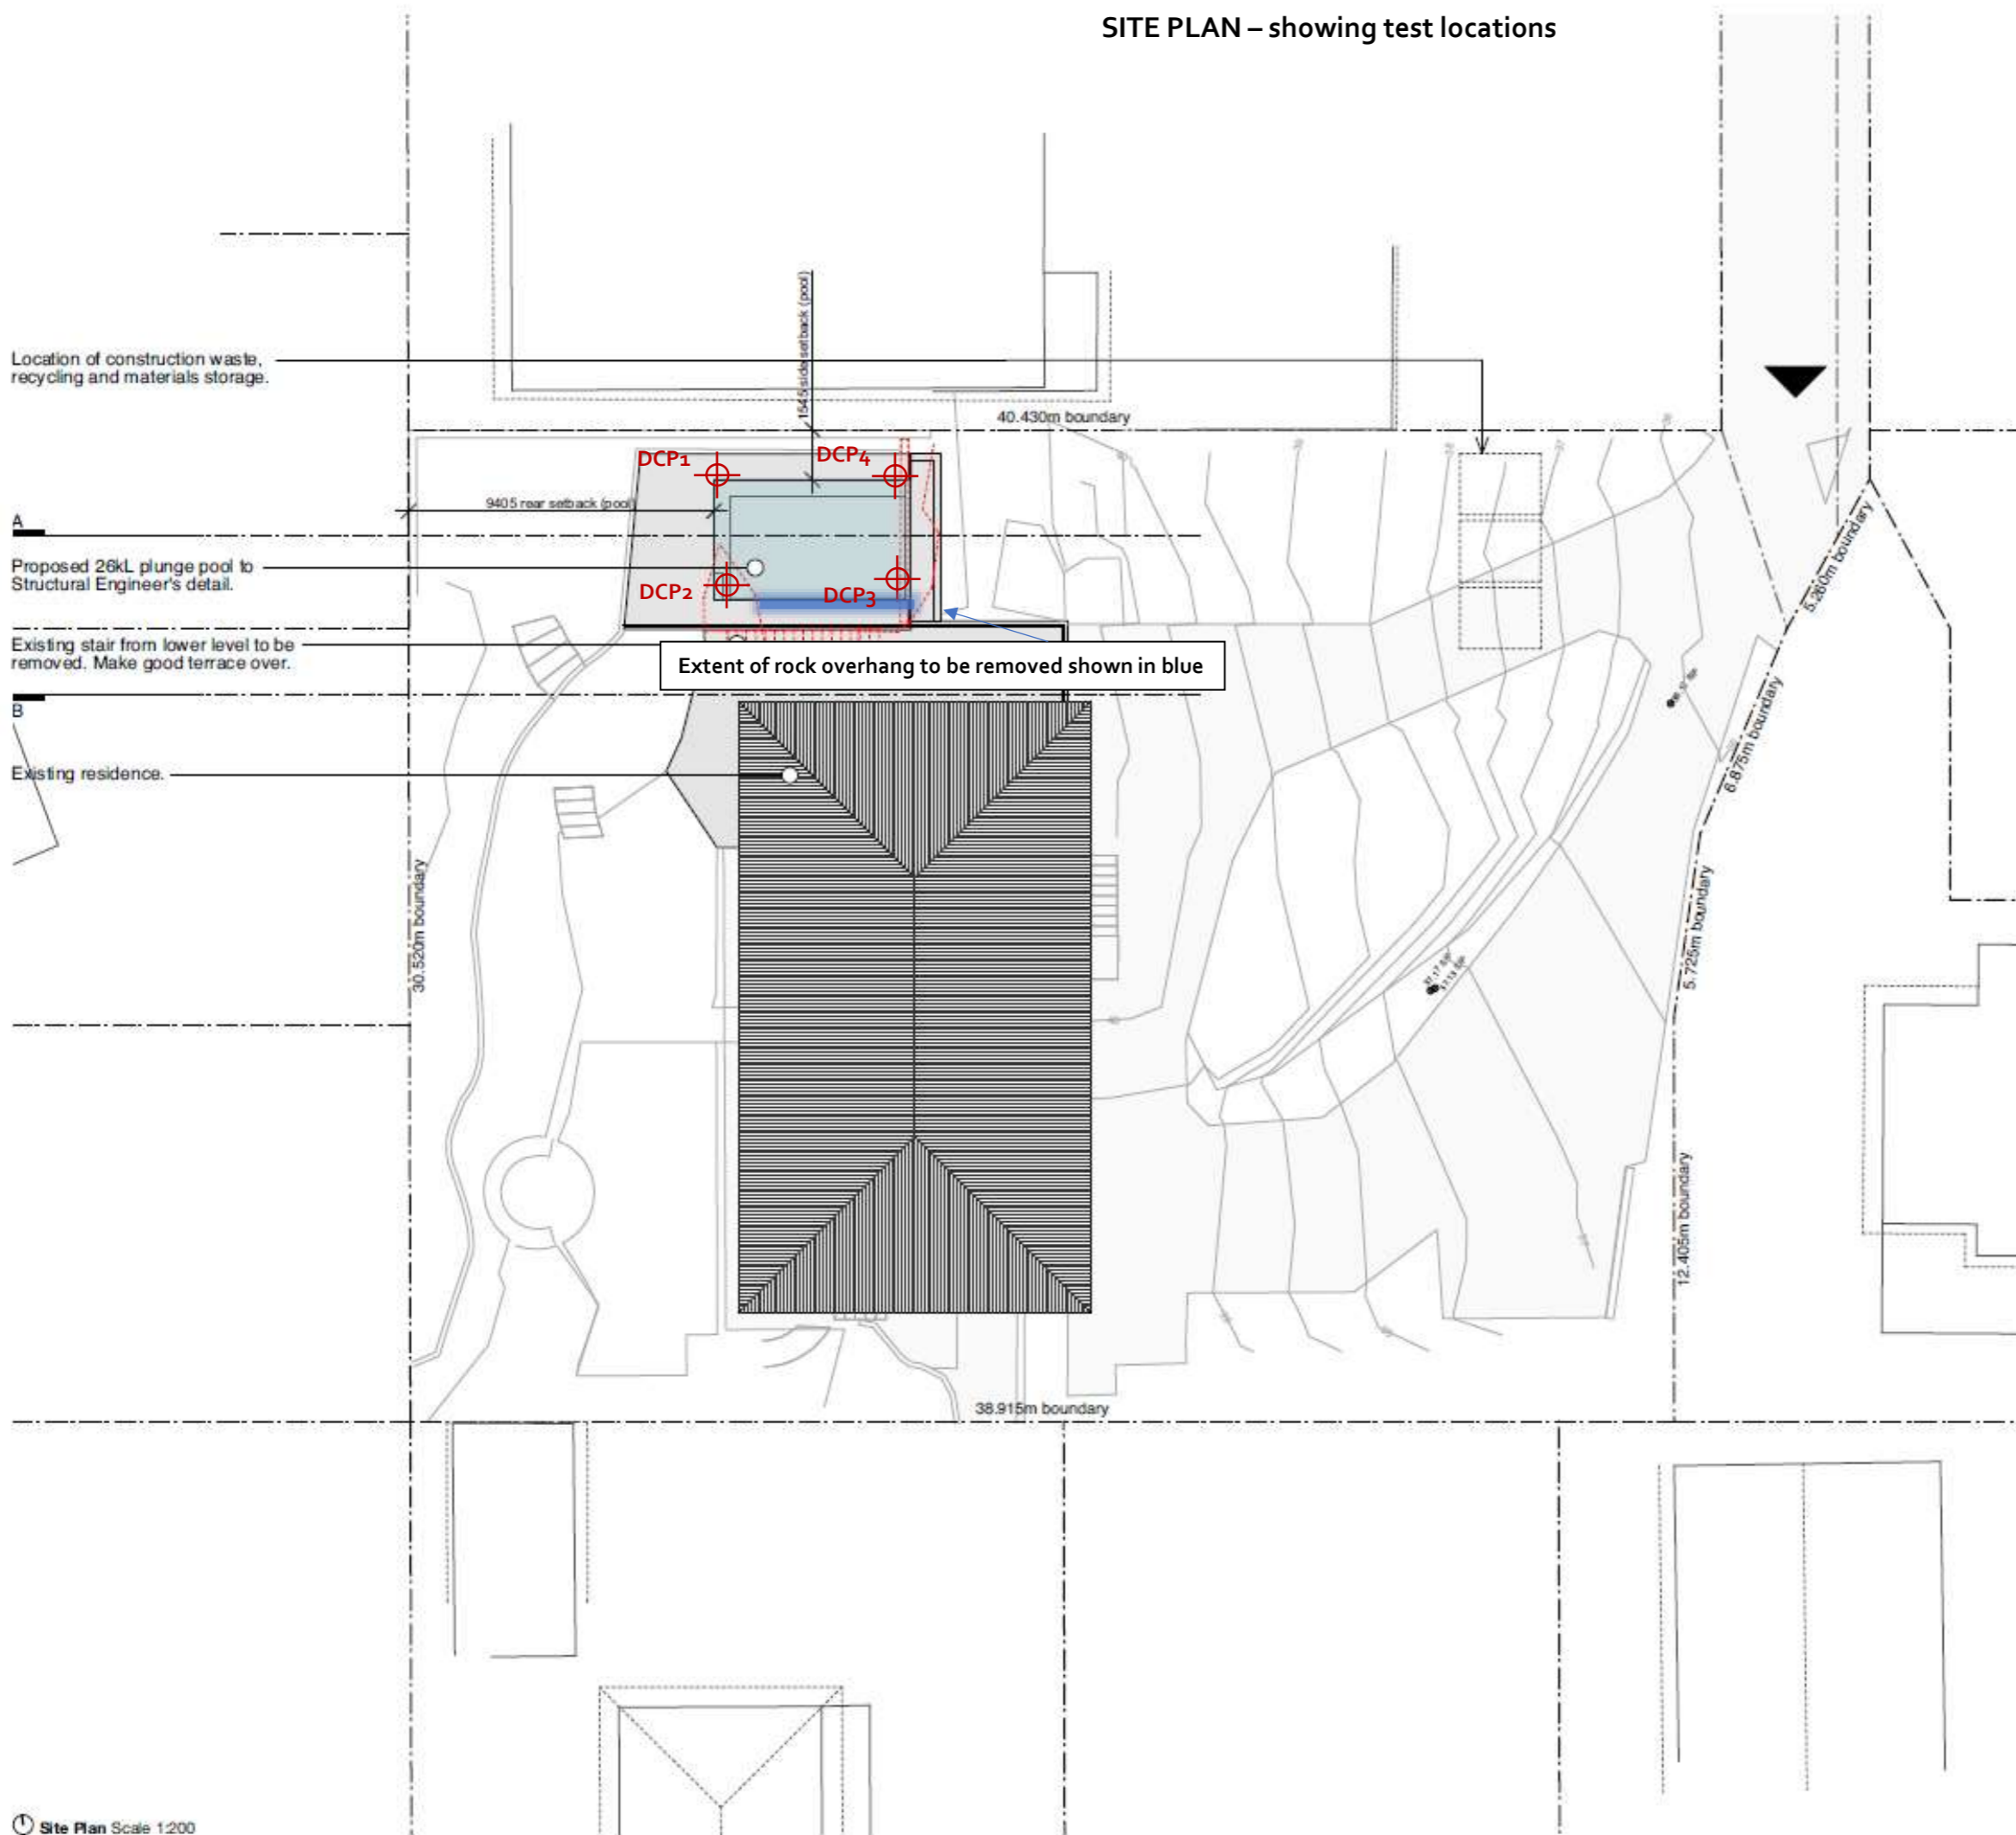
SITE PLAN – showing test locations

Four Dynamic Cone Penetrometer (DCP) tests were put down to determine the relative density of the overlying soil and the depth to bedrock. The locations of the tests are shown on the site plan attached. It should be noted that a level of caution should be applied when interpreting DCP test results. The test will not pass through hard buried objects so in some instances it can be difficult to determine whether refusal has occurred on an obstruction in the profile or on the natural rock surface. This is not expected to be an issue for the testing on this site. However, excavation and foundation budgets should always allow for the possibility that the interpreted ground conditions in this report vary from those encountered during excavations. See the appended "Important information about your report" for a more comprehensive explanation. The results are as follows:

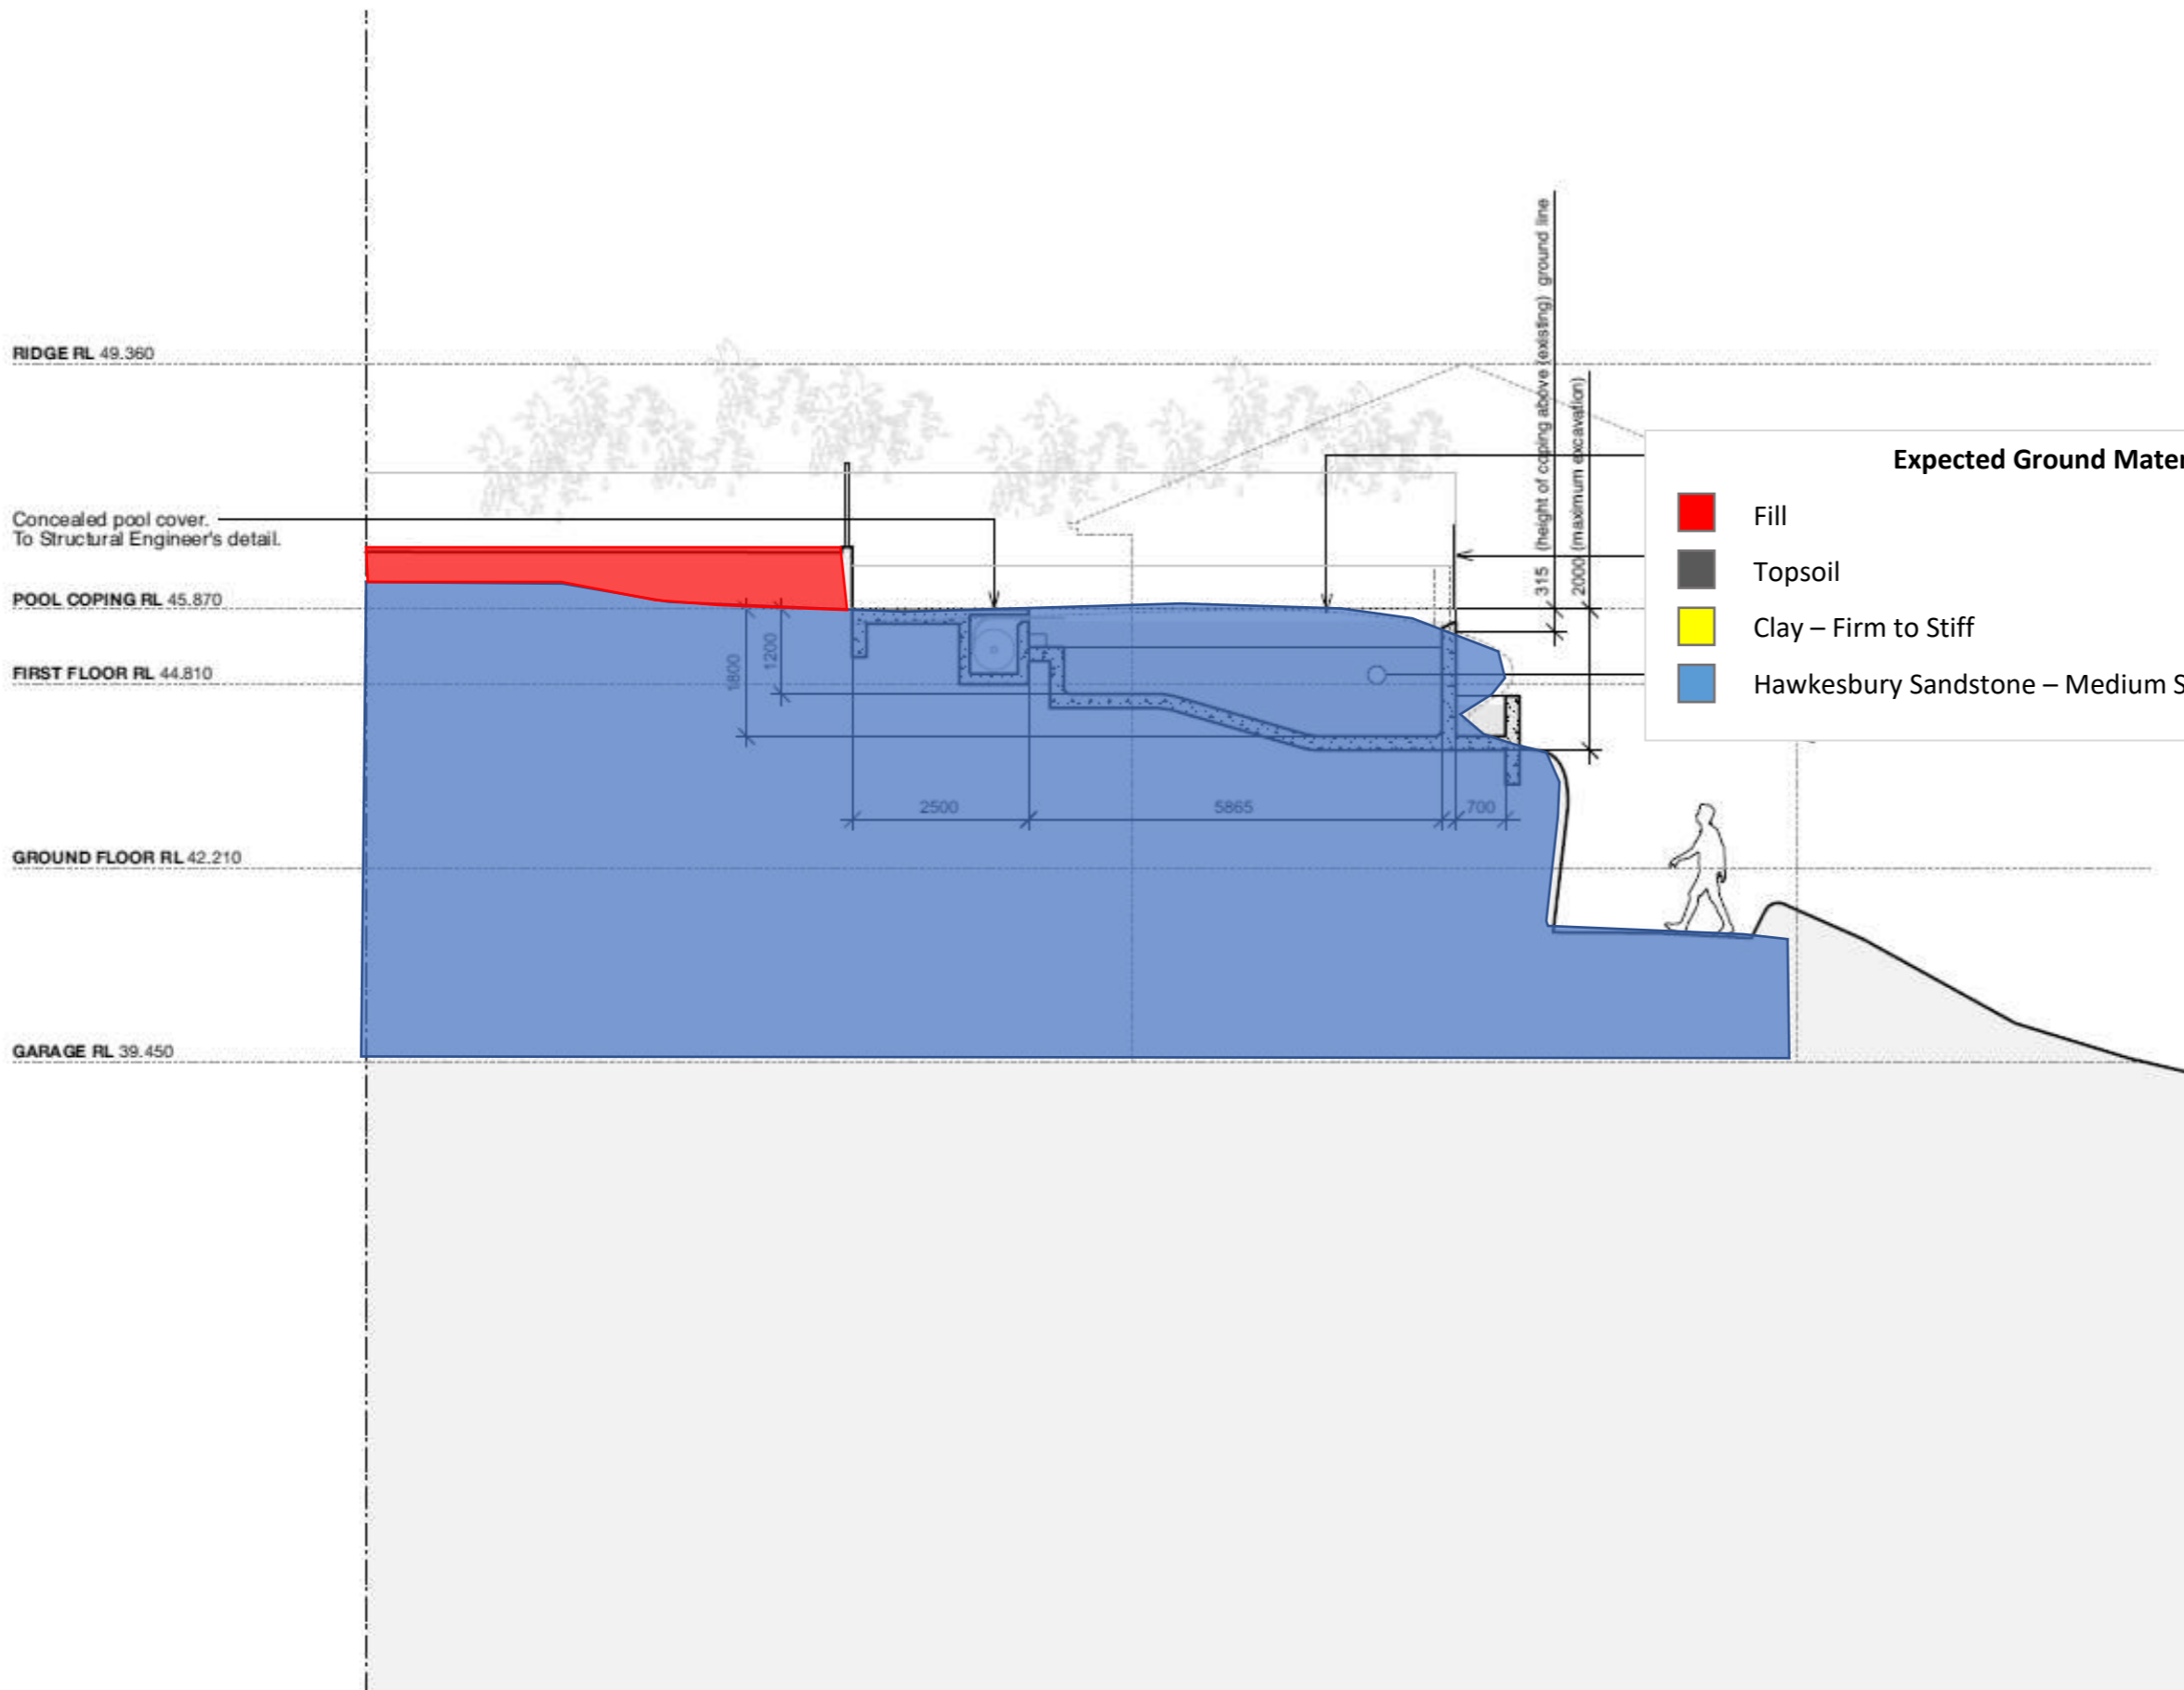
TYPE SECTION – Diagrammatical Interpretation of expected Ground Materials

The surface features of the block are controlled by the outcropping and underlying sandstone bedrock that steps up the property forming sub-horizontal benches between the steps. Where the grade is steeper, the steps are larger and the benches narrower. Where the slope eases, the opposite is true. Where the rock is not exposed, it is overlain by fill and sandy soils that fill the bench step formation. Filling has been placed near the upper common boundary for a level lawn area and garden beds. In the test locations, competent Medium Strength Sandstone bedrock was entirely exposed. The outcropping sandstone on the property is estimated to be medium strength or better and similar strength rock is expected to underlie the entire site. See Type Section attached for a diagrammatical representation of the expected ground materials.
