GEOTECHNICAL INVESTIGATION:

New House and Pool at 1 Tabalum Road, Balgowlah Heights

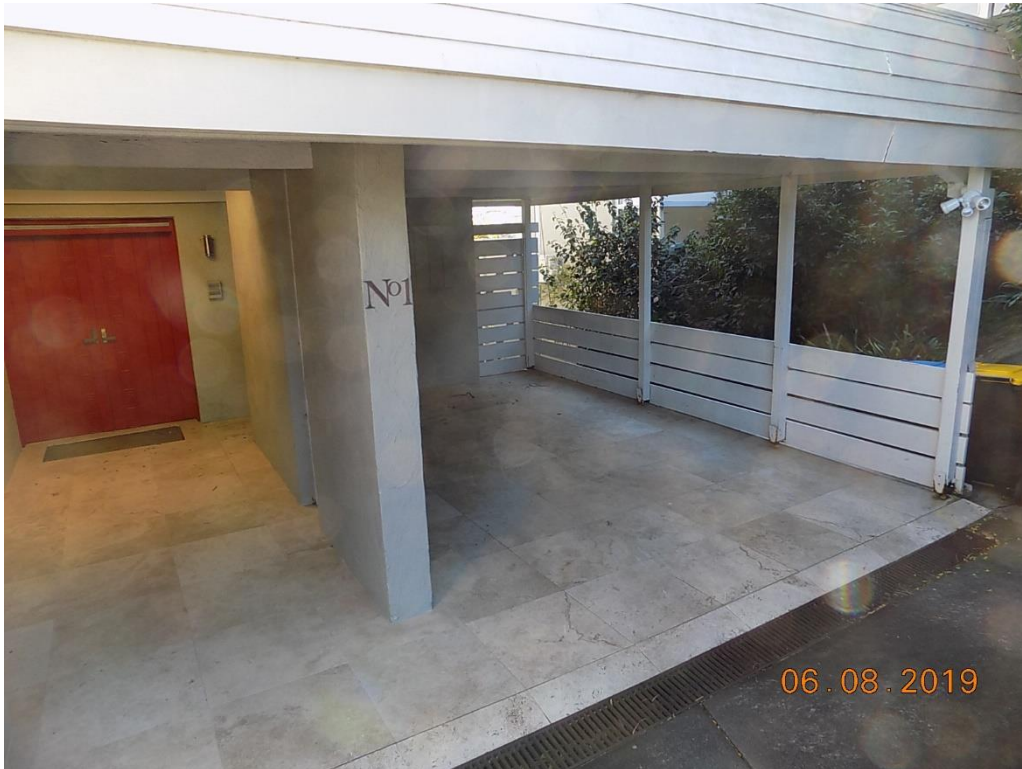
Photo 1

- 2.3** At the road frontage to Tabalum Road, a concrete driveway runs to a carport attached to the uphill side of the house (Photo 1). Competent Medium Strength Sandstone bedrock was observed to be outcropping on both sides of this driveway (Photo 2). Between the road frontage and the house is a gently sloping garden area (Photo 3). At the road frontage to Cutler Road, a concrete driveway runs to a garage on the lower ground floor of the house (Photo 4). The cut for the driveway has been partially taken through outcropping sandstone (Photo 5). The remainder of the cut is

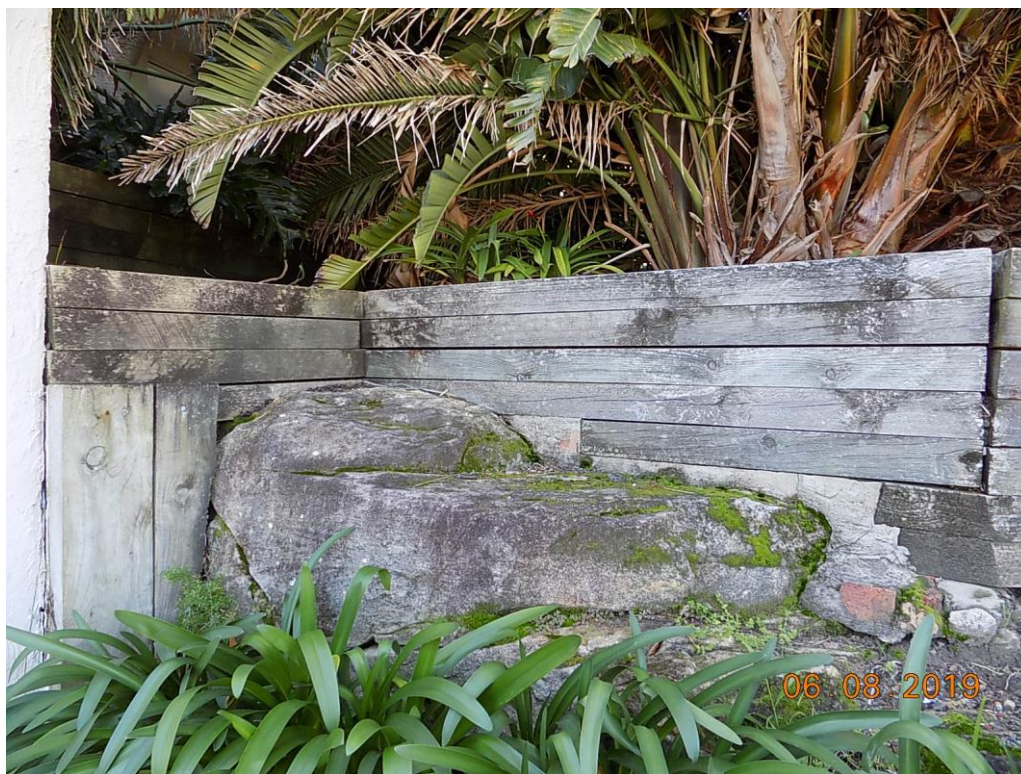
Photo 5

supported by a timber retaining wall. The part three-storey rendered brick house was observed to be supported directly onto outcropping sandstone bedrock and will be demolished as part of the proposed works (Photo 6). A pool has been constructed on the downhill side of the property and will be partially demolished as part of the proposed works (Photo 7). A gently sloping lawn-covered fill has been placed around the pool and is supported by a stable sandstone block retaining wall ~4.0m high (Photo 8).

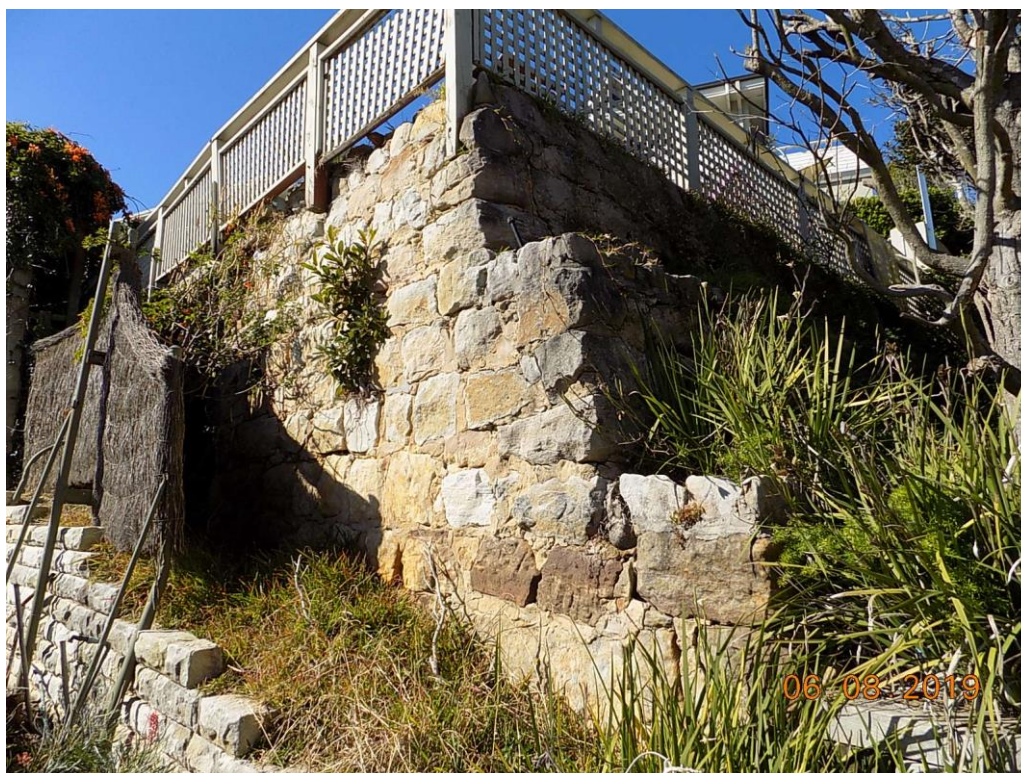
Photo 8

HAZARDS	Hazard One	Hazard Two	Hazard Three
TYPE	The moderate slope that falls across the property and continues below failing and impacting on the property.	The vibrations produced during the proposed excavations and pool demolition impacting on the surrounding structures (Photo 8).	A loose boulder, wedge, or similar geological defect toppling onto the work site during the excavation process.
LIKELIHOOD	'Unlikely' (10^{-4})	'Possible' (10^{-3})	'Possible' (10^{-3})
CONSEQUENCES TO PROPERTY	'Medium' (20%)	'Medium' (15%)	'Medium' (30%)
RISK TO PROPERTY	'Low' (2×10^{-5})	'Moderate' (2×10^{-4})	'Moderate' (2×10^{-4})
RISK TO LIFE	8.3×10^{-7} /annum	5.3×10^{-7} /annum	1.2×10^{-3} /annum
COMMENTS	'ACCEPTABLE' level of risk to life & property.	This level of risk to property is 'UNACCEPTABLE'. To move risk to 'ACCEPTABLE' levels, the recommendations in Section 12 are to be followed.	This level of risk to life and property is 'UNACCEPTABLE'. To move risk to 'ACCEPTABLE' levels, the recommendations in Section 13 are to be followed.

The proposed pool excavation will be taken mostly through fill and partially through the existing pool. The proposed pool excavation will be on the uphill side of the sandstone block retaining wall at the lower boundary of the property (Photo 8). The work will need to be carried out with care so as not to damage the existing wall. Depending on the construction technique, the wall may need to be propped or lowered as necessary to avoid damage from the proposed works. Pool foundations will need to be taken below the base of the wall or to sandstone bedrock so surcharge loads from the pool don't act on the wall.
