**Project No.:** 2019-164

Jim and Bronwen Curtis  
21 Bligh Crescent,  
Seaforth NSW 2095

**Preliminary Landslip Assessment for 21 Bligh Crescent, Seaforth, NSW.**

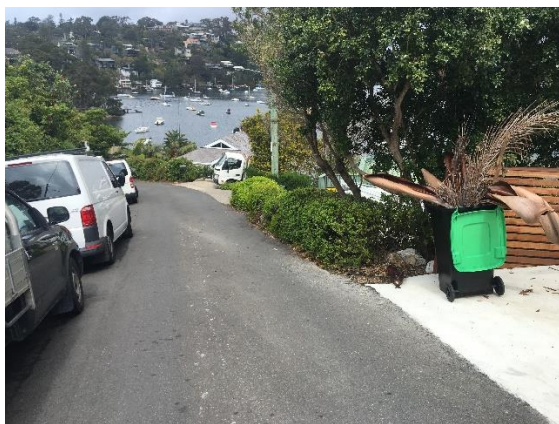
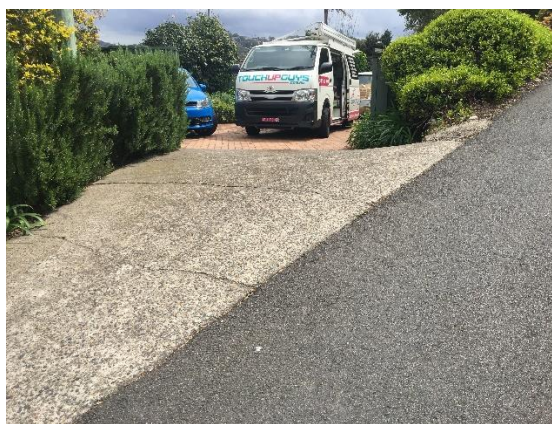
The front edge of the site is formed with a paved driveway that extends from the south-east corner across to the northern side boundary and a set of access stairs down to the house terrace. A narrow garden bed is located on the eastern and northern side of the driveway, at the base of a mortared sandstone rock retaining wall that supports the road reserve and a low excavation into bedrock that is exposed to the north. The driveway shows no signs of excess deflection, settlement or movement whilst the bedrock outcrop is stable. The sandstone rock retaining wall along the eastern boundary rises up to 2.0m in height at its northern end, the wall appears generally in good condition with one crack near its northern end that may be related to the installation of a steel post.

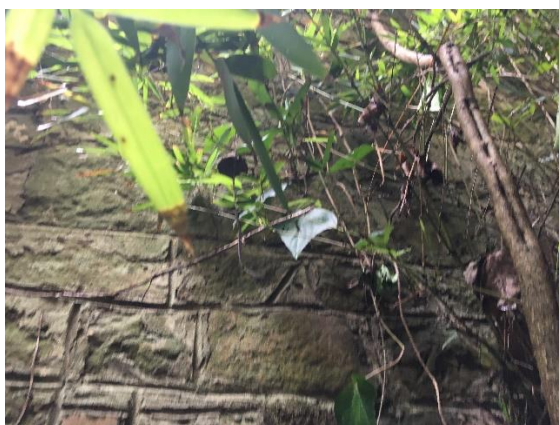
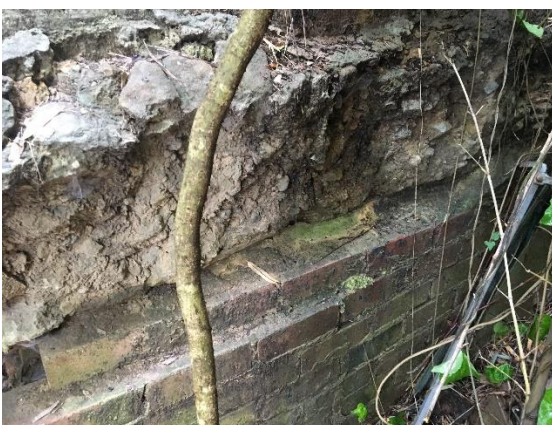
The driveway extends to the south boundary and also has a narrow garden bed formed along its western side. The south boundary and garden bed are supported by a mortared sandstone rock retaining wall that is formed partly along the south boundary and then extends across the block to the north.

The wall increases in height up to 3.0m in its south-west corner and then remains at near 2.5m in height across to the north, where it ends at the access stairs. The wall is partly supported via a weak concrete footing over a brick underpinning wall at its south-west corner, however the remainder of the wall footing is unexposed. The wall appears up to 0.60m in thickness where openings/weep holes allowed inspection. The wall appeared generally straight however there were several distinct vertical cracks identified.

However, it is recommended that the carport structure be founded via pier footings extended to bedrock so as to prevent any loading to the existing retaining wall located to the west and south of the proposed development. All footings require geotechnical inspection to confirm the insitu nature of the foundation.
