Geotechnical Assessment

Project: Alterations & Additions
11 Plateau Road, Avalon Beach NSW

Prepared for:
Mrs S. Mander, c/ TCDG

Ref: AG 24549
25 February 2025

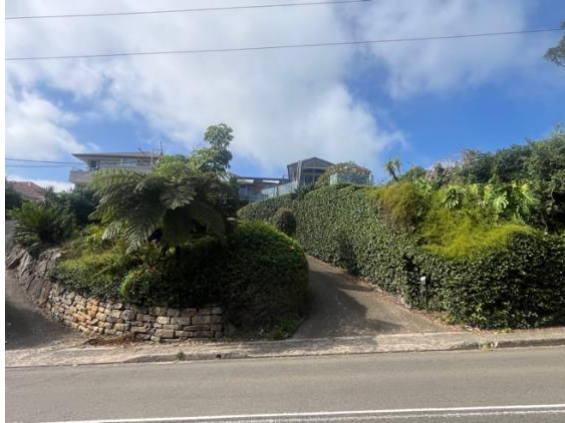
Photo 1: Site frontage, area of the proposed works

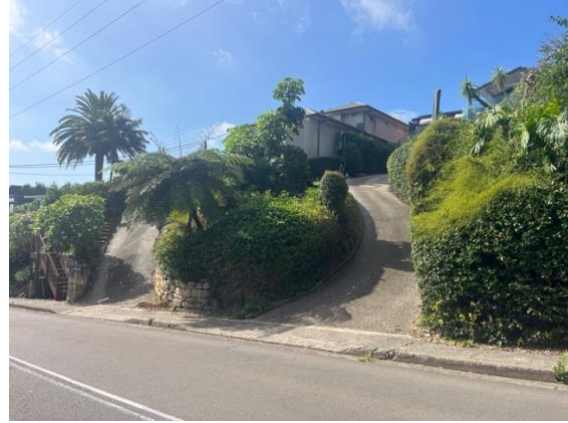
Photo 2: Site frontage, area of the proposed works

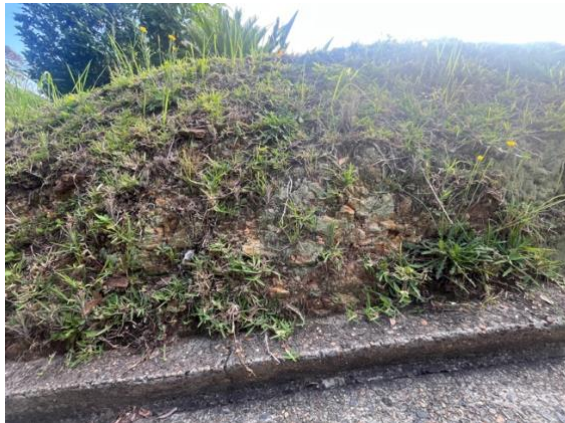
Photo 3: Extremely weathered shale bedrock outcropping in the driveway cutting

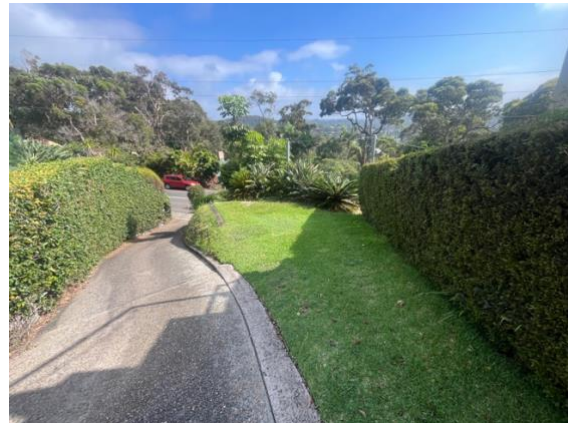
Photo 4: Looking from the front of the house towards the street frontage

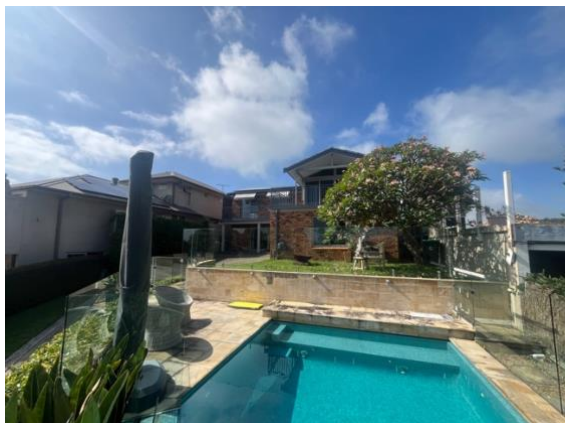
Photo 5: Pool & house frontage

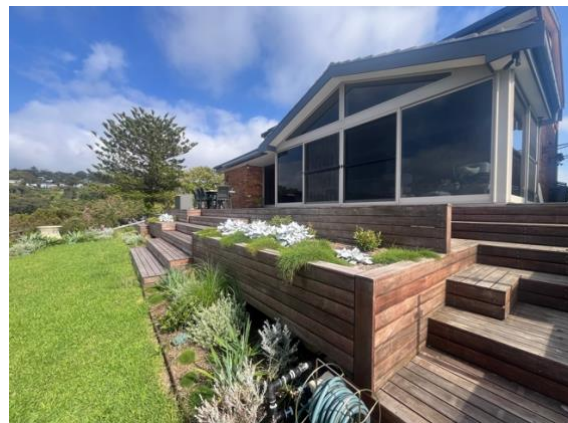
Photo 6: House rear
