Report Title: Geotechnical Report 8 Belinda Place, Newport
Report Date: 15/05/23

GEOTECHNICAL INVESTIGATION:

Alterations and Additions at 8 Belinda Place, Newport

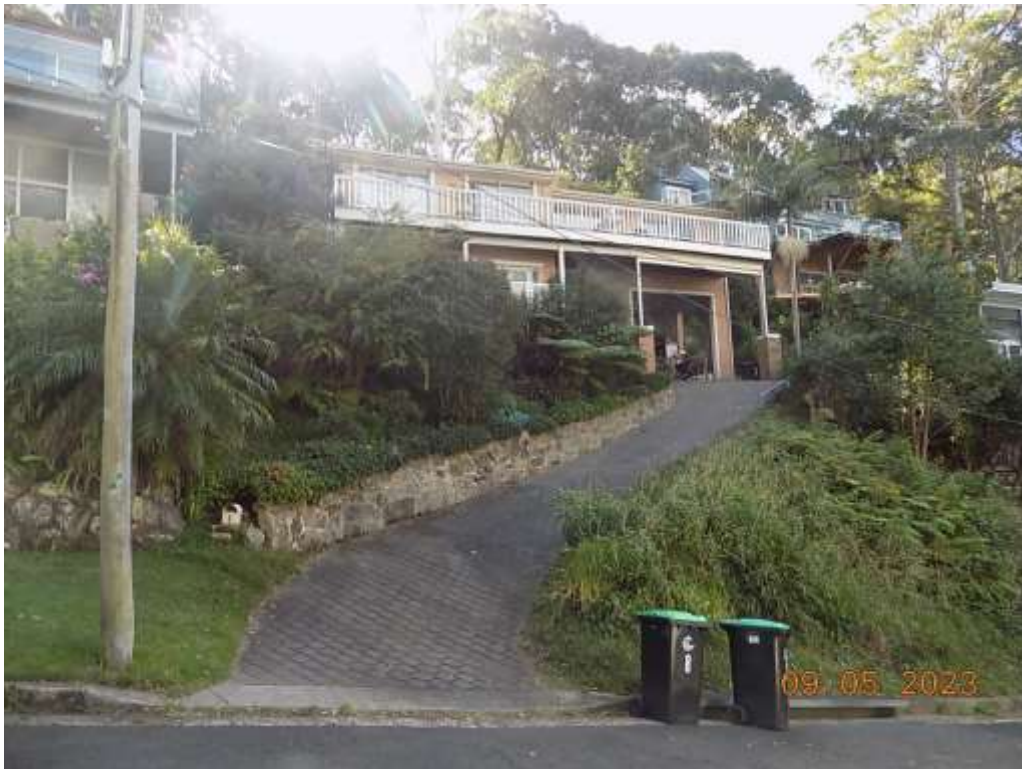
Photo 1

- 2.3** At the road frontage, a concrete driveway runs up the slope to a carport underneath the house (Photo 1). The cut for the driveway is lined by a covering of rock armour reaching up to $\sim 1.1\text{m}$ in height (Photo 2). The cut for the carport is supported by a stable $\sim 1.0\text{m}$ high brick retaining wall. In between the road frontage and the house is a steeply sloping densely vegetated **garden area** (Photo 3). The part two-storey brick house is supported on brick walls (Photo 4). The brick walls show no significant signs of movement. A $\sim 5.0\text{m}$ high sandstone cliff face rises at near vertical angles immediately upslope of the house (Photo 5). Low Strength Shale was observed

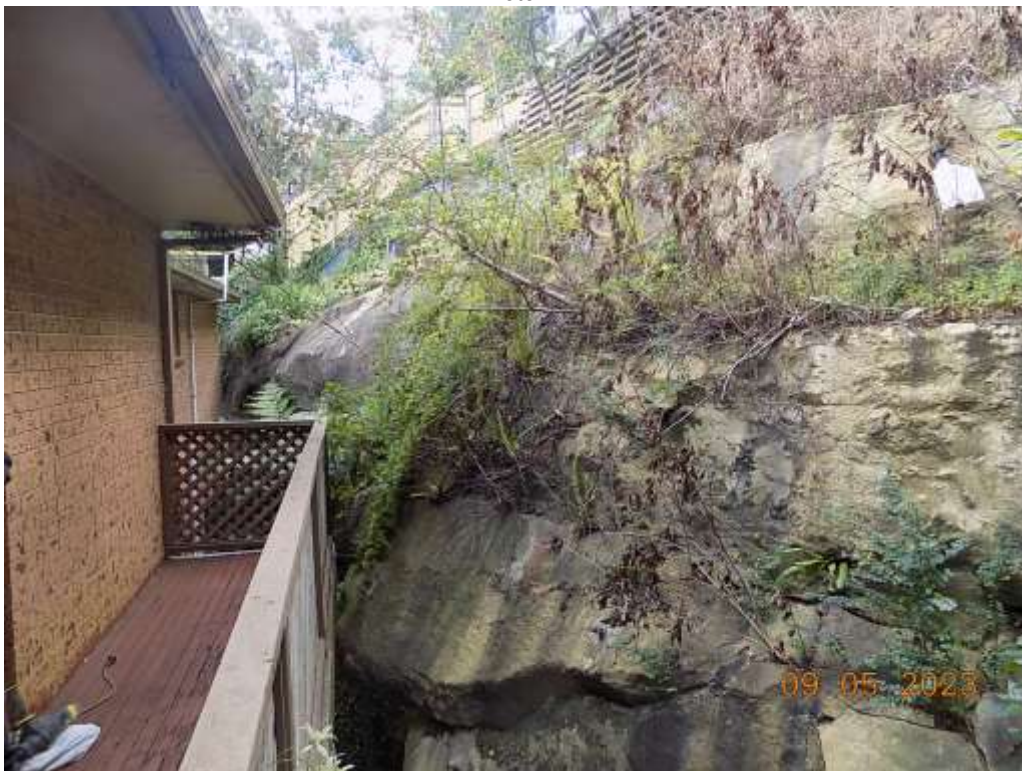
Photo 5

No geotechnical hazards were observed beside the property. The steeply graded slope that rises across the property and continues above and below is a potential hazard (**Hazard One**). The undercut rock face (Photos 5 - 10) failing and toppling onto the slope below is a potential hazard (**Hazard Two**).

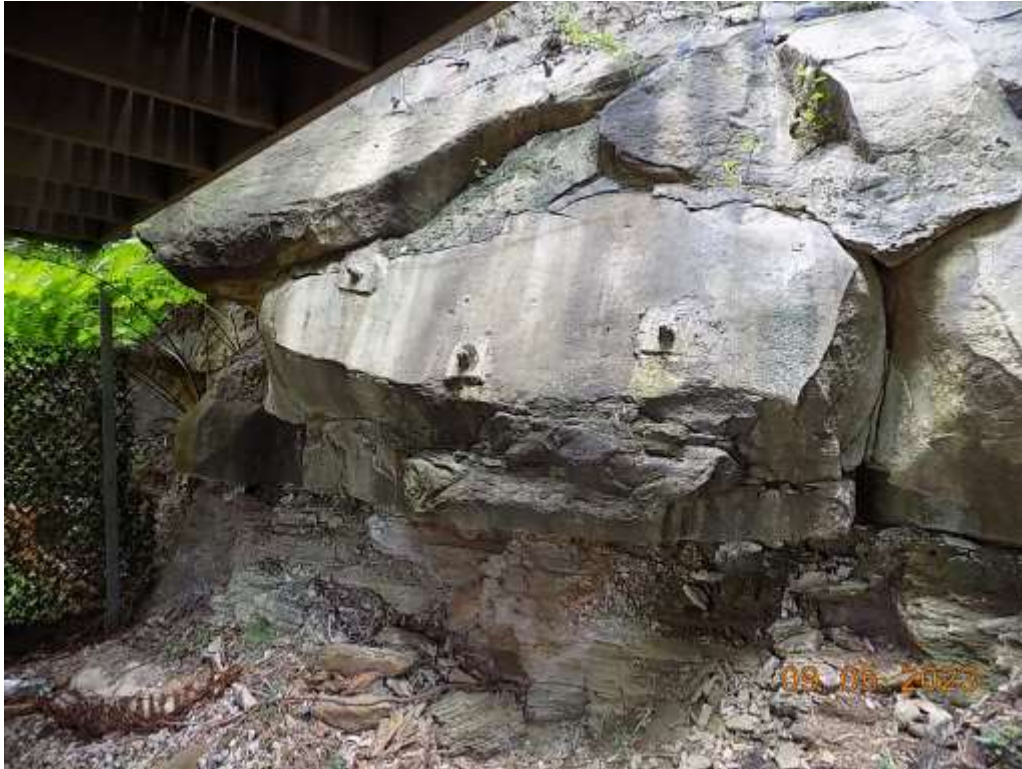
Photo 6

at the base of this rock and it is likely that this is the contact between the Newport Formation of the Narrabeen Group and Hawkesbury Sandstone (Photo 6). The sandstone cliff was slightly undercut in several locations and was jointed (Photo 7). Six rock anchors had previously been installed to support the cliff face (Photo 8). A stable stone retaining wall reaching up to ~2.0m high supports the slope batter immediately above the sandstone cliff (Photo 9). A stable ~3.5m high concrete crib wall supports the fill for the neighbouring driveway along the upper common boundary.

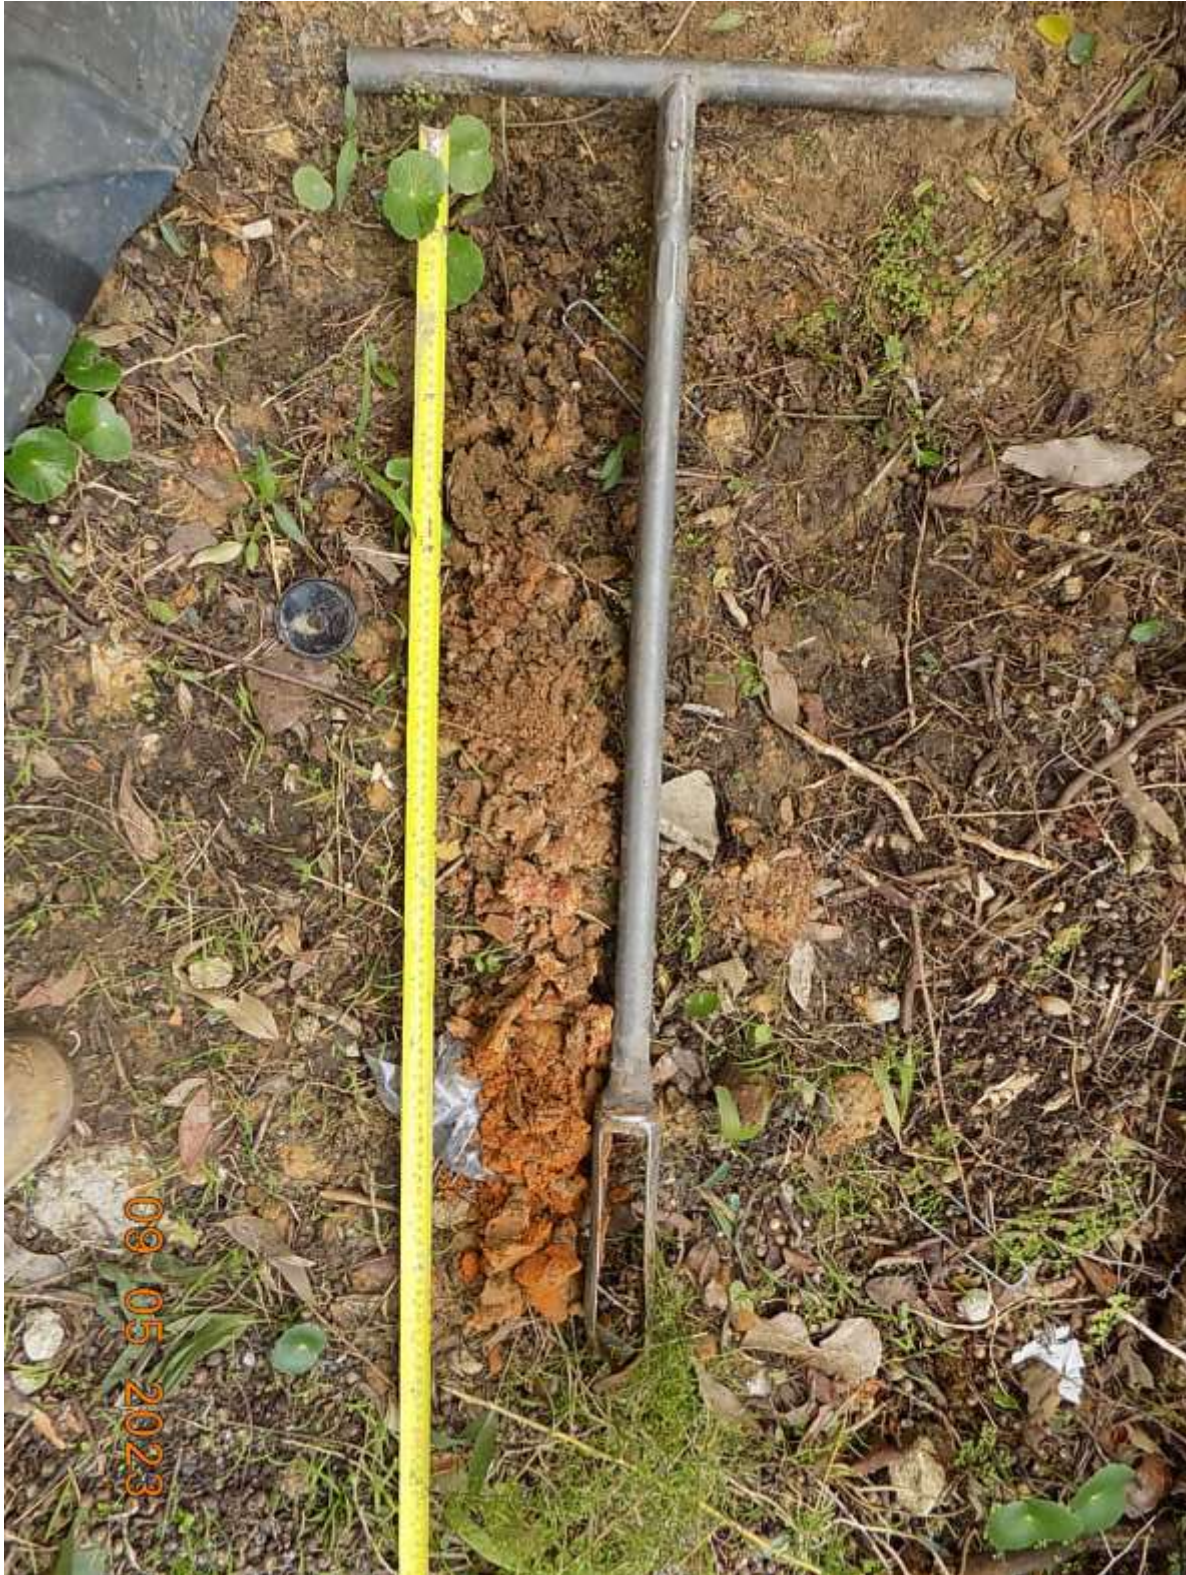
Photo 10 (top to bottom)

AUGER HOLE 1 (~RL80.0) – AH1 (Photo 10)

Depth (m)	Material Encountered
0.0 to 0.3	FILL , dark brown clay, fine traces of organic matter, damp.
0.3 to 0.6	FILL , mottled clay, fine grained, firm to stiff, dry.
0.6 to 0.9	CLAY , sandy, orange, and brown, fine grained, stiff, dry.

End of test @ 0.9m. No water table encountered.

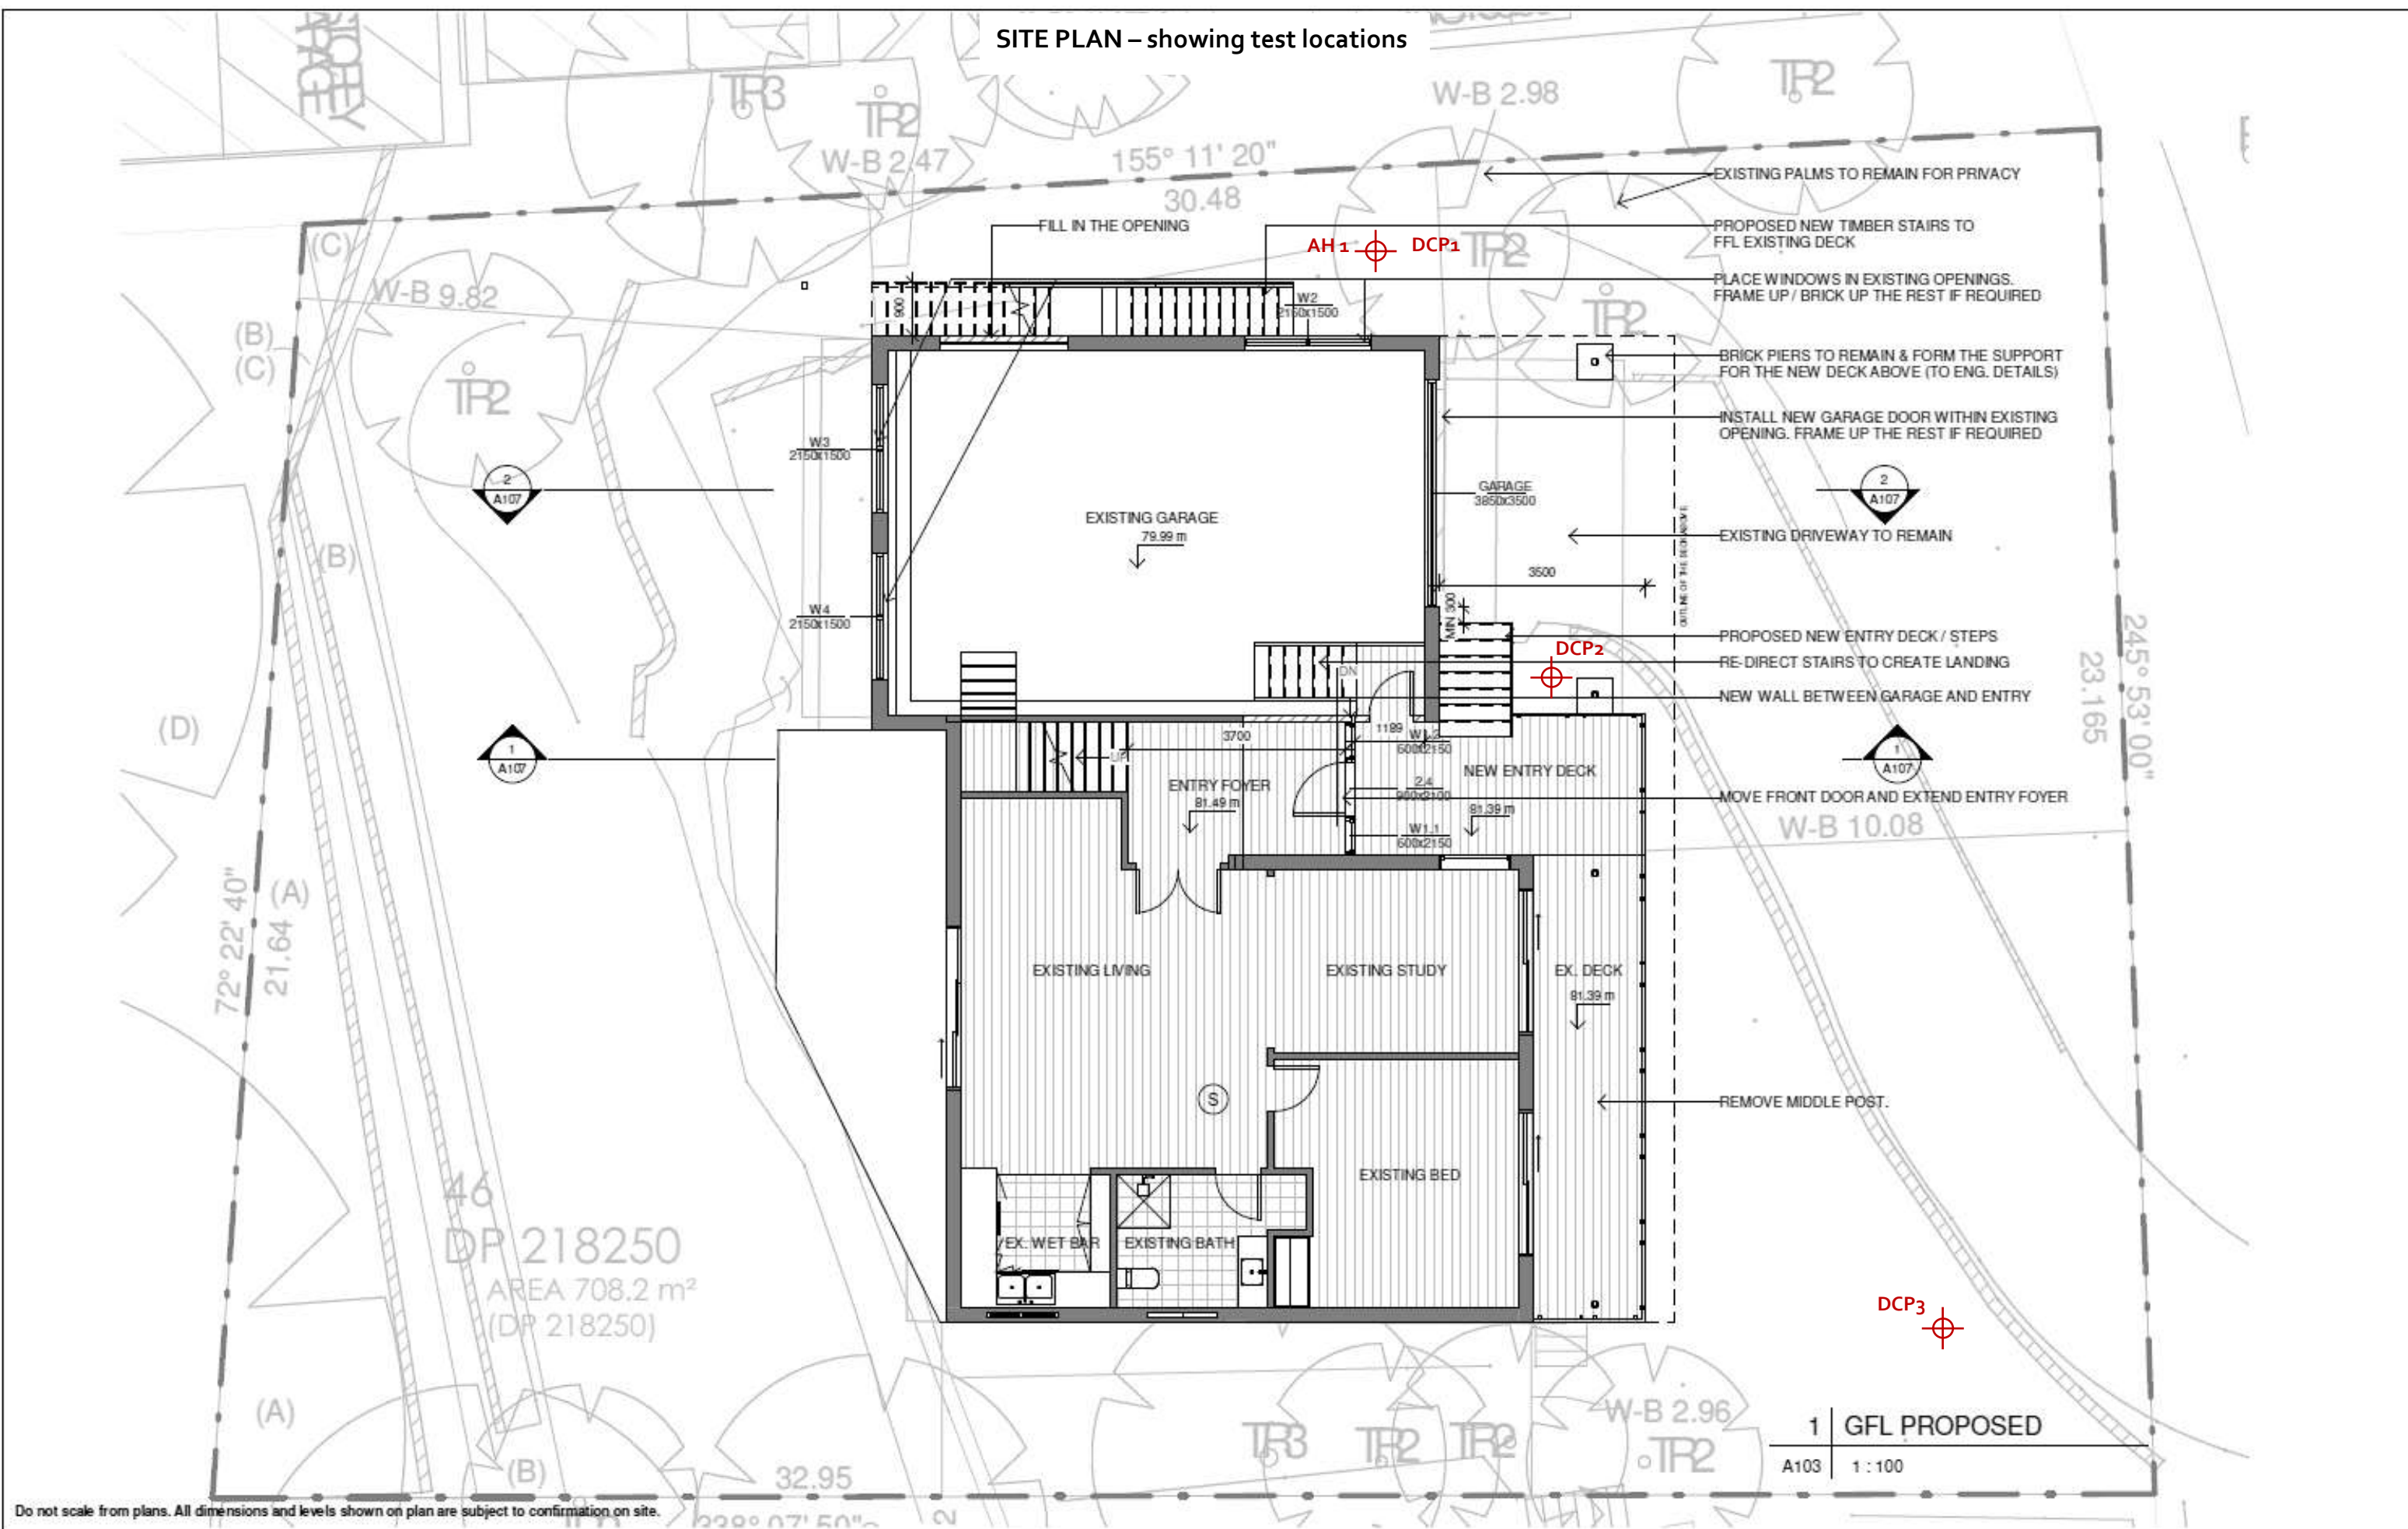
SITE PLAN – showing test locations

One hand Auger Hole (AH) was put down to identify soil materials. Three Dynamic Cone Penetrometer (DCP) tests were put down to determine the relative density of the overlying soil and the depth to weathered rock. The locations of the tests are shown on the site plan attached. It should be noted that a level of caution should be applied when interpreting DCP test results. The test will not pass through hard buried objects so in some instances it can be difficult to determine whether refusal has occurred on an obstruction in the profile or on the natural rock surface. This is not expected to be an issue for the testing on this site. However, excavation and foundation budgets should always allow for the possibility that the interpreted ground conditions in this report vary from those encountered during excavations. See the appended "Important information about your report" for a more comprehensive explanation. The results are as follows:

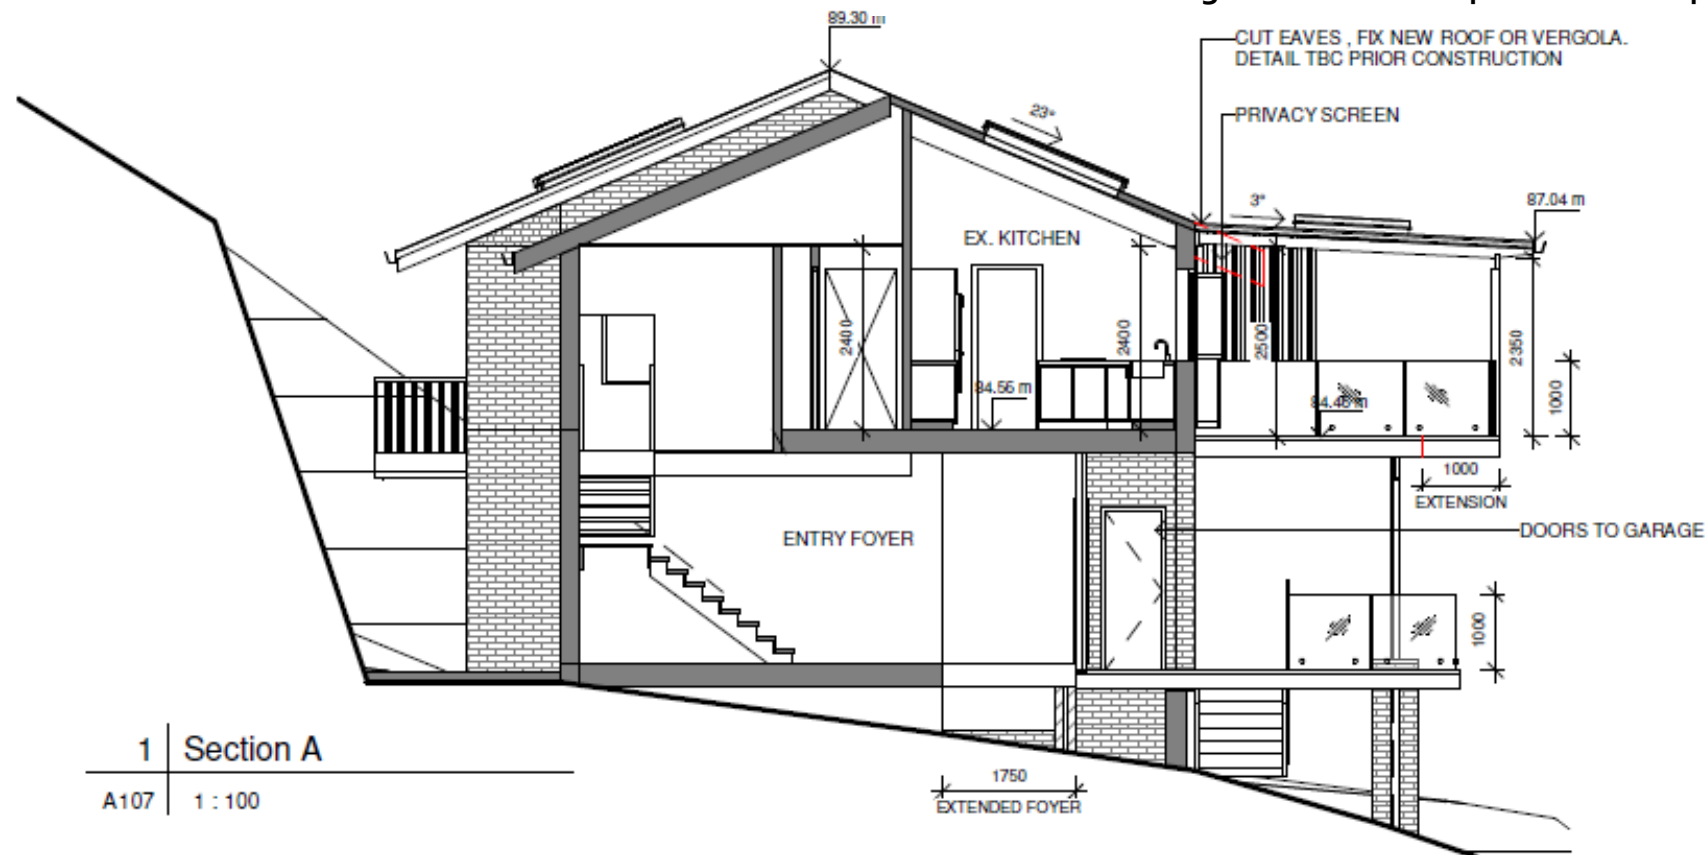
TYPE SECTION – Diagrammatical Interpretation of expected Ground Materials

horizontal benches between the steps. Where the grade is steeper, the steps are larger, and the benches narrower. Where the slope eases, the opposite is true. The geomorphology of the slope under and below the house is indicative of a shale-derived slope typical of the Narrabeen Group. In the test locations, the depth to Extremely Low Strength Shale ranged between ~1.2m and ~1.5m below the current ground surface. We point out around the contact of two rock types (sandstone & shale) groundwater seepage can be higher than usual. See Type Section attached for a diagrammatical representation of the expected ground materials.

- Fill
- Topsoil
- Clay – Firm to Stiff
- Narrabeen Group Rocks – Extremely Low Strength Shale or better - *after being cut up by excavation equipment can resemble a stiff to hard clay.*
- Sandstone – Medium Strength
