Arboricultural Impact Assessment

31-33 Sturdee Lane, Elvina Bay

Ref: 250027

13/03/2025

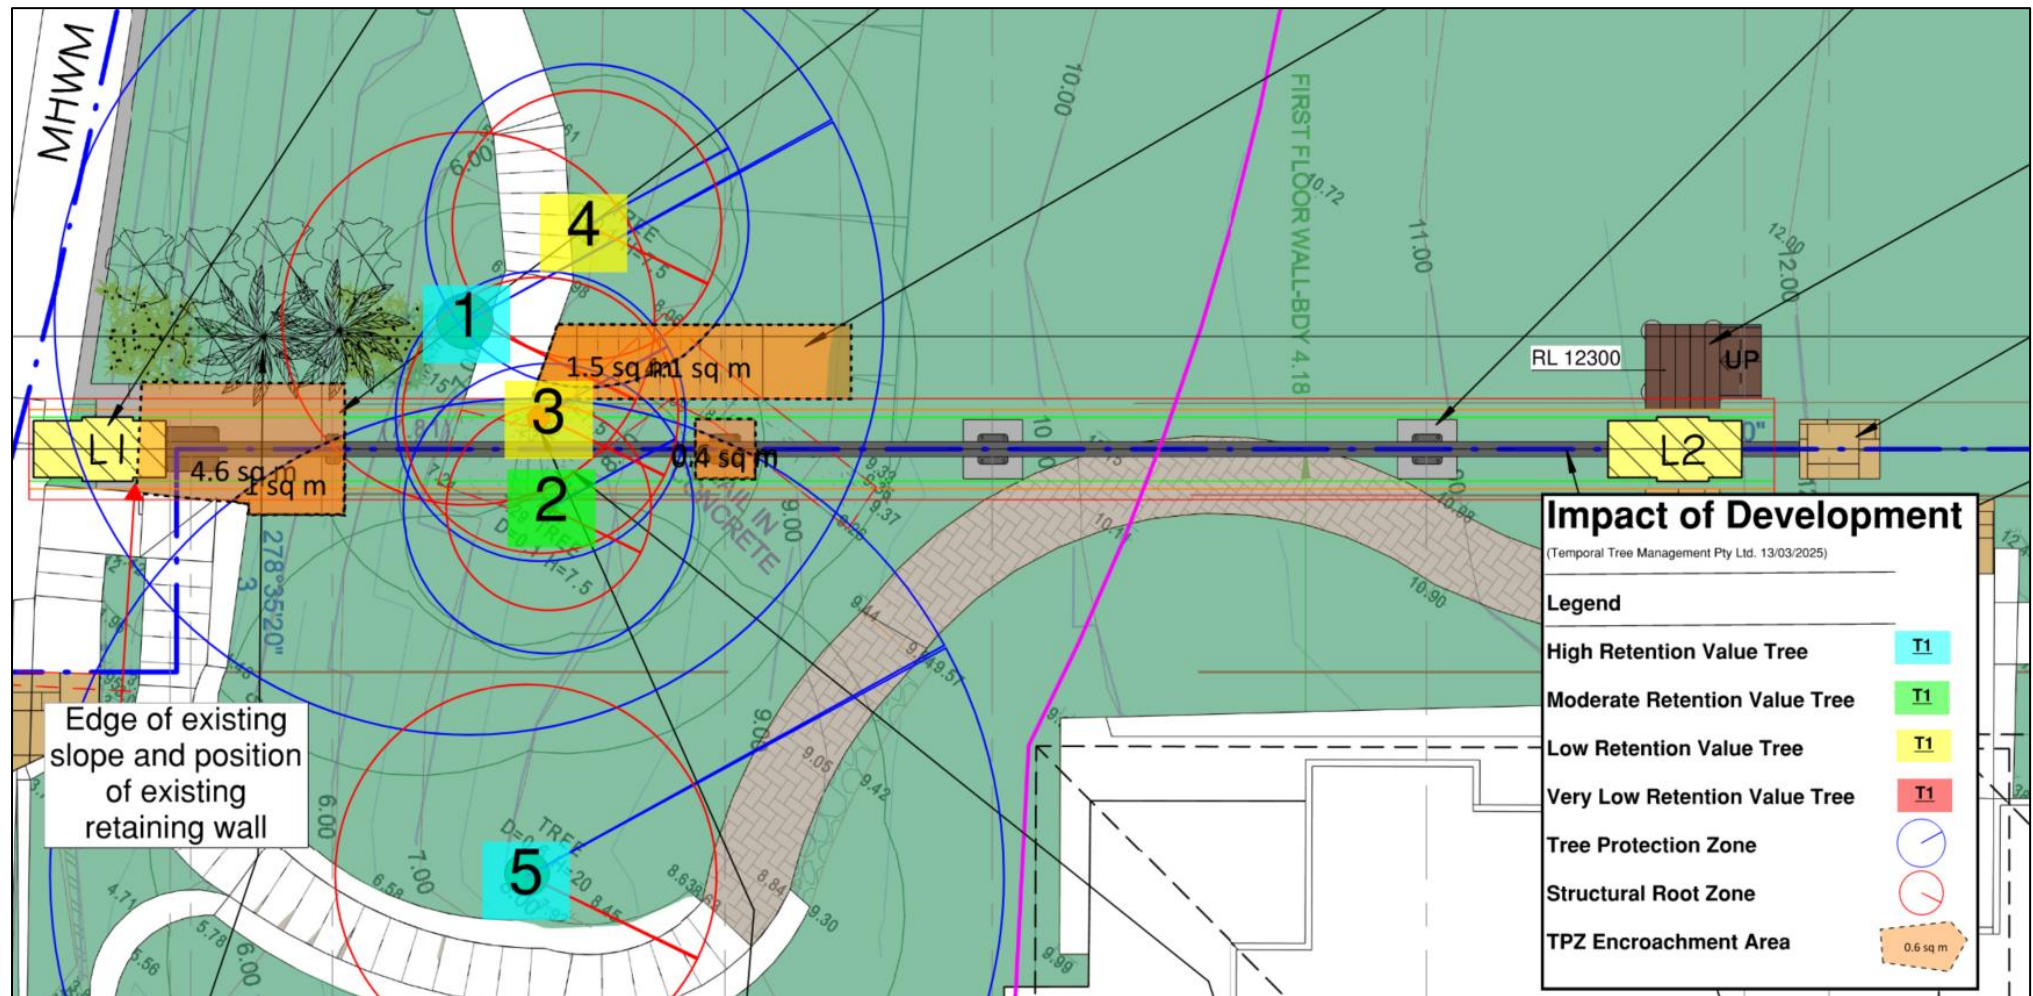
Figure 8. Retention values, TPZs, SRZs and Encroachments for five trees positioned within the subject site. Rail Plan, prepared by *Peter Downes Designs* (Reference: 2417, Drawing No: 02, Drawn: 11/07/2024). Annotated by Temporal Tree Management Pty Ltd (13/03/2025).

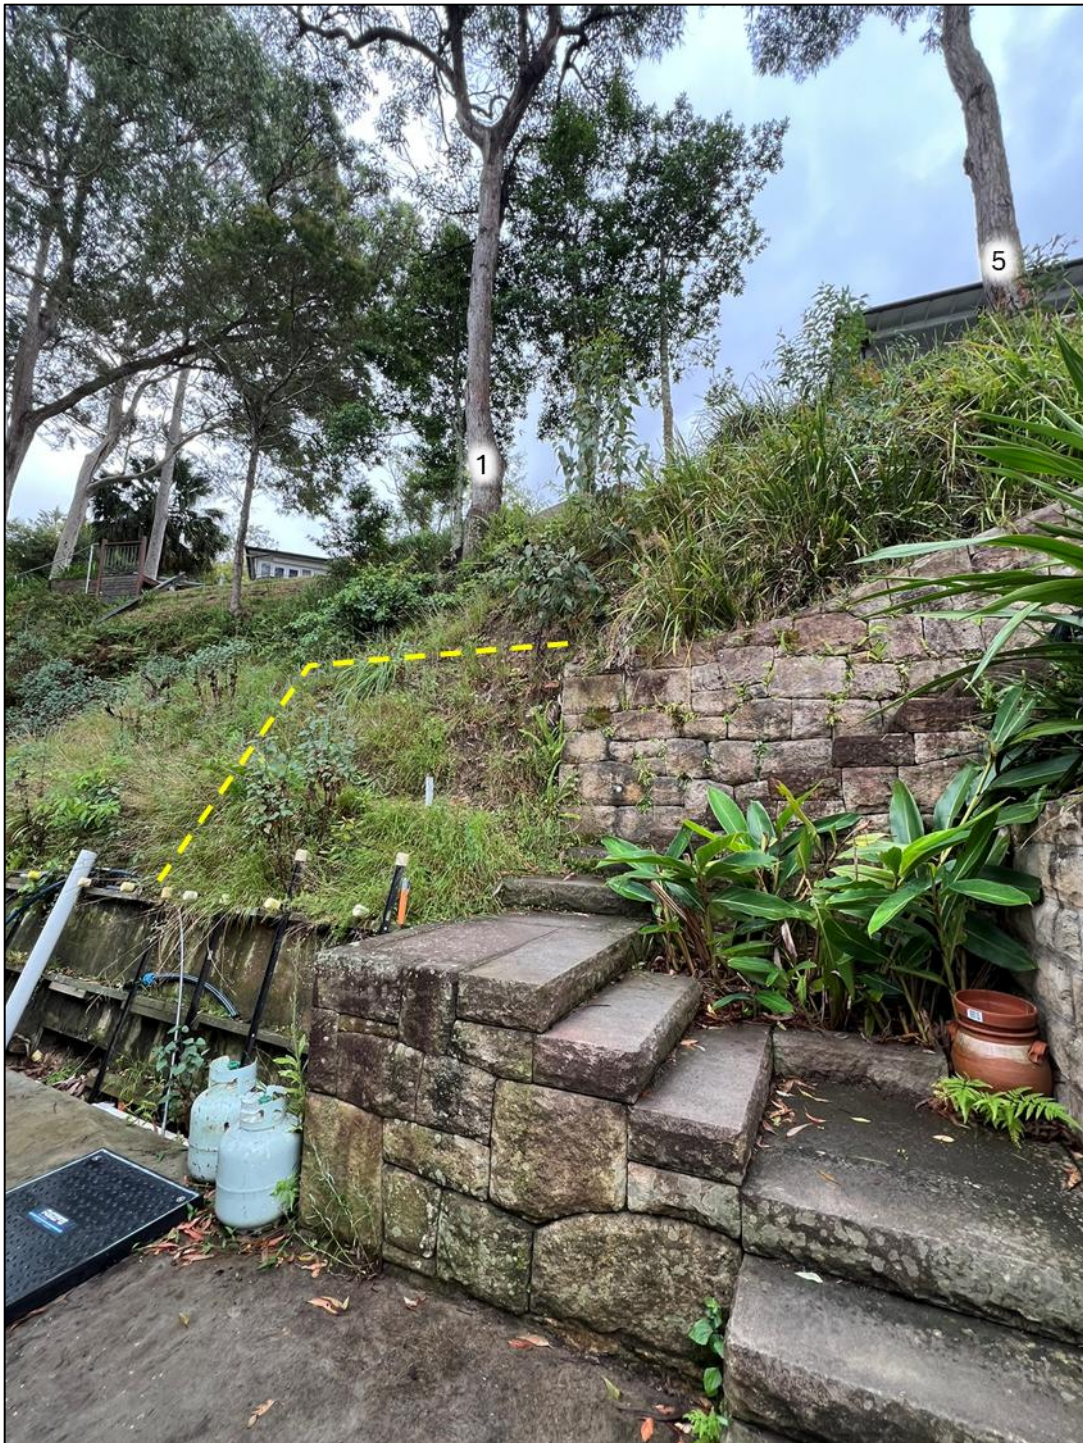
| Tree | SRZ Encroachment | Encroachment (%) | Impact | Mitigation | Proposed Management |
|---|---|---|---|---|--|
| 1 | Yes | 9 | Low | Existing southern edge of slope and retaining wall will mitigate the impact of excavation for the proposed southern landing and associated retaining wall. Small, pier foundation of proposed stairway on northern side of pathway will significantly mitigate the impact of this feature. The undisturbed area adjacent to the western portion of this tree's TPZ will suitably compensate for the encroached area. | Retain. Install trunk protection measures in accordance with Section 4.5.2 of AS4970 (2009). All excavation within the TPZ of Tree 1 must be undertaken using hand tools only and under the supervision of the Project Arborist. Position of Footing C3 for rail must be dynamic to avoid damage or disturbance to any encountered major roots. |
| 5 | No | 1 | Low | Tree will sustain a minor encroachment within western portion of TPZ during excavation for the southern landing and Rail Footing C3. Existing southern edge of slope and retaining wall will mitigate the impact of excavation for the proposed southern landing and associated retaining wall. The undisturbed area adjacent to the western portion of this tree's TPZ will suitably compensate for the encroached area. | Retain. Install trunk protection measures in accordance with Section 4.5.2 of AS4970 (2009). All excavation within the TPZ of Tree 5 must be undertaken using hand tools only and under the supervision of the Project Arborist. Position of Footing C3 for rail must be dynamic to avoid damage or disturbance to any encountered major roots. |

Figure 9. Existing slope, retaining wall and stairway will mitigate the impact of excavation required for the southern landing on Trees 1 and 5

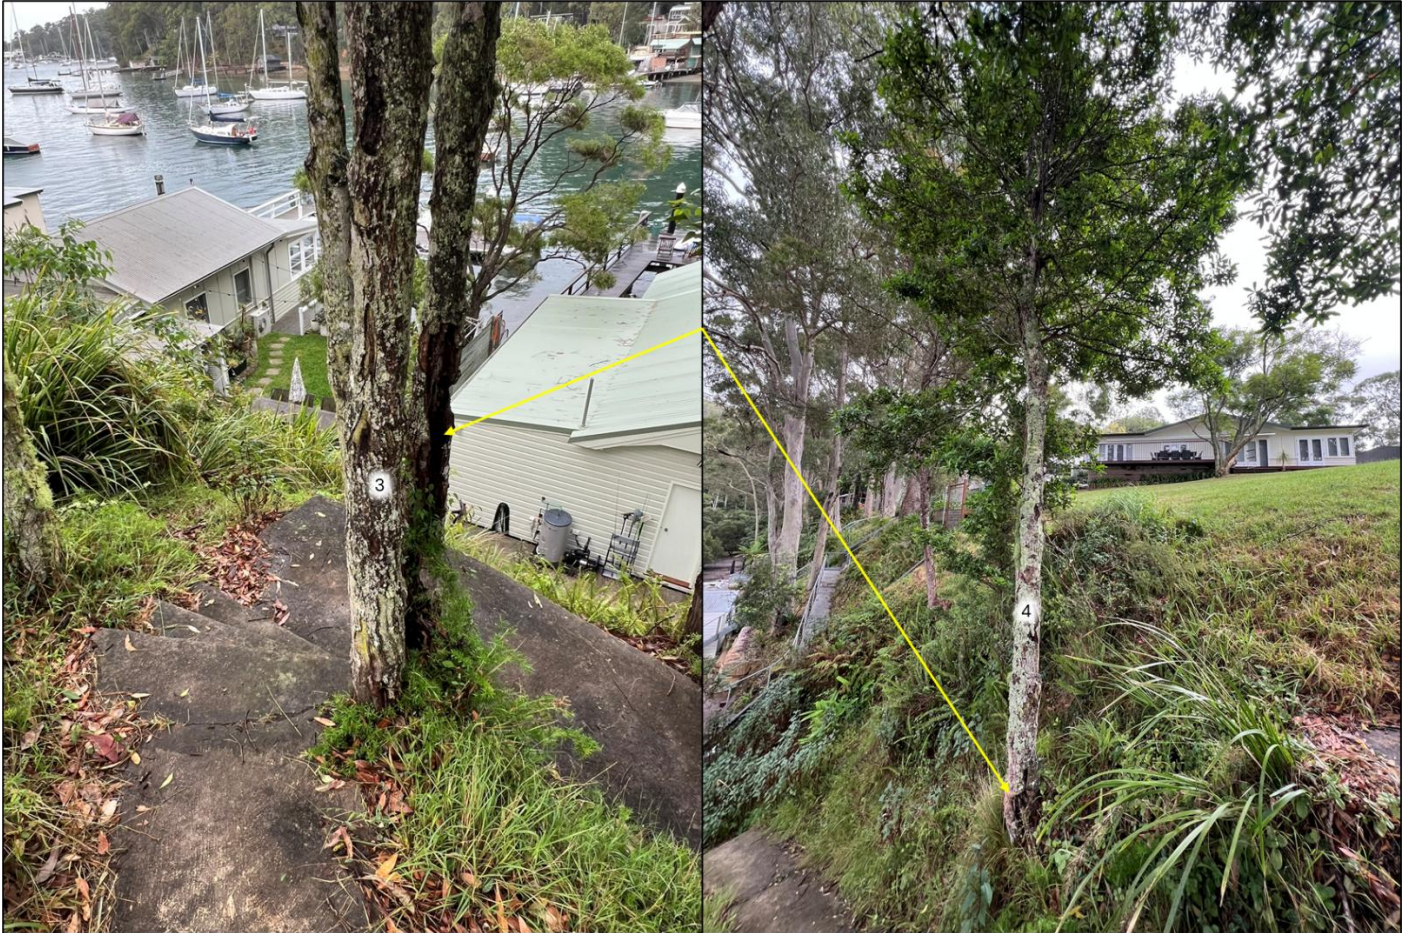
| Tree | Scientific Name | Common Name | Maturity | Height (m) | Width (m) | DBH (cm) | DRF (cm) | Health | Structure | ULE | Landscape Significance | Retention Value | R _{TPZ} (m) | R _{SRZ} (m) | Comments |
|---|---|---|---|---|---|---|---|---|---|---|---|---|---|---|--|
| 3 | <i>Stenocarpus sinuatus</i> | Firewheel Tree | Mature | 6 | 4 | 16 | 27 | Good | Poor | Short | Moderate | Low | 2.0 | 1.9 | Small tree in suppressed position. Poorly positioned adjacent to existing stairs. Stem trifurcates at ground level. Advanced decay in lower stems. |
| 4 | <i>Stenocarpus sinuatus</i> | Firewheel Tree | Mature | 6 | 4 | 18 | 23 | Good | Poor | Short | Moderate | Low | 2.2 | 1.8 | Small tree in suppressed position. Tree poorly positioned in steep slope adjacent to existing stairway. Advanced decay in lower stem. |

Trees 3 and 4 were determined to be of Low Retention Value within the surrounding landscape. Both trees were determined to be of Moderate Landscape Significance due to their native species value. However, observation of advanced decay at the base of both trees' stems underpinned the Short ULE estimates and Low Retention Value ratings determined for them. The retention of this tree should not obstruct or require alteration of the proposed development. Trees 3 and 4 are suitable for removal if required as part of the proposed development.

Figure 10. Observation of advanced decay at the base of trees 3 and 4 underpinned the Low Retention Value ratings determined for them.

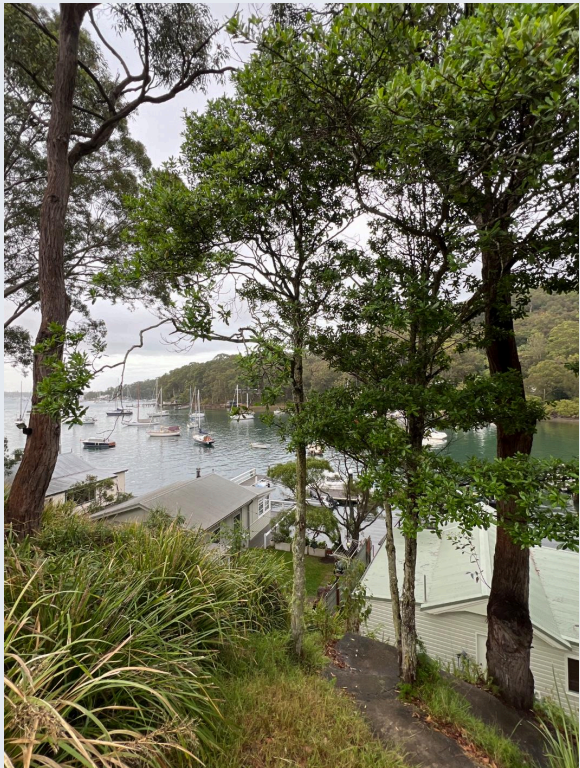
Larger tree of indigenous species significance. Canopy with minor signs of dieback. Deadwood throughout. Positioned adjacent to existing concrete pathway in steep slope. Bulge on southern side of stem. Root growth has caused minor displacement of adjacent pathway.

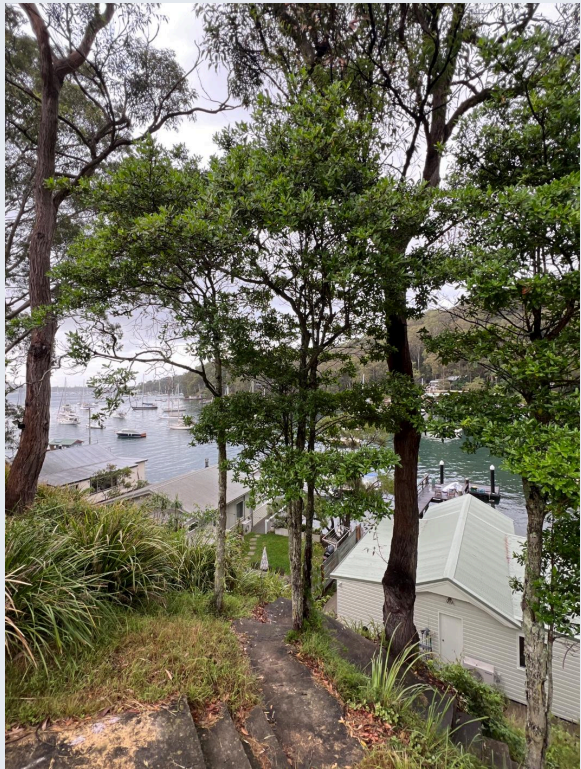
| Tree Comments: | Small tree in suppressed position. Poorly positioned adjacent to existing stairs. Stem trifurcates at ground level. Advanced decay in lower stems. |

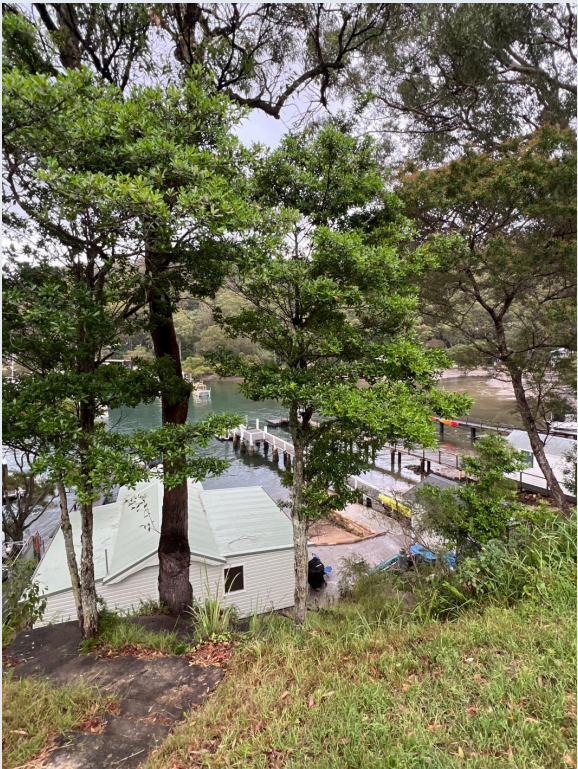
| Tree Comments: | Small tree in suppressed position. Tree poorly positioned in steep slope adjacent to existing stairway. Advanced decay in lower stem. |
