REPORT ON GEOTECHNICAL SITE INVESTIGATION

PROPOSED NEW INCLINATOR

4 NOTTING LANE, COTTAGE POINT, NSW

Project No.: 2012-228.1

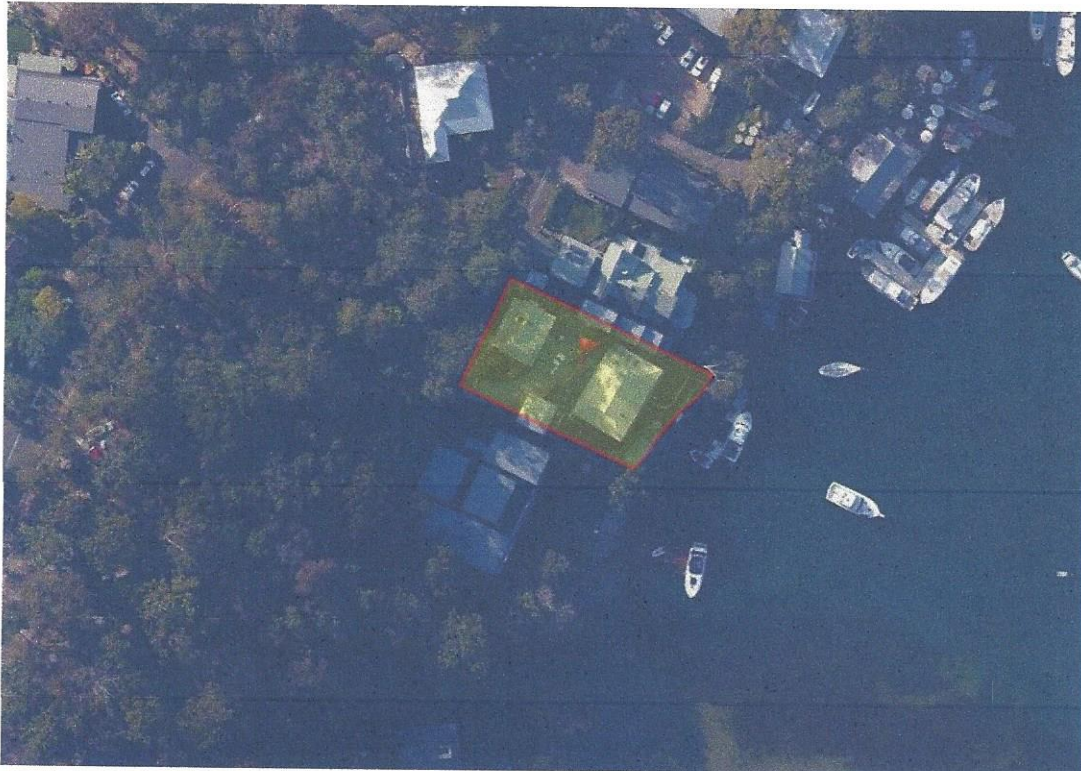
Photograph 1: Aerial photo of site and surrounds

The site is a trapezoidal shaped block within moderately south dipping topography. An aerial photograph of the site and its surrounds is provided below (Photograph 1), as sourced from NSW Government Six Map spatial data system. The site is located at the tip of a north-east striking ridge line that extends down to Cottage Point, Sydney NSW. It is located on the south-eastern side of the ridge, at the base of the slope adjacent to Coal & Candle Creek. The property is situated on the low eastern side of Notting Lane within moderate to steep east dipping topography down to the waterway.

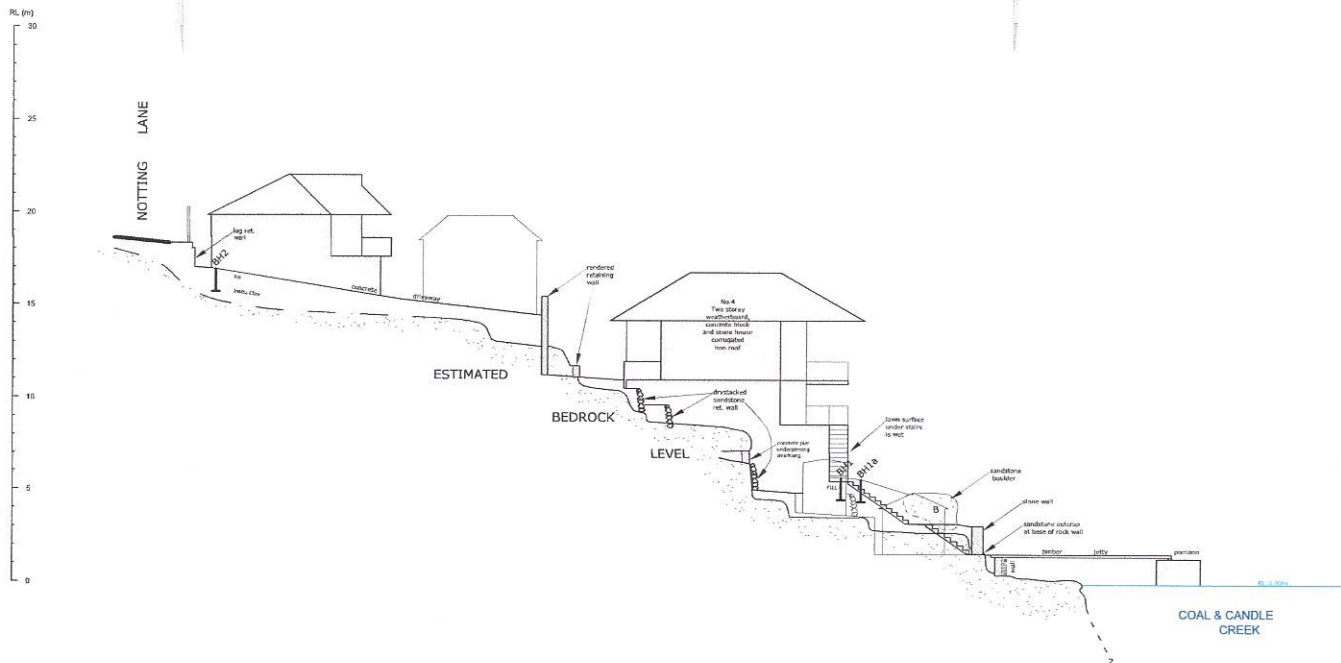
NB. FOR LOCATION OF SECTION A-A', PLEASE REFER TO FIGURE 1. SITE PLAN AND TEST LOCATIONS
