# Preliminary Geotechnical Assessment

**Project:** Alterations & Additions  
44 Borghis Street, Davidson NSW

**Ref:** AG 24556  
11 December 2024

**44 Borgnis Street, Davidson NSW**

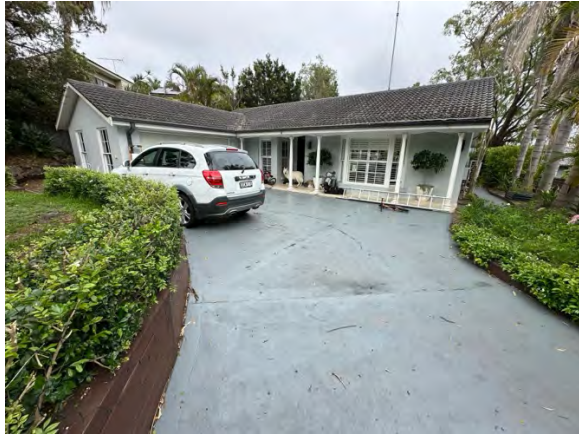
**Photo 1:** Frontage of the dwelling facing west.

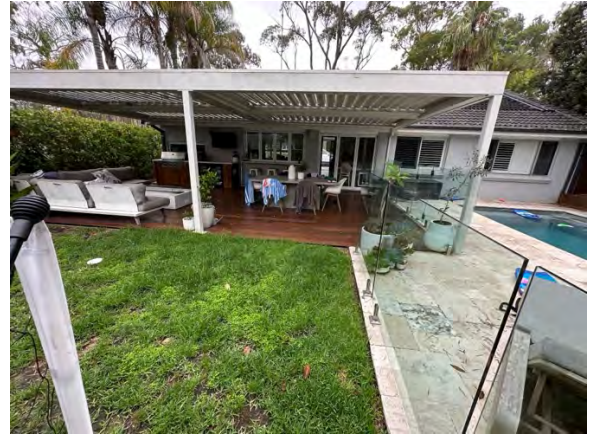
**Photo 2:** Rear of the dwelling facing south-east.

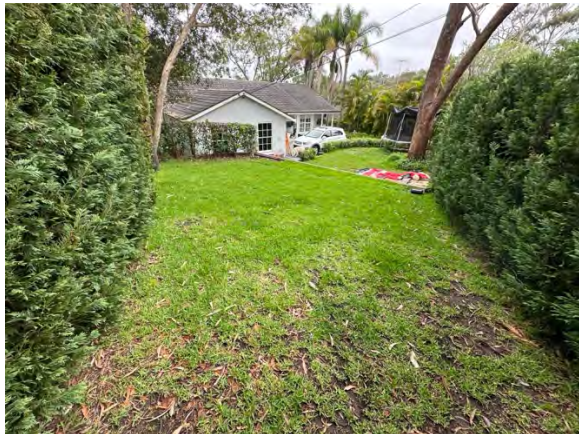
**Photo 3:** Front garden area facing north.

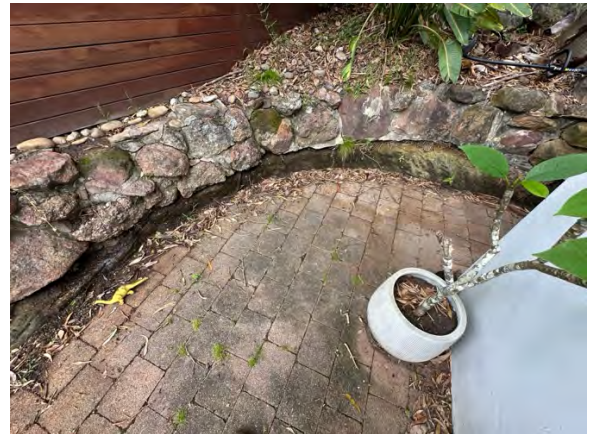
Parameter	Description
Retaining Structures	Low level stackrock, and soldier pile landscaping walls in reasonable condition for their age.
Neighbouring Environment	Residentially developed to the north, east, and west. Borgnis Street to the south.
Geology	The Sydney 1:100,000 Geological Sheet 9130 (NSW Dept. Mineral Resources, 1983) indicates that the site is underlain by the Middle Triassic Hawkesbury Sandstone (Rh). The Hawkesbury rocks outcrops on the subject slope and in the surrounding properties.
Potential Geotechnical Hazards	No evidence of significant settlement, slope instability, undercutting, jointing or other geotechnical hazards were identified at the time of our assessment.
Groundwater	Due to the position of the site relative to the slope and the underlying geology, no significant standing water table is expected to influence the site.

**Photo 4:** Inferred sandstone bedrock outcropping under stackrock landscaping wall.
