GEOTECHNICAL RISK MANAGEMENT POLICY FOR PITTWATER
FORM NO. 1 – To be submitted with Development Application

Address of site 2 Bruce Street Mona Vale

Report Title: TGE22026 Report on Geotechnical Investigation 2 Bruce Street Mona Vale

2 BRUCE STREET MONA VALE

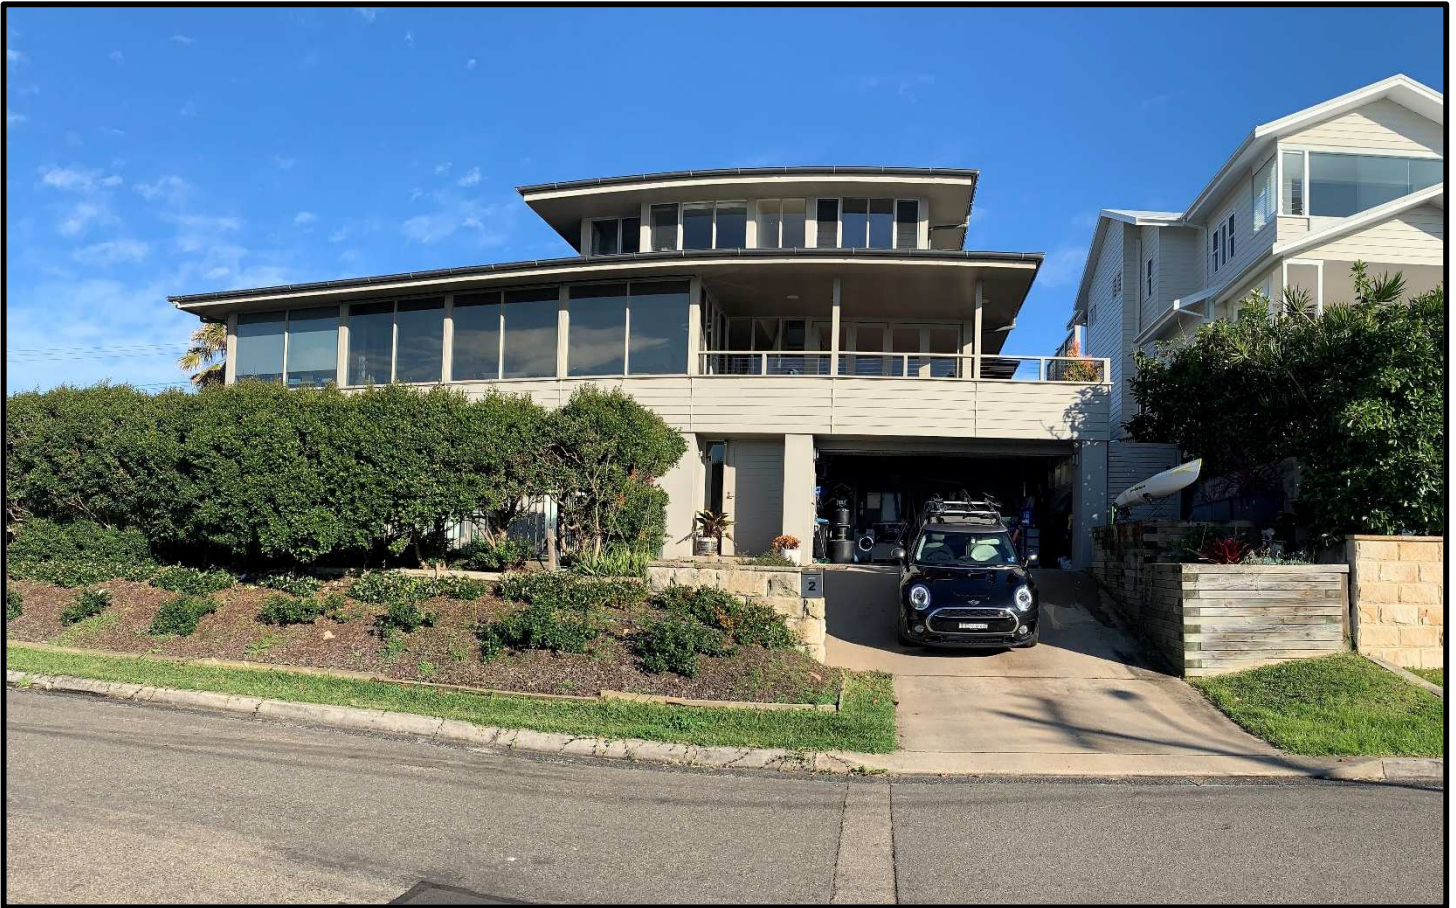
Photo 1 – View of site from Bruce Street, looking west.

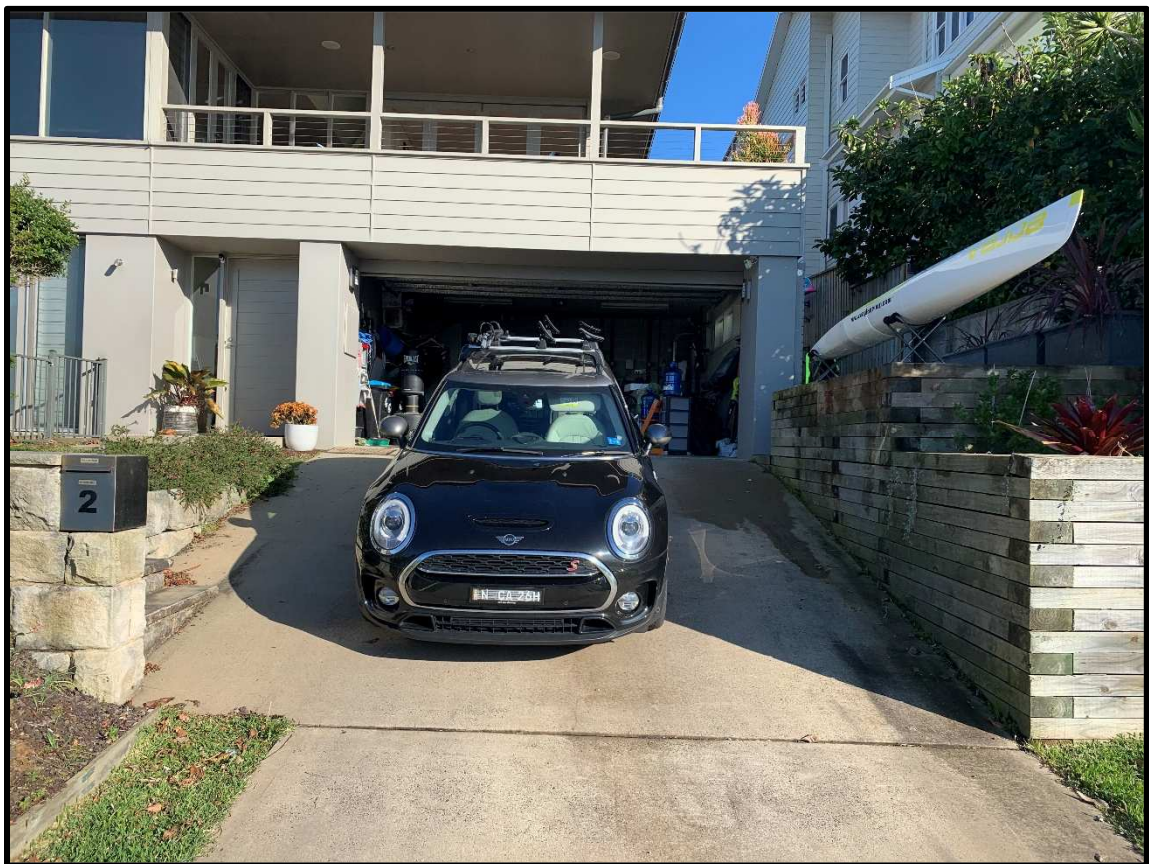
Photo 2 – View of north eastern section of site where carport is to be located, looking west.

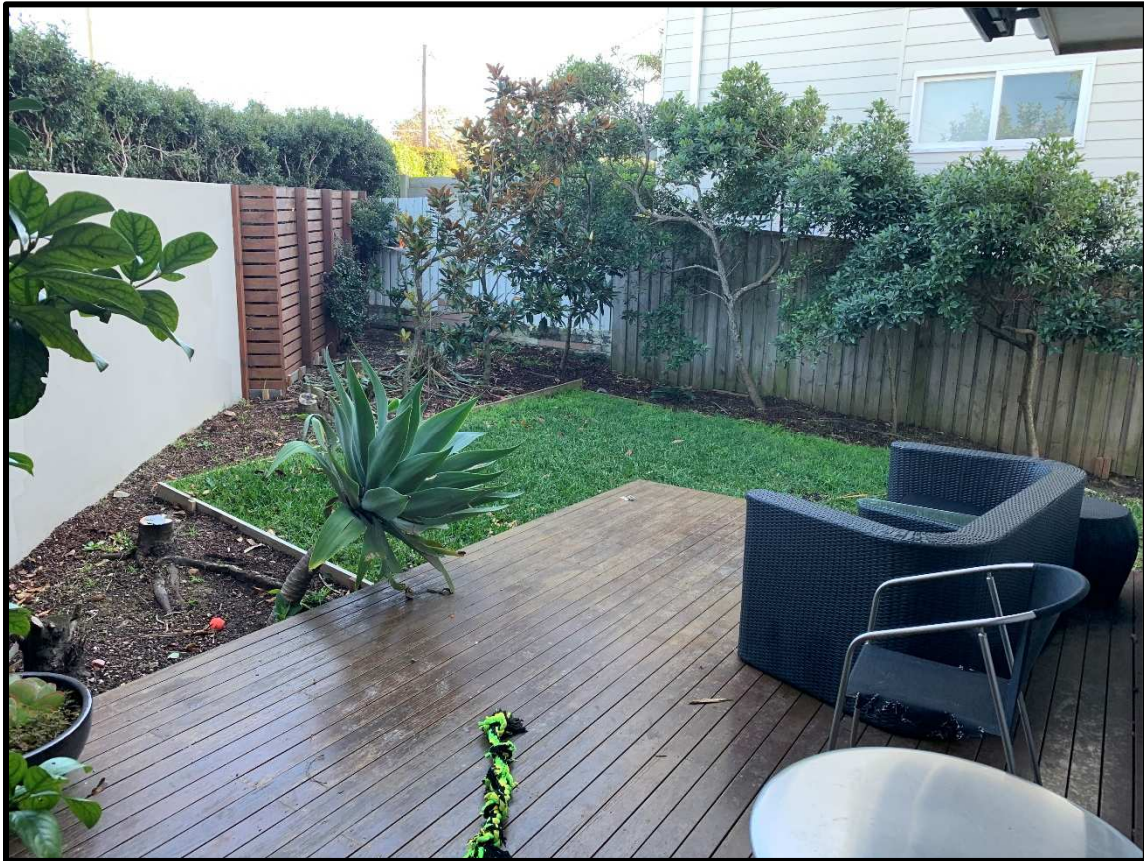
Photo 3 – View of north western section of site where pool is to be located, looking north west.

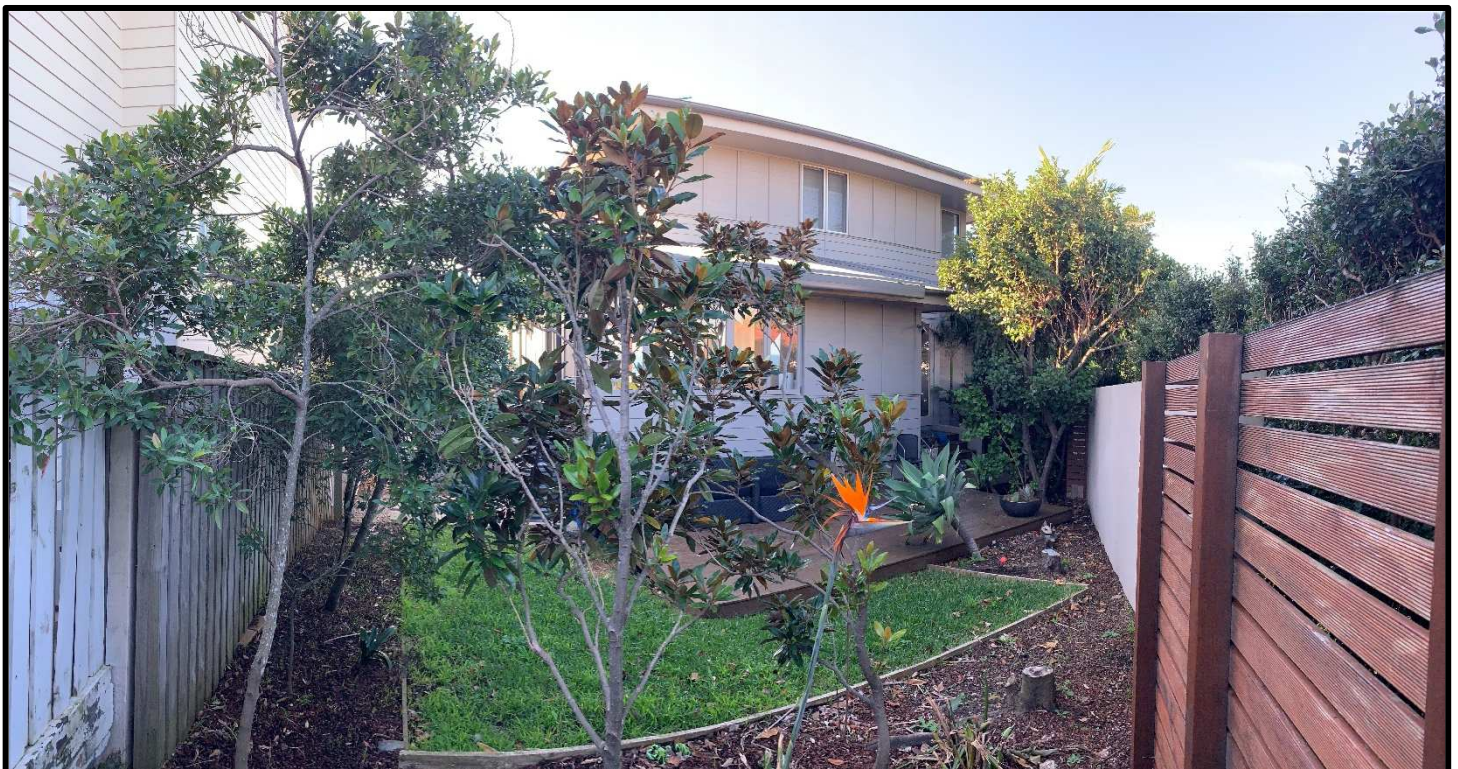
Photo 4 – View of north western section of site where pool is to be located, looking south east.
