8 Addison Road, Manly

Undercut Rock

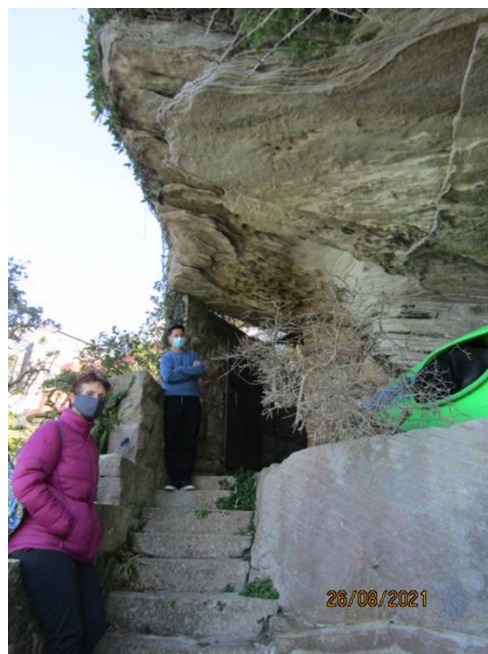
Photo 1

The access stairs down to the water front passes under overhanging rock (Photo 1) and is supported on rock that is undercut (Photo 2 & 3). The storage area for water craft near the end of the access stairs is located under a thin, long overhanging bed of rock (Photo 4 & 6). North of this area lower on the rock face and close to the rock platform, the rock is undercut slightly (Photo 5) and is cracked through the supporting cantilever arm. However, this is close to the rock platform and waterline and the owners inform us this area is rarely frequented due to its location. The upper rock out crop is undercut by up to ~ 4.0m (Photo 6 & 7). The rock formation is Medium Strength or better. The undercutting is occurring along the bedding planes which vary from ~ 0.5 to 2.5m thick. The upper beds in the formation show some tightly spaced jointing at 0.4 to 1.5m that strike NNE, roughly following the shore line.

1. Access path under over hanging rock (Photo 1). Support with single blade wall.
2. Undercut below access path (Photo 2 & 3). Support with two blade walls.
3. Long thin overhang over watercraft storage (Photo 4 & 6). Break down over hanging rock with rock saw.
4. Waterfrontage upper rock face overhang (Photo 6 & 7). Support with multiple blade walls.
