Report Title: Geotechnical Report 130 Irrubel Road, Newport  
Report Date: 24/12/21

## **GEOTECHNICAL INVESTIGATION:**

New Pool at **130 Irrubel Road, Newport**

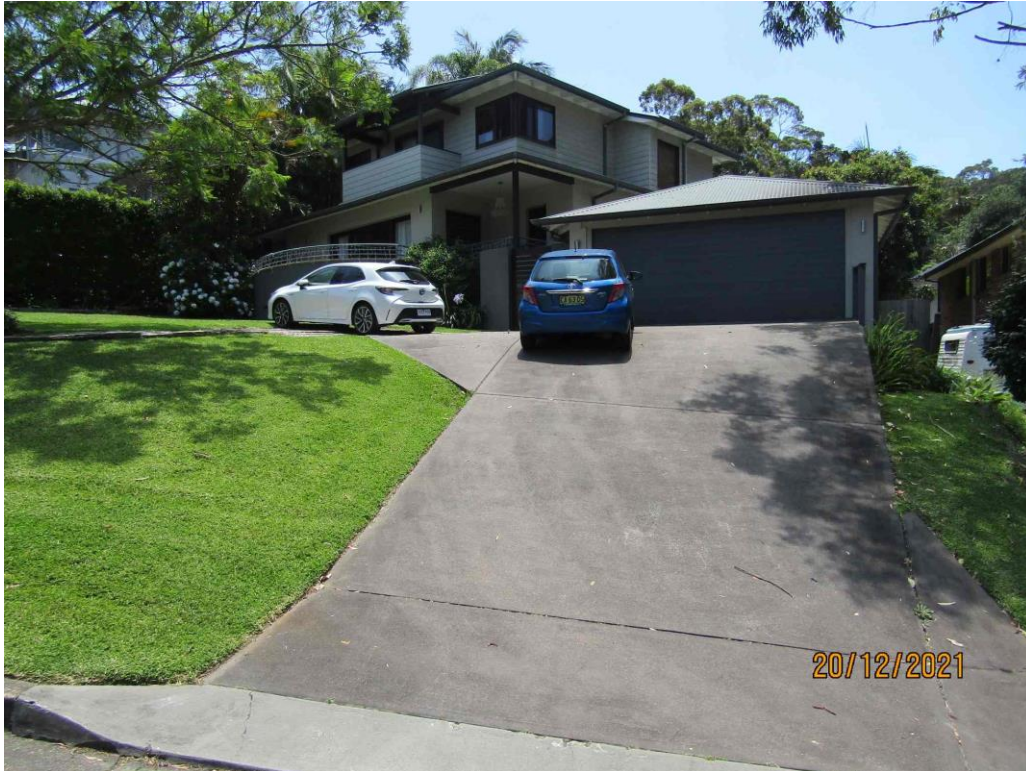
Photo 1

- 2.3** At the road frontage a concrete driveway runs up the slope to a garage beside the house (Photo 1). A low rendered masonry retaining wall supports the fill for the upper portion of the driveway. Between the road frontage and the house is a gently sloping lawn. The two storey rendered masonry and timber clad house is supported by masonry walls (Photos 1 & 2). The external supporting walls show no significant signs of movement. A timber deck and lawn and garden areas extend off the N side of the house (Photos 2 & 3). The fills for the lawn and garden areas are supported by low timber retaining walls (Photo 4). A timber retaining wall ~1.6m high along the W common boundary supports fill on the W neighbouring property (Photo 5). The wall is tilting at up to ~13° downslope. See '**Section 16 Remedial Works**'. Apart from the

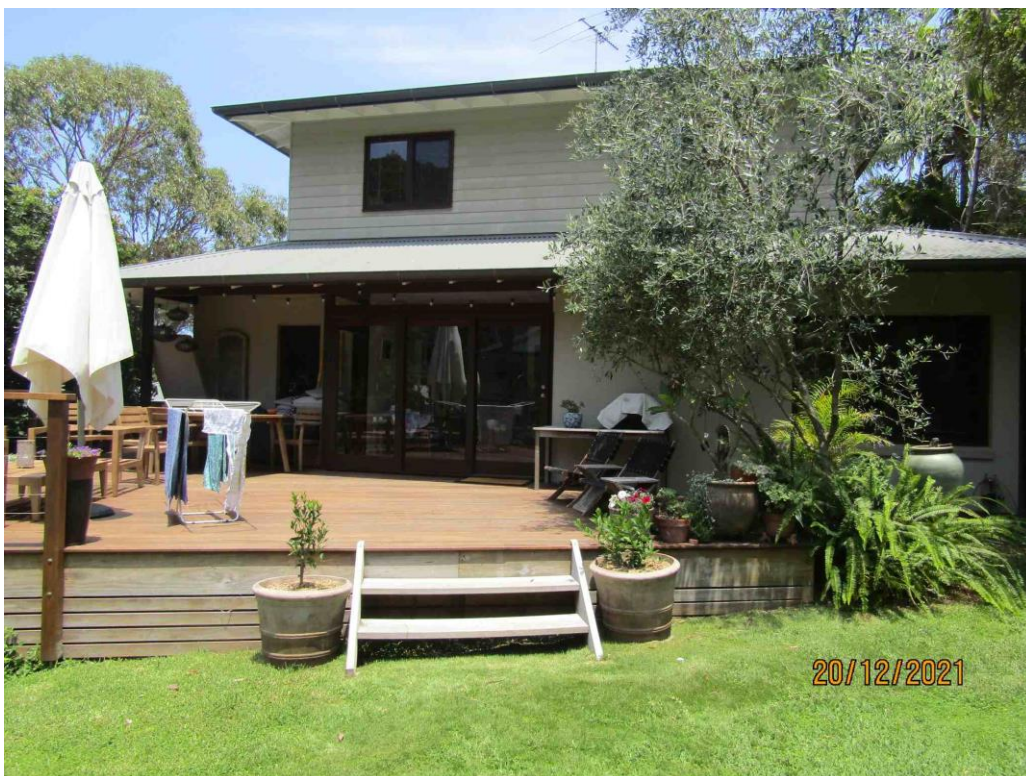
Photo 2

HAZARDS	Hazard One	Hazard Two
TYPE	The gentle to moderately graded slope that falls across the property and continues above failing and impacting on the property.	The proposed excavation for the pool collapsing onto the worksite and undercutting the existing deck (Photo 2) during the excavation process.
LIKELIHOOD	'Unlikely' ( $10^{-4}$ )	'Possible' ( $10^{-3}$ )
CONSEQUENCES TO PROPERTY	'Medium' (12%)	'Medium' (20%)
RISK TO PROPERTY	'Low' ( $2 \times 10^{-5}$ )	'Moderate' ( $2 \times 10^{-4}$ )
RISK TO LIFE	$8.3 \times 10^{-7}$ /annum	$3.7 \times 10^{-6}$ /annum
COMMENTS	This level of risk is 'ACCEPTABLE'.	This level of risk to life and property is 'UNACCEPTABLE'. To move the risk to 'ACCEPTABLE' levels, the recommendations in <b>Section 13</b> are to be followed.

An excavation to a maximum depth of ~1.8m is required to install the proposed pool. The excavation is set back ~0.8m from the existing timber deck (Photo 2).

The timber posts supporting the N edge of the deck are to be propped and supported with beams, prior to the excavation commencing.

As the majority of the excavation is through fill and sand it is recommended the cut batters be temporarily supported as the excavation is progressed with typical pool shoring such as braced form ply or similar until the pool structure is in place. See the site plan attached for the minimum extent of the required shoring shown in blue.

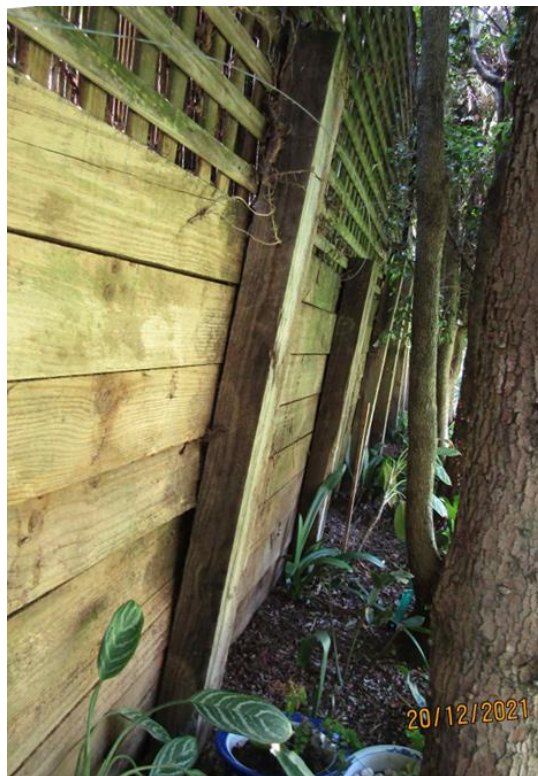
Photo 5

tilting retaining wall supporting fill, no signs of slope instability were observed on the property.

It is recommended additional soldier posts be installed to support the middle portion of the tilting timber retaining wall (where it is tilting at up to 13° downslope - Photo 5) as part of the proposed works. The posts are to be designed and approved by the structural engineer.

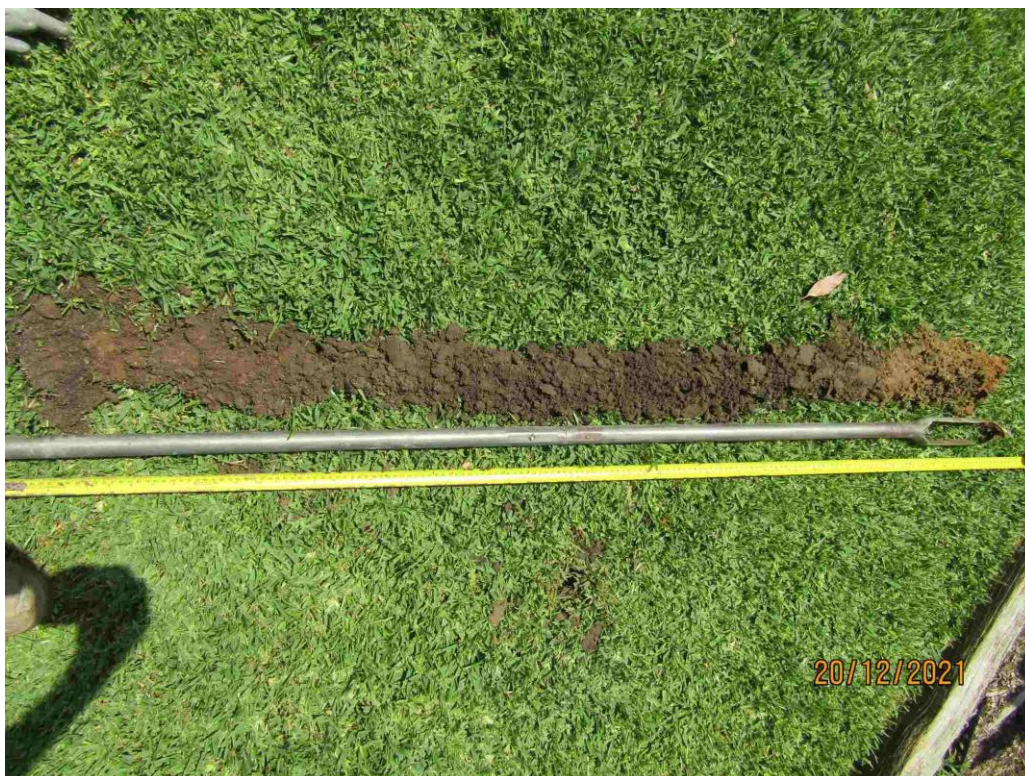
#### AUGER HOLE 1 (~RL10.7) – AH1 (photo 6)

Depth (m)	Material Encountered
0.0 to 1.3	<b>FILL</b> , sandy soil, dark brown, moist, fine to medium grained.
1.3 to 1.5	<b>SAND</b> , grey brown, moist, fine to medium grained.
1.5 to 1.6	<b>SANDY CLAY</b> , orange, moist, firm.

End of Hole @ 1.6m in firm sandy clay. No watertable encountered.

Photo 6: AH1 – Downhole is from left to right.
