ARBORICULTURAL IMPACT STATEMENT

On: Tree Specimens at tree inspection at
552 Pittwater Road North Manly NSW
2100

For.Mr. & Mrs. Davey
On. 21/8/2021

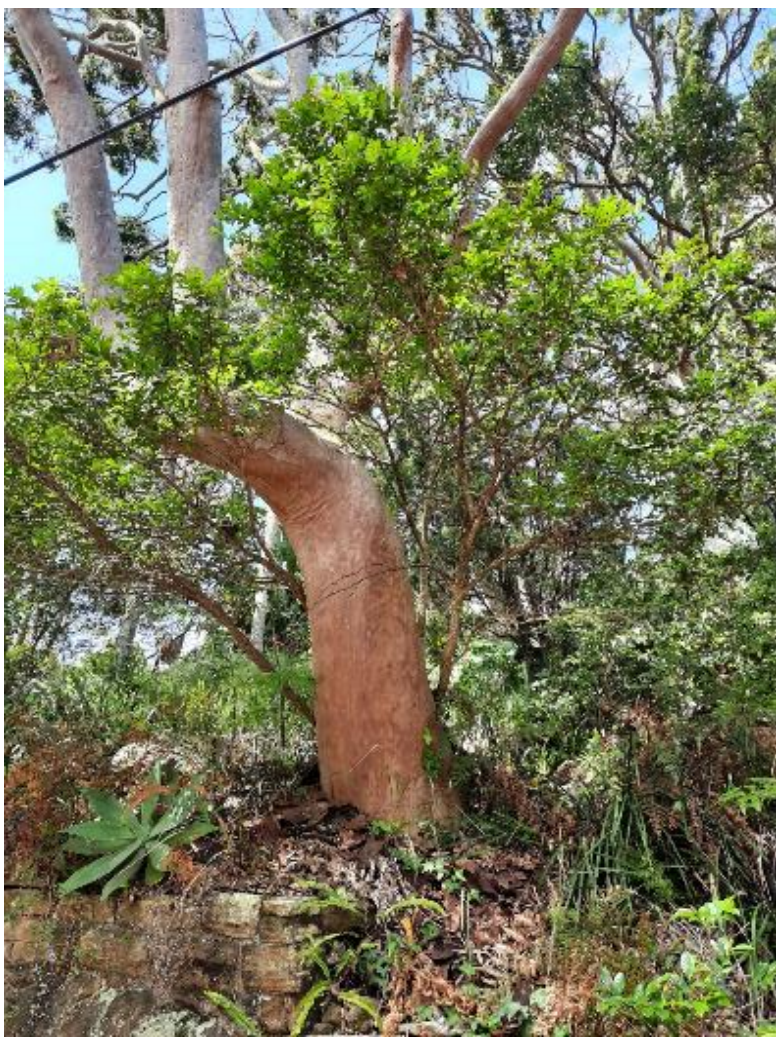
4.1 Trees **T1 & T12** are both *Angophora costata* or 'Argyle Apple' which is an endemic tree common to the Sydney region and the Northern Beaches Council LGA¹ (See Figs. 2, 14 & 15). Both trees are forest remnants and therefore environmentally significant.

- **T1** is well outside the building area and the deep excavation and is not anticipated to be adversely affected by the proposed development.
- **T12** has been accommodated for in the plans in that the deep excavation will leave a 3m sandstone bench in situ to accommodate the tree.

Fig 2. Photo of T1 an *Angophora costata*

6.2 Trees **T1** and **T12** are to be retained and protected.

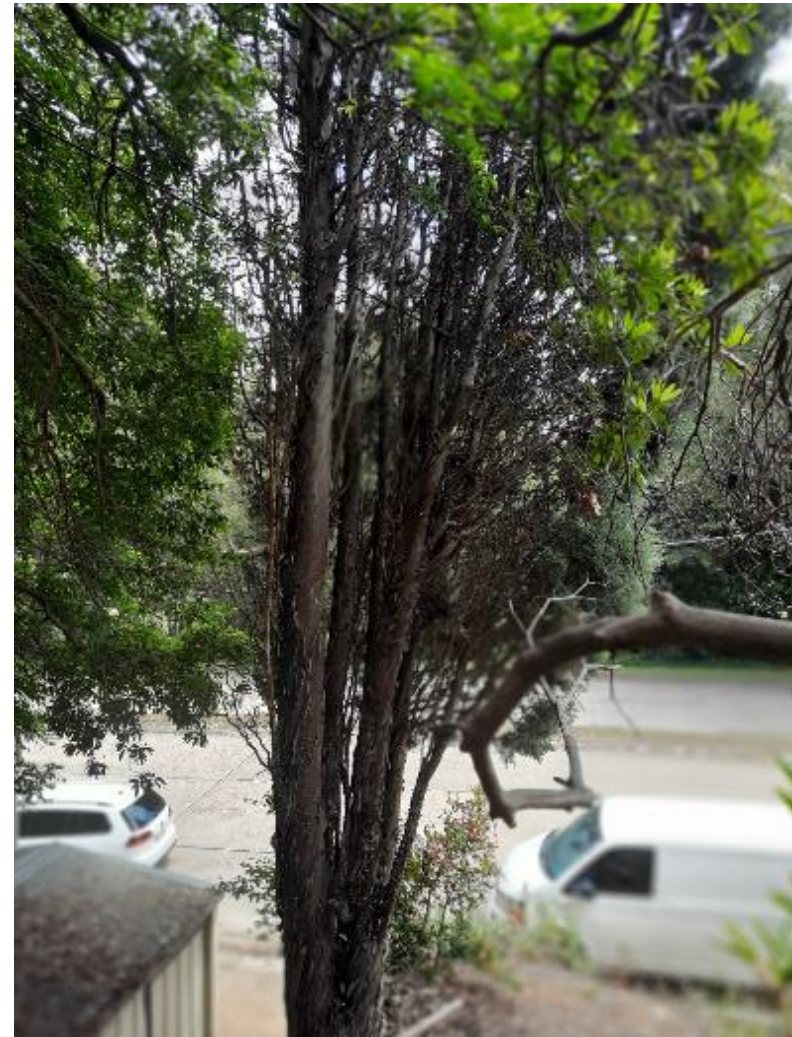
4.2 Trees **T2 & T9** are both *Cupressus macrocarpa* or 'Monteray Cypress' which is an exotic conifer species that have been planted in the front yard to the West of the existing dwelling (See Figs. 6 & 7). Both trees have significant defects in the form of multiple stems which adjoin in 'V' shaped stem junctions (See Figs. 3 & 9).

Both of these specimens will be entirely engulfed by the new extension and carparking space and will need to be removed for the development to proceed as planned (See Appendix 2b).

Fig 3. Photo of tree T2 a *Cupressus macrocarpa*.

6.1 It is recommended that trees **T2, T3, T4, T5, T6, T7, T8, T9, T10, T11 & T13** be removed from the Site for the development to proceed as planned.

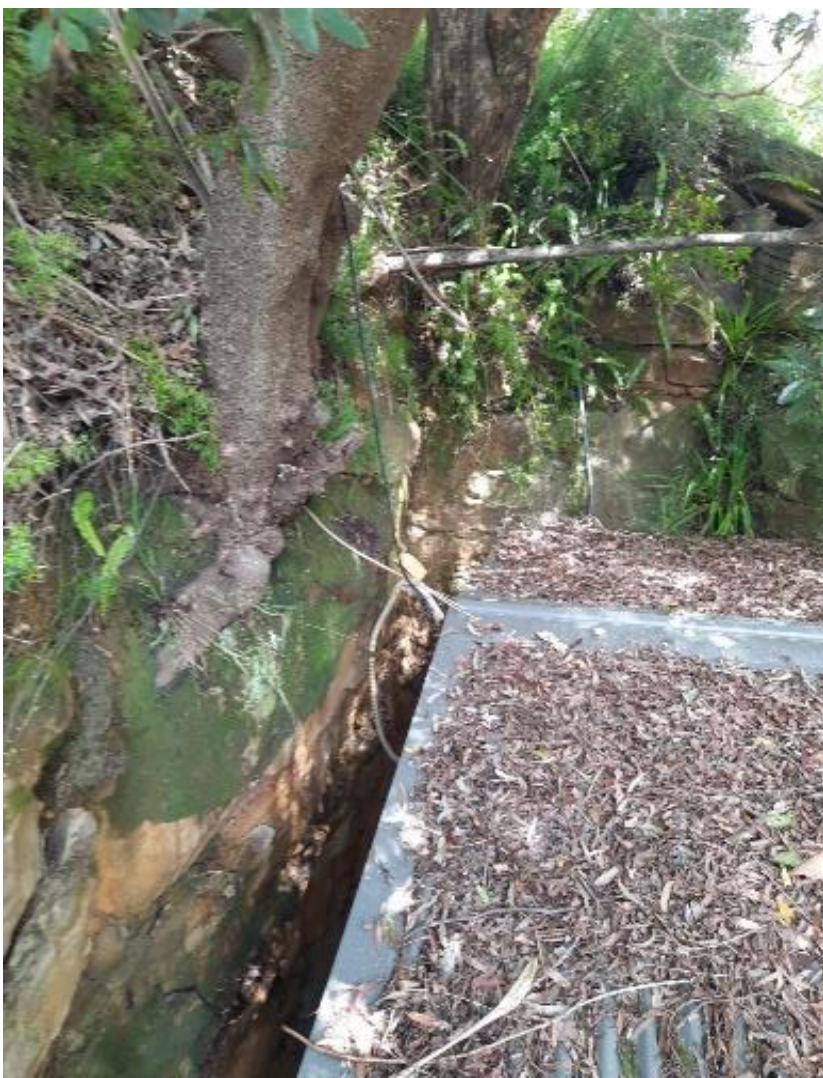
4.3 Tree **T3** is a *Pittosporum undulatum* or 'Native Daphne' which is an endemic tree common to the Sydney region and the Northern beaches LGA. The species is undesirable due to its weedy properties (NSW Weedwise)

This specimen will be entirely engulfed by the new extension and carparking space and will need to be removed for the development to proceed as planned (See Appendix 2b).

4.4 Trees **T4** and **T5** are both *Glochidion ferdinandii* or 'Cheese tree' which is an endemic tree common to the Sydney region and the Northern beaches LGA. They are growing at the top of the cutting above the existing garage (See Figs. 4 & 5).

Fig 4. Photo of lower stems from trees T3 and T4 beside garage excavation.

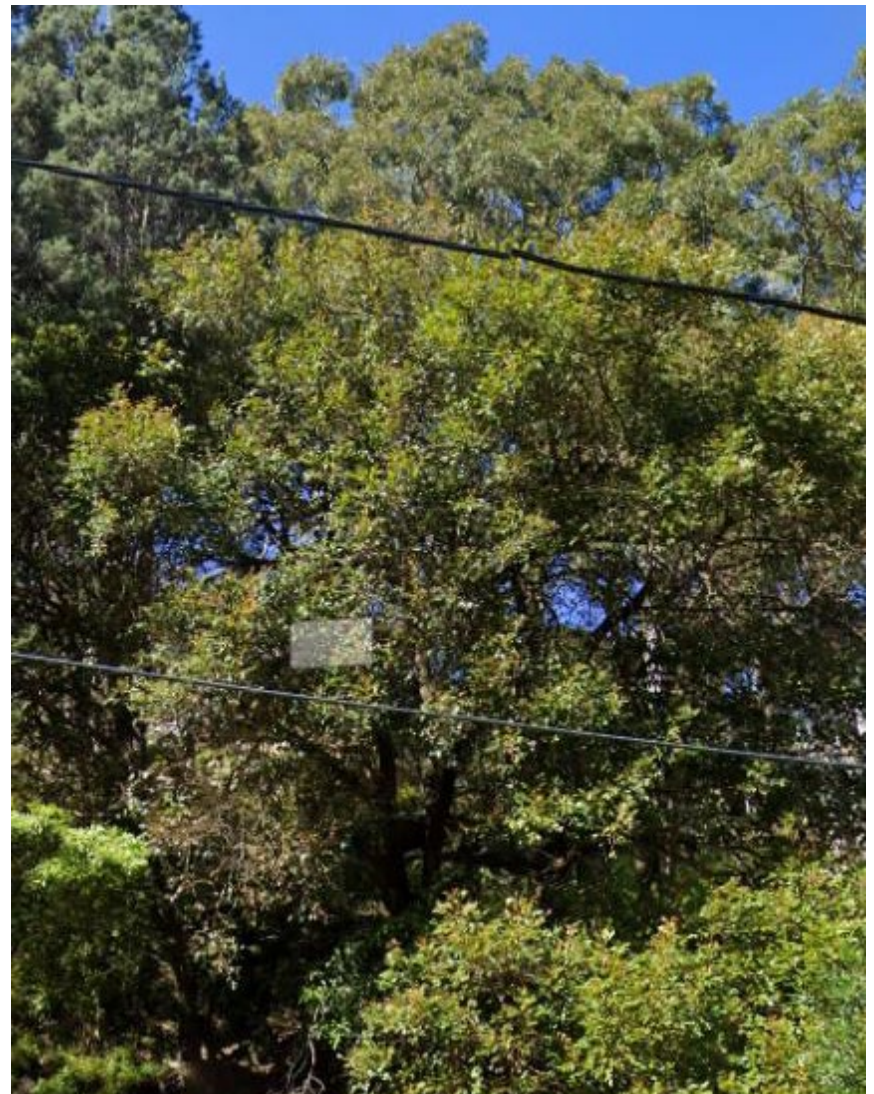
These specimens will be entirely engulfed by the new extension and carparking space and will need to be removed for the development to proceed as planned (See Appendix 2b).

Fig 5. Photo of T5 a *Glochidion ferdinandii*.

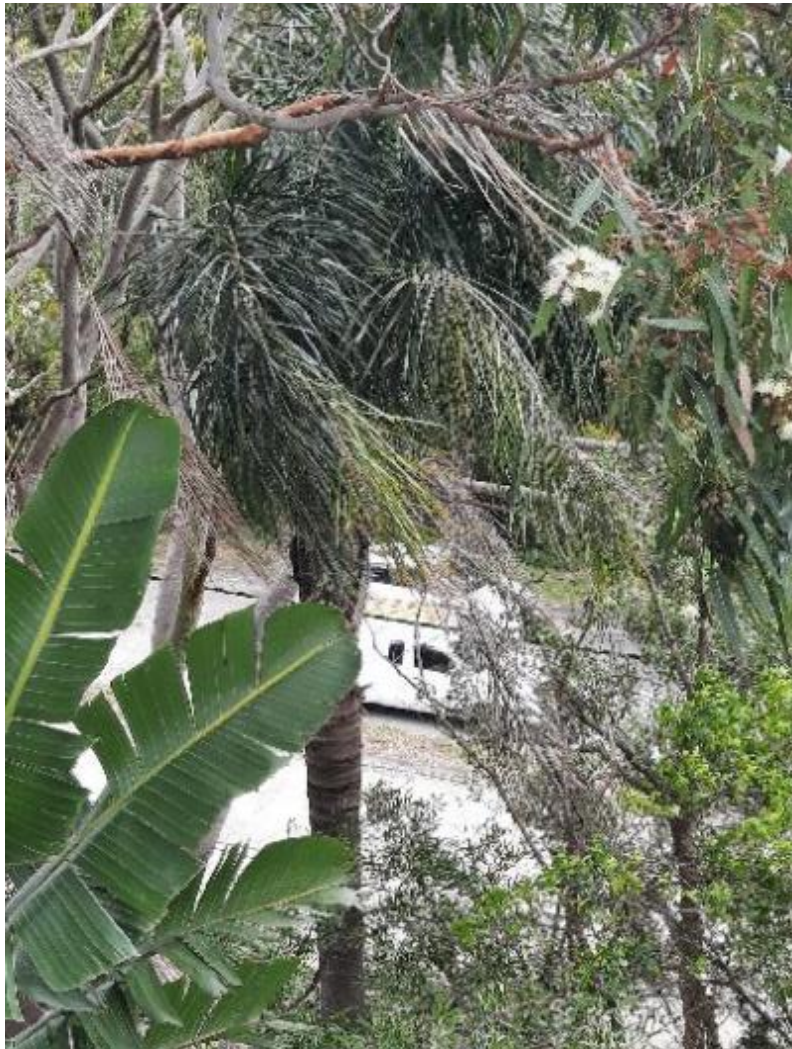
4.5 Trees **T6**, **T7** and **T10** are all *Syagrus romanzoffianum* or 'Cocos Palms' which is an exotic species endemic to South America. They are growing in the front yard to the West of the existing dwelling (See Figs. 6, 7, 8 & 9). The species is listed as exempt from protection in the Northern Beaches DCP and can be removed without consent.

Fig 6. Photo of T6 a *Syagrus romanzoffiana*

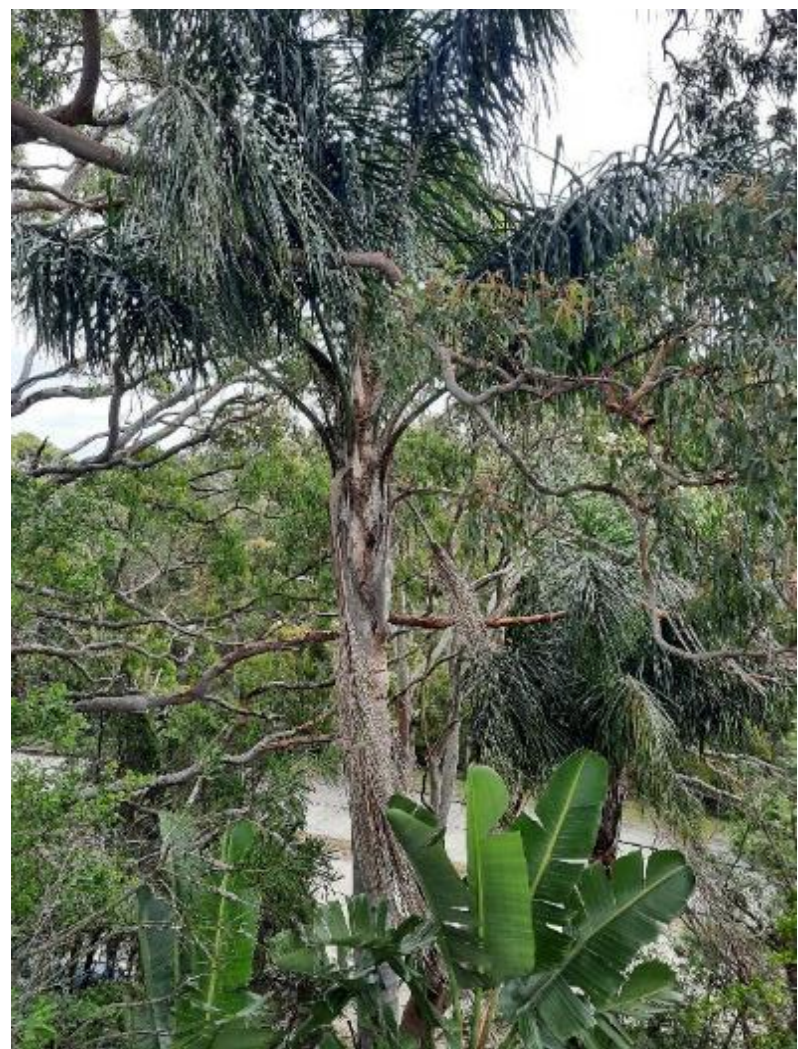
Fig 7. Photo of T7 a *Syagrus romanzoffiana*.

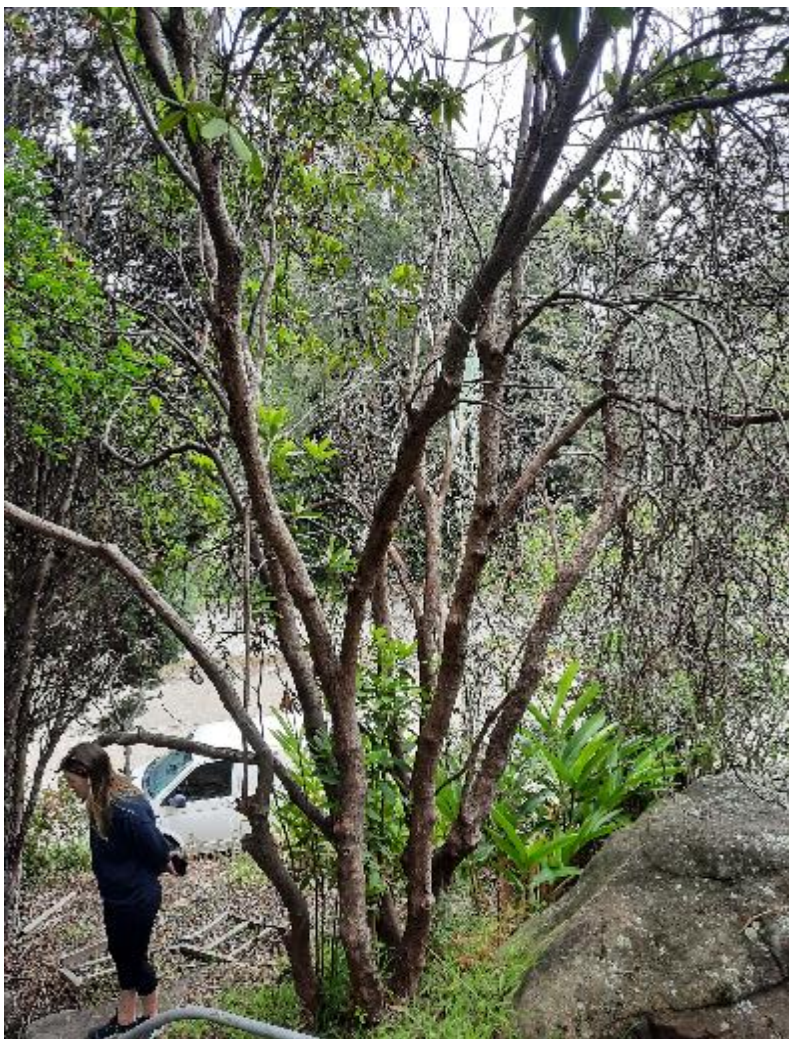
4.6 Tree **T8** is a *Rhododendron* which is an exotic species that has been planted in the front yard to the West of the existing dwelling (See Fig. 10). The tree is in poor condition with at least 50% of its canopy dead or dying.

This will be entirely engulfed by the new extension and will need to be removed for the development to proceed as planned (See Appendix 2b).

Fig. 10. Photo of T8 a *Rhododendron* with many dead limbs and branches

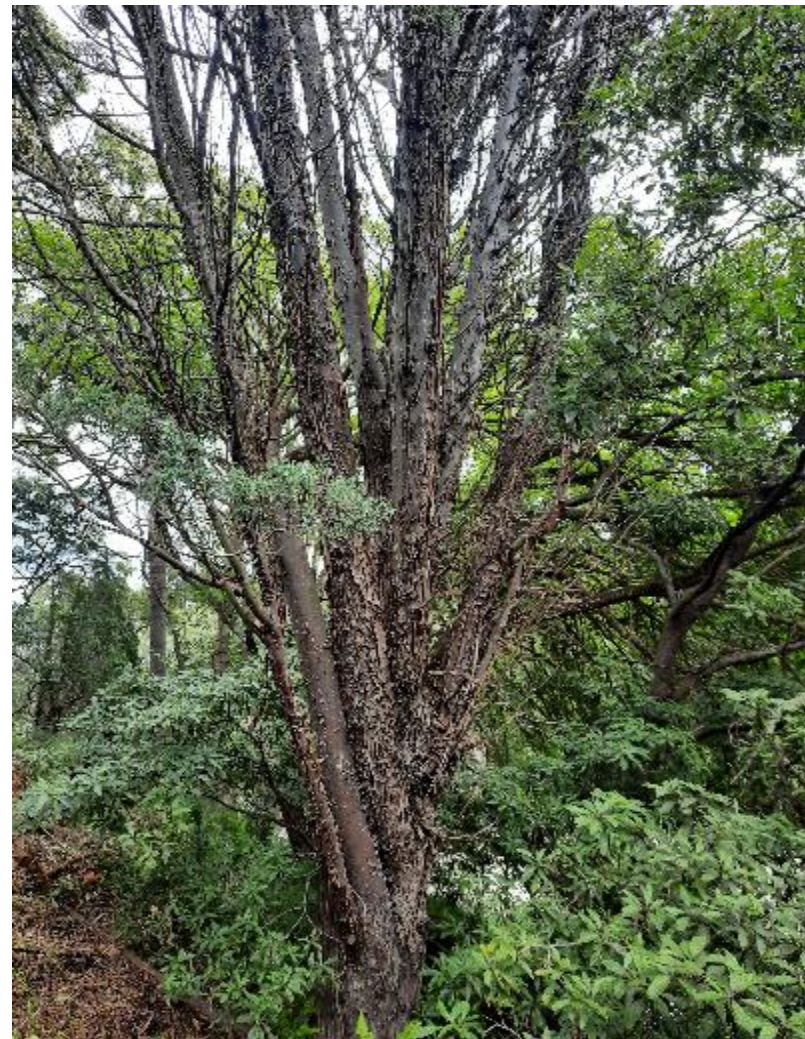
Fig. 11. Photo of T9 a *Cupressus macrocarpa*.

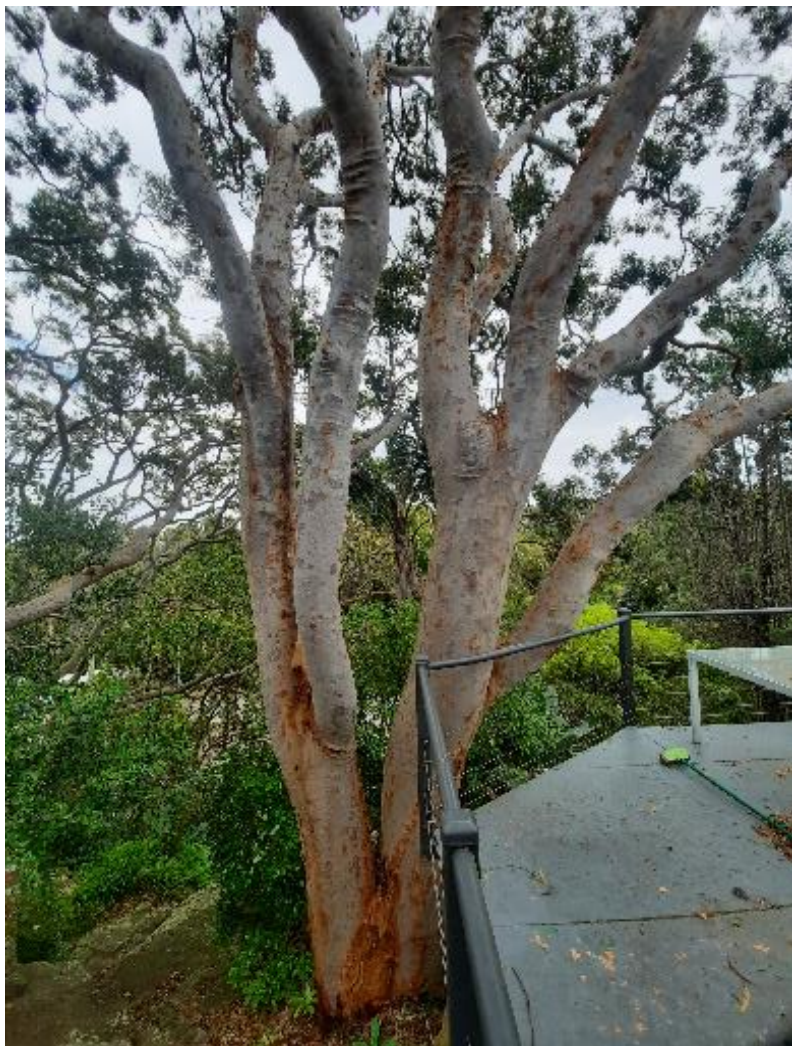
5.3 Tree **T12** will require stem and branch protection during the development.

Fig. 14. Photo of T12 an *Angophora costata*

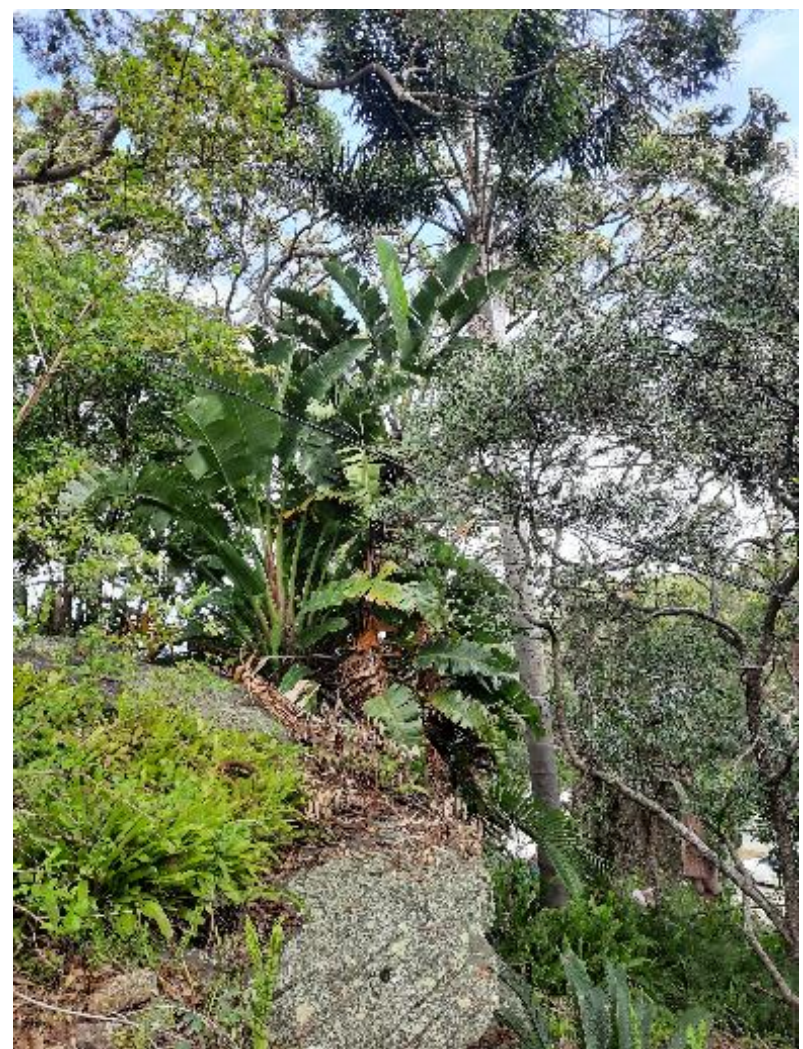
Fig. 15. Photo of rock shelf to the West of tree T12.

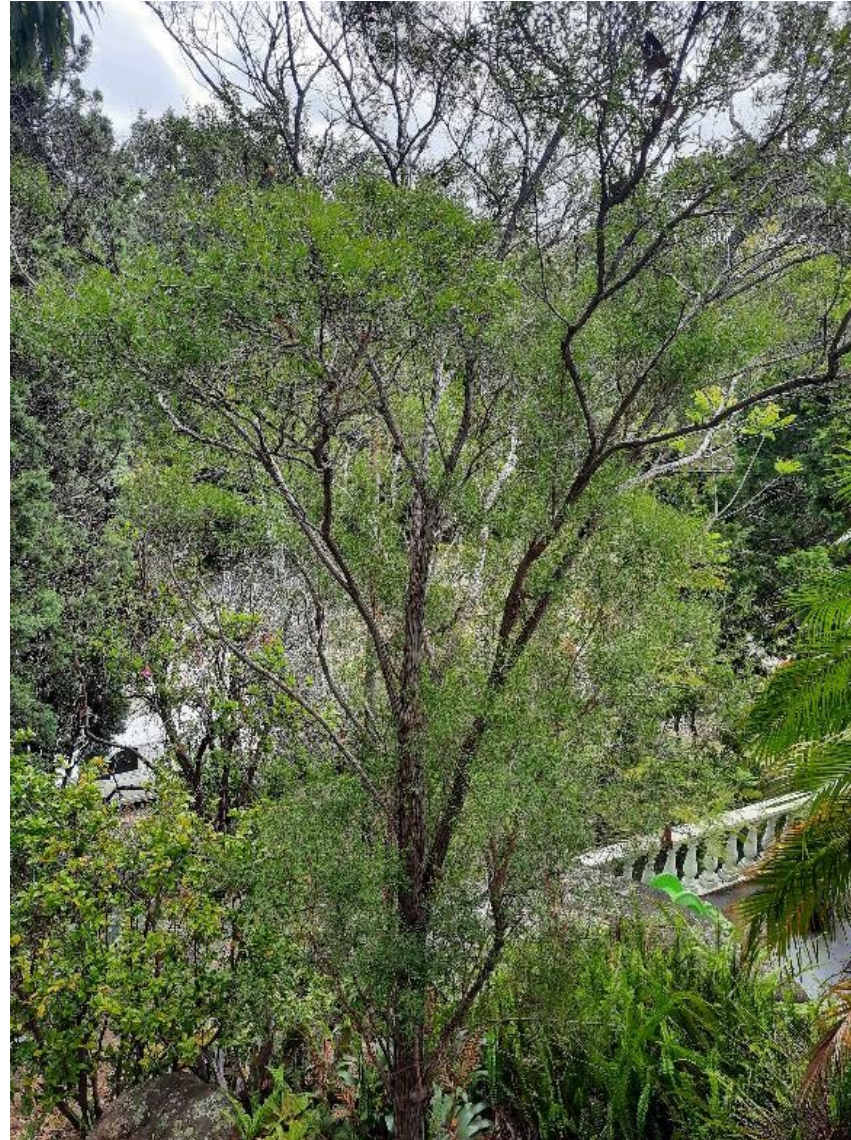
- 4 specimens, **T6, T7, T9 & T10** belong the species which are exempt from protection in the NBC local government area (LGA) and can be removed.
- Two exotic conifers, **T2 & T9**, are in poor condition.
- Three medium sized endemic trees, **T3, T4 & T5**, will be engulfed by the deep excavation for the garage. These are common in the LGA, seed readily and not rare or endangered.
- One exotic tree, **T8**, is in poor condition with many dead branches.
- On native tree, **T13**, will be engulfed by the new staircase coming up from the garage.

Fig. 15. Photo of tree T13 a *Leptospermum petersonii*
