# Geotechnical Assessment

**Project:** Alterations & Additions  
121 Rickard Road, North Narrabeen NSW

**Ref:** AG 24281  
23 July 2024

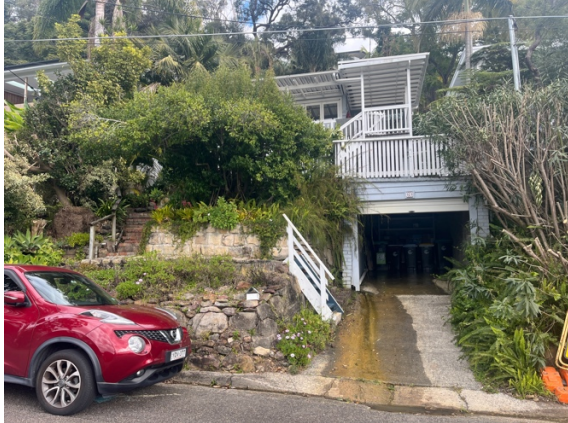
Significant seepage was observed through the soil profile in the north-western rear of the site, across the bedrock at the southern corner of the house and from the base of the rear wall of the garage.

**Photo 1:** Site frontage, note significant seepage from the rear wall of the garage

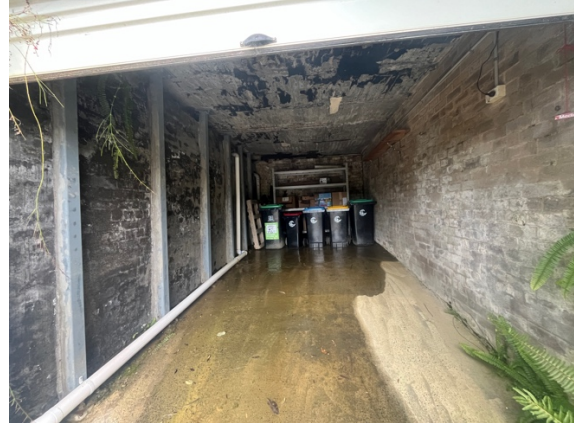
**Photo 2:** Brick garage, note left hand side wall is budging and has been braced by installation of vertical steel beams

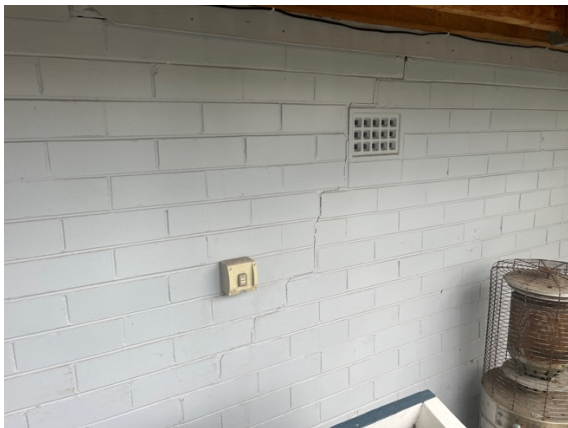
**Photo 3:** Cracking through the brick wall of the residence frontage, indicative of settlement of the northern corner of the house

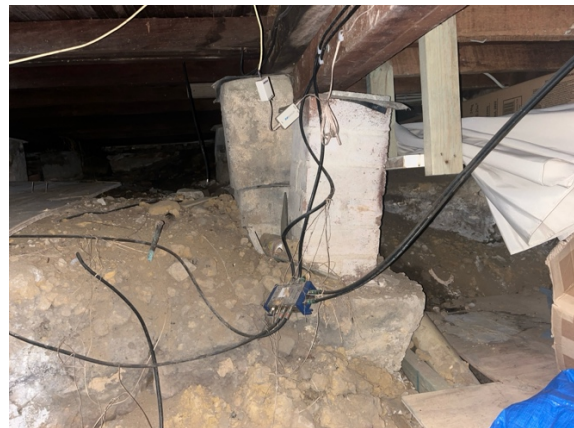
**Photo 4:** Cracked and sunken piers under the northern side of the house

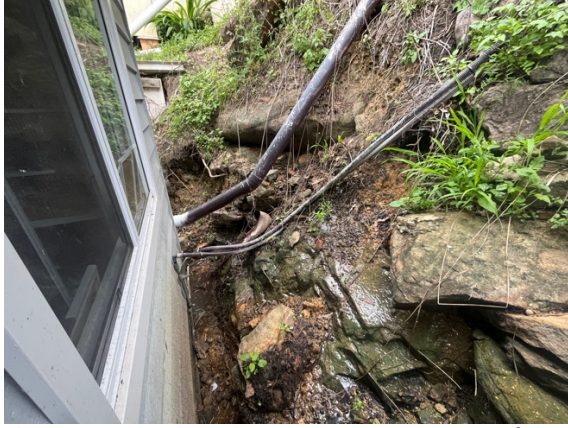
**Photo 5:** Bedrock at the southern rear corner of the dwelling, significant seepage

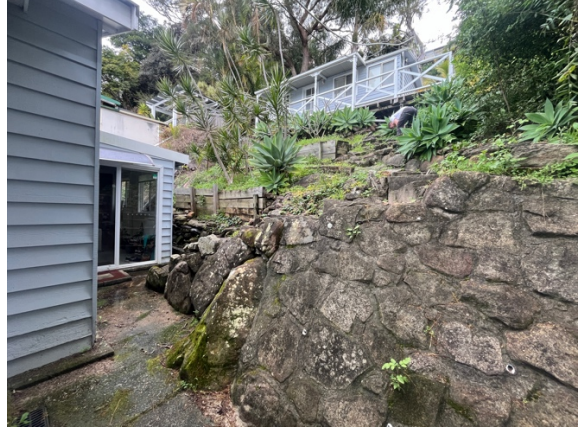
**Photo 6:** Rear of the dwelling, rear yard and timber studio
