Geotechnical Assessment

Project: Alterations & Additions
49 Tatiara Crescent, North Narrabeen NSW

Ref: AG 24504
29 November 2024

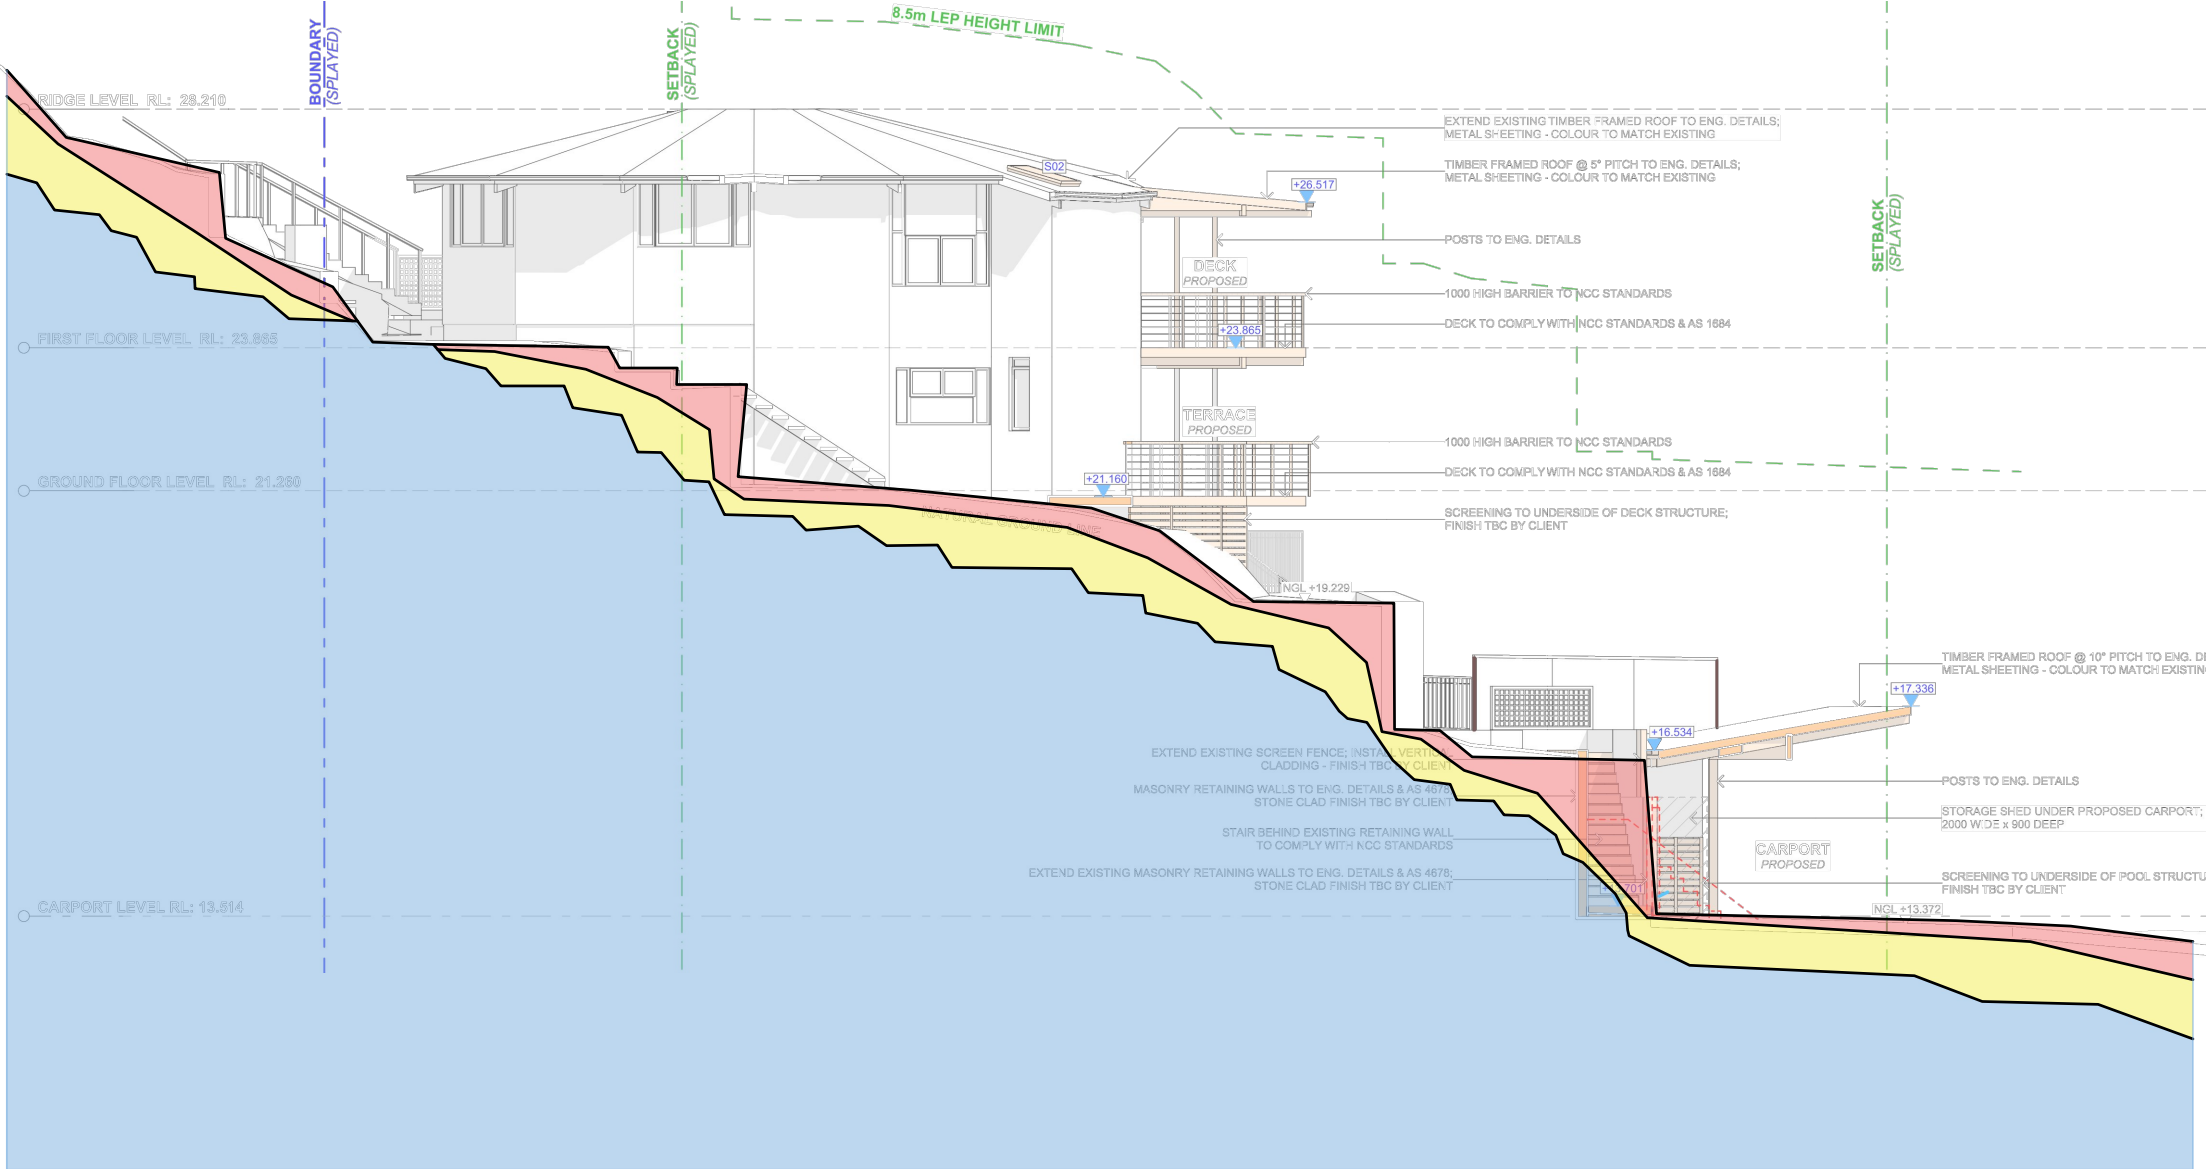
INFERRED GEOLOGICAL SECTION

INTERPRETED SUBSURFACE SECTION ONLY.
ACTUAL GROUND CONDITIONS MAY VARY.

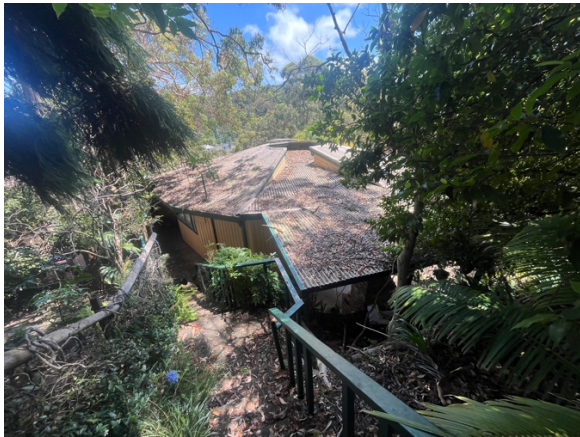
Photo 1: North-eastern side of the residence

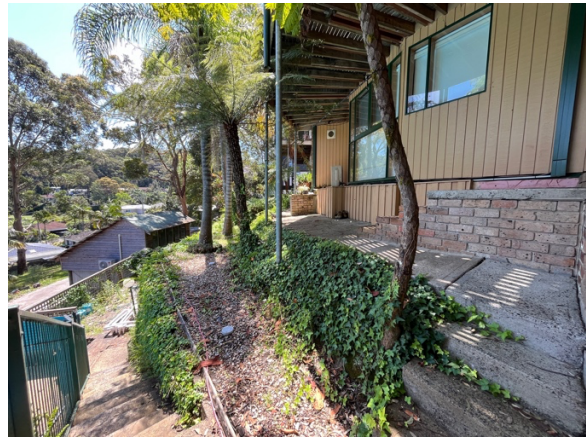
Photo 2: Southern side of the residence

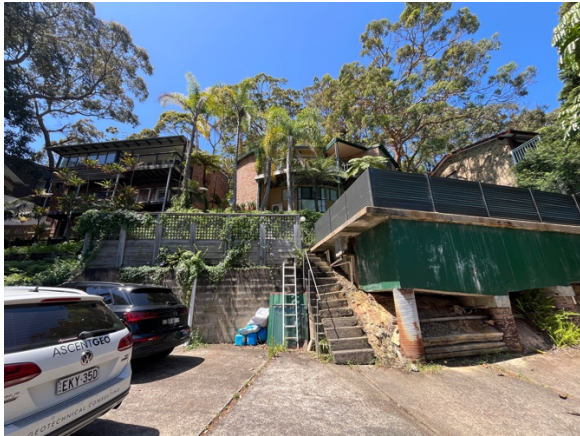
Photo 3: Looking towards the area of the proposed works and the south-western side of the residence.

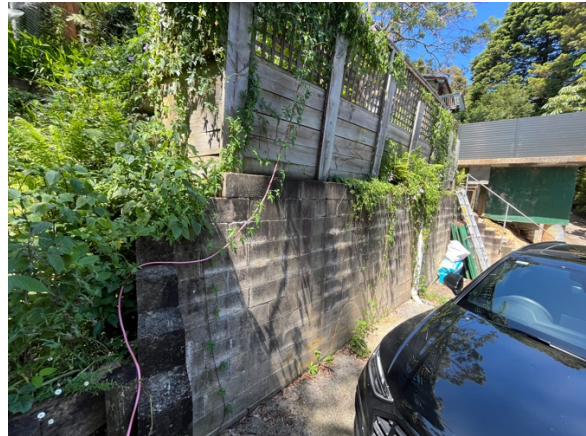
Photo 4: Concrete block wall on the western side of the site, in the area of the proposed works.
