## **GEOTECHNICAL INVESTIGATION:**

Subdivision and New Houses at **10 Beverley Place, Curl Curl**

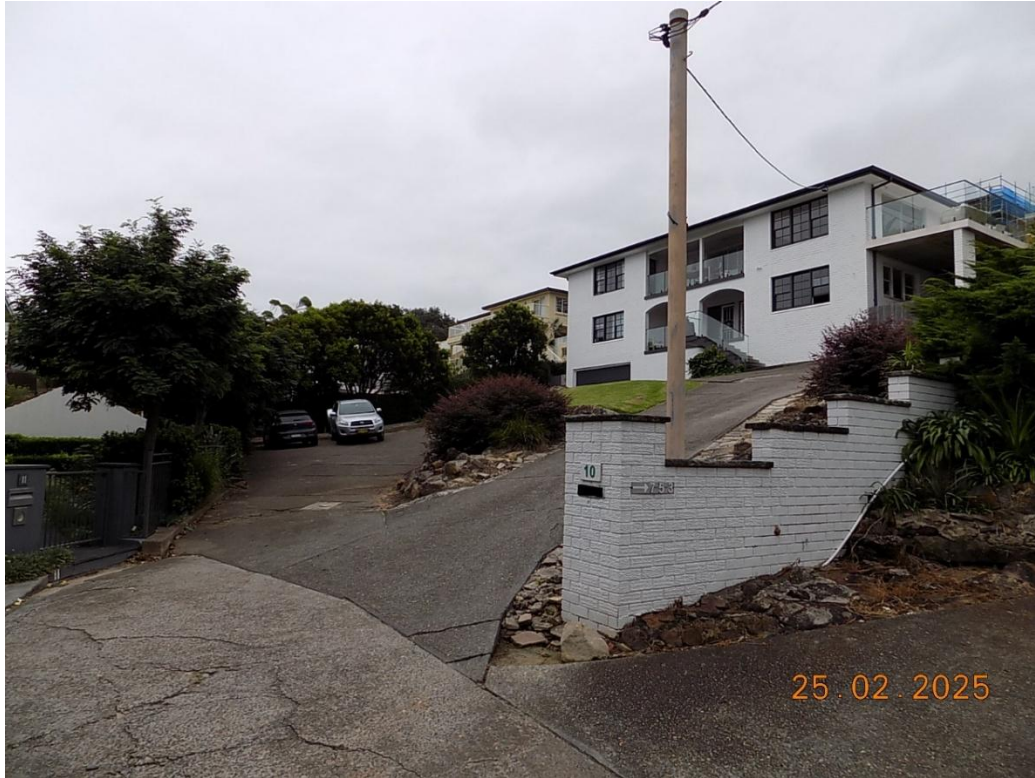
Photo 1

**2.3** At the road frontage, a concrete driveway runs to a garage underneath the downhill side of the house (Photo 1). Fill for the driveway on the downhill side is supported by a brick retaining wall reaching ~1.0m high (Photo 2). Fill for a lawn area in between the lower common boundary and the house is supported by a ~2.0m high stable sandstone flagging retaining wall which has been constructed with a tilt back into the slope (Photo 3). The two-storey house is supported on brick walls. No significant signs of movement were observed in the visible supporting walls. A cut to create a level platform for the house has been taken entirely through Competent Medium Strength Sandstone which outcrops and steps ~4m up the property in this location (Photo 4). Fill for a level patio above the house is supported by a stable ~1.0m high brick retaining wall which has been constructed directly on sandstone (Photo 5). The outcropping rock in this location was measured to be undercut in places by up to a depth of ~1.1m but is otherwise considered stable (Photos 6 & 7). A ~1.3m high stable stack rock retaining wall lines the upper common boundary (Photo 8). A pool which shows no signs of movement has been cut entirely into sandstone N of the house (Photo 9). The N side of the outcropping rock was observed to be overhanging (Photo 10). This outcrop is currently considered stable and the proposed works are sufficiently set back so as not to impact on its stability.

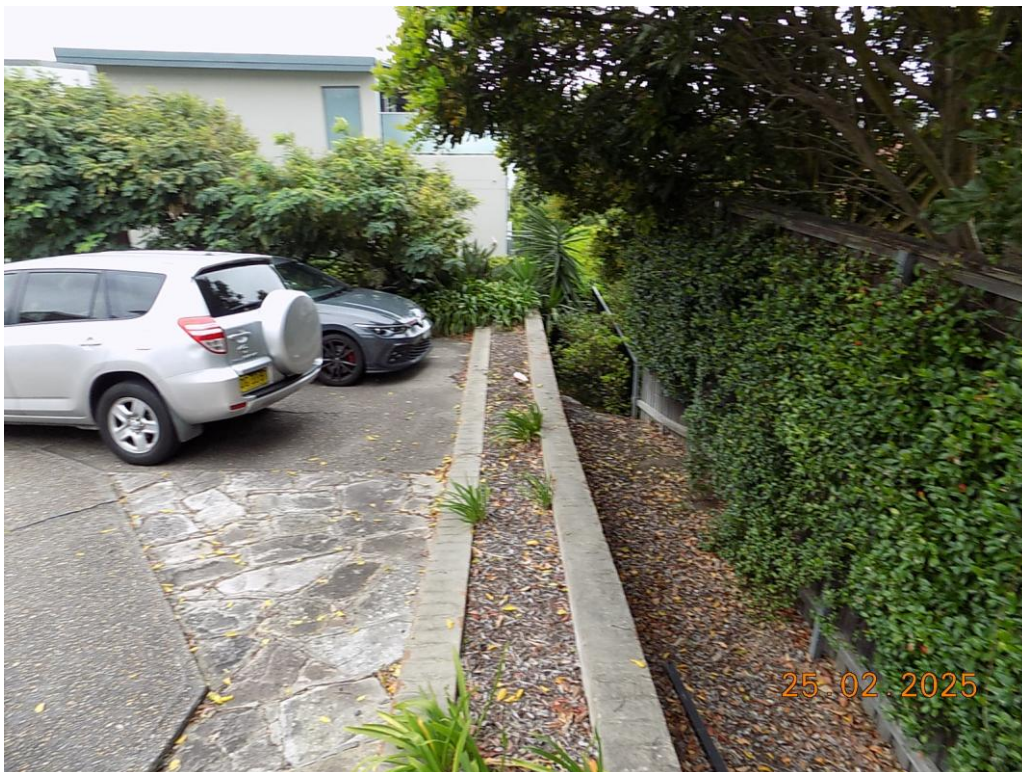
Photo 2

The excavation requires the removal of the two ~1.0m brick retaining walls which support fill for landscaping above the house and below driveway (Photos 2 & 5), as well as the ~2.0m mortared sandstone retaining wall below the house (Photo 3). The walls are to be demolished from the top down in an orderly manner with the fill behind the walls being systematically lowered at the same time. The soil batter slope is not to exceed 1.0 Vertical to 1.7 Horizontal (30°) as the walls are demolished.

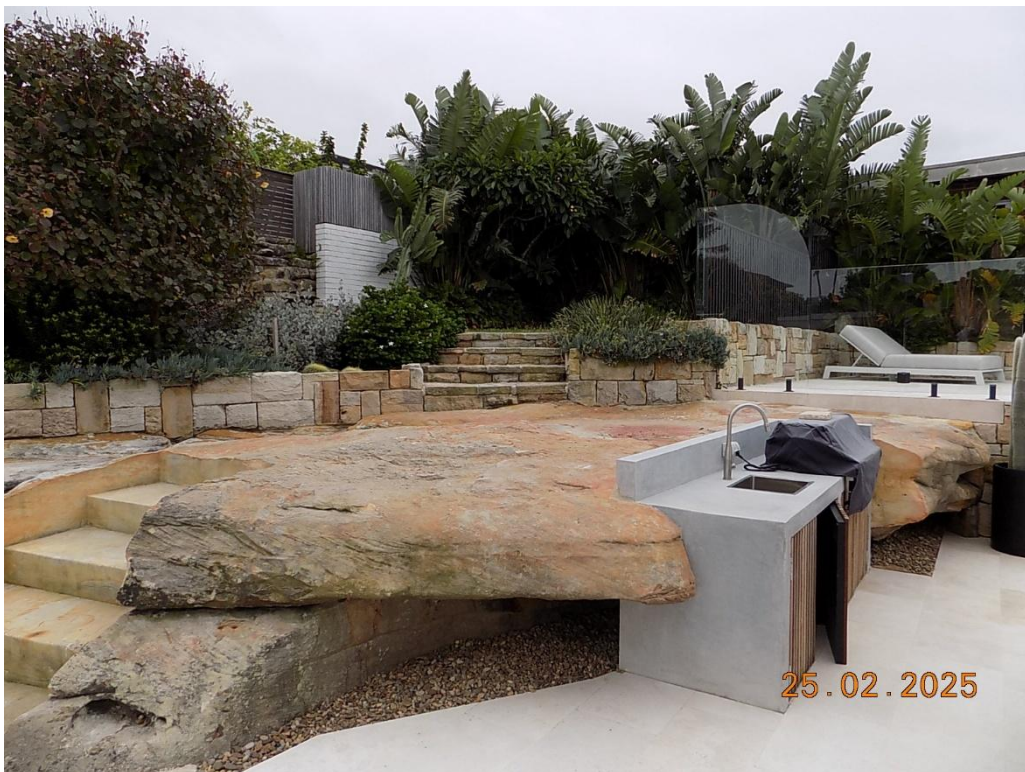
Photo 7

The overhanging rock around the BBQ will be immediately above the proposed excavation (Photo 7). We recommend the overhanging portions of the rock (approximately 1.1m) be removed prior to the commencement of the bulk excavation for the houses.

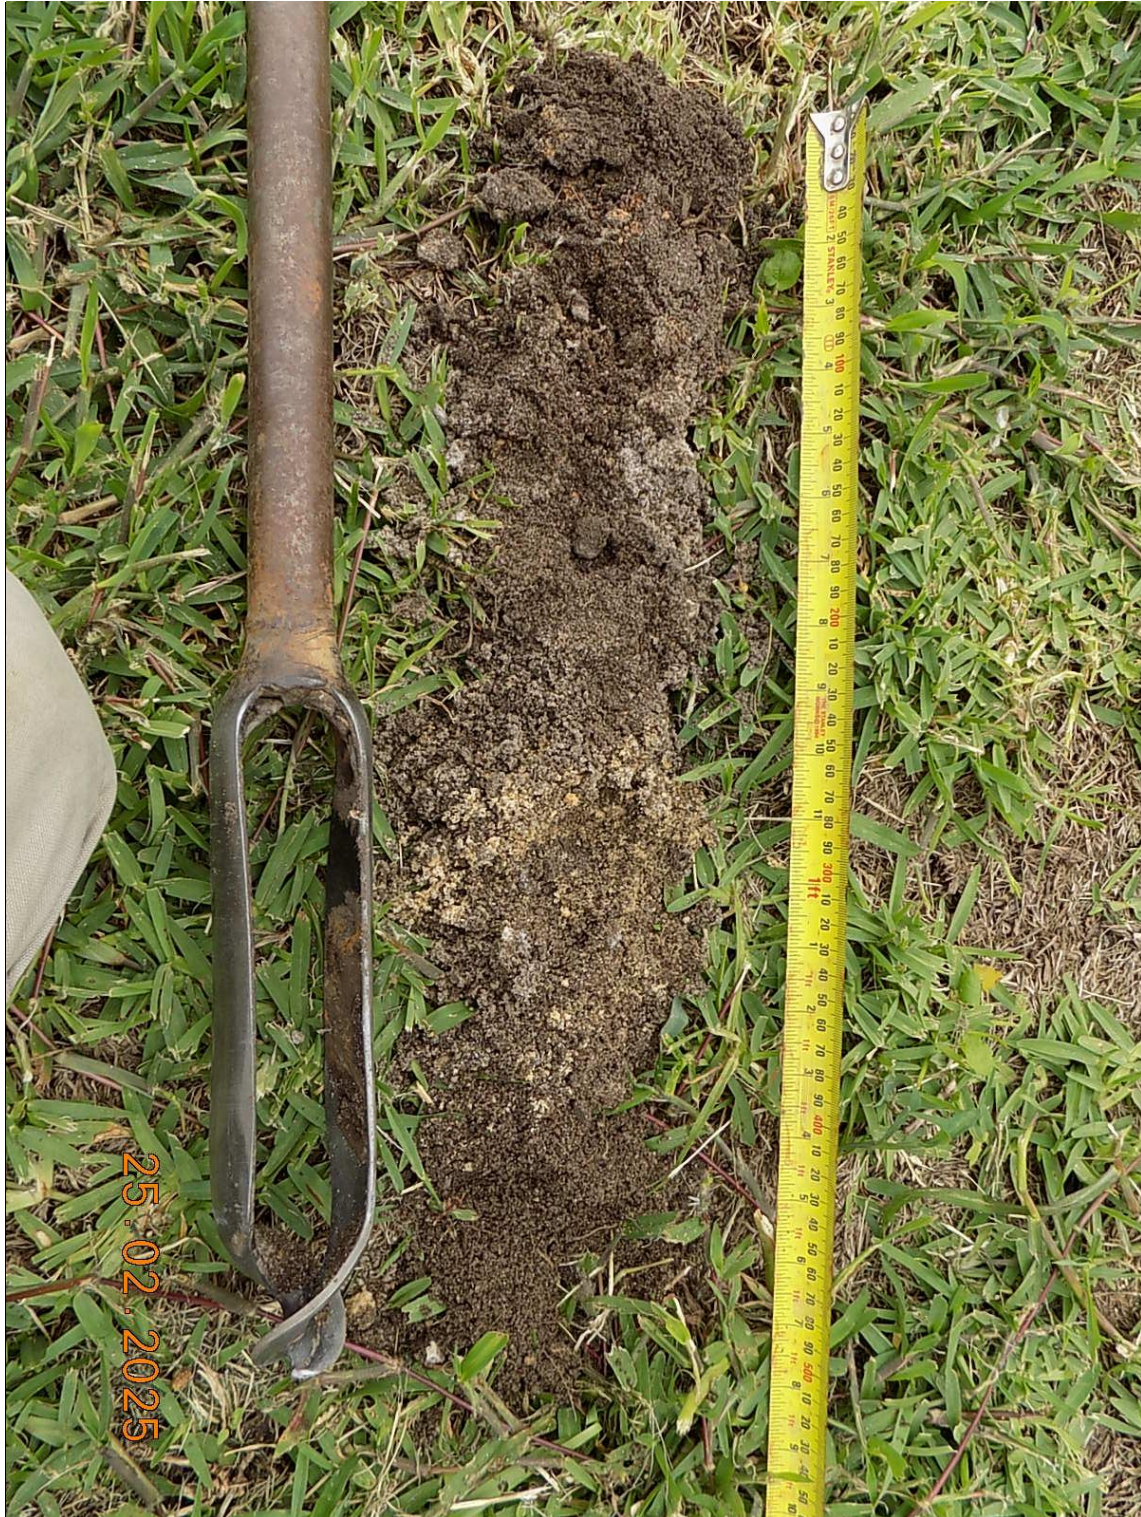
Photo 11 – downhole is top to bottom

### AUGER HOLE 1 (~RL37.6) – AH1 (Photo 11)

Depth (m)	Material Encountered
0.0 to 0.5	FILL, soil and crushed sandstone, brown, Medium Dense to Dense, dry, fine to coarse grained.

Refusal @ 0.5m in fill. Auger grinding. No water table encountered.

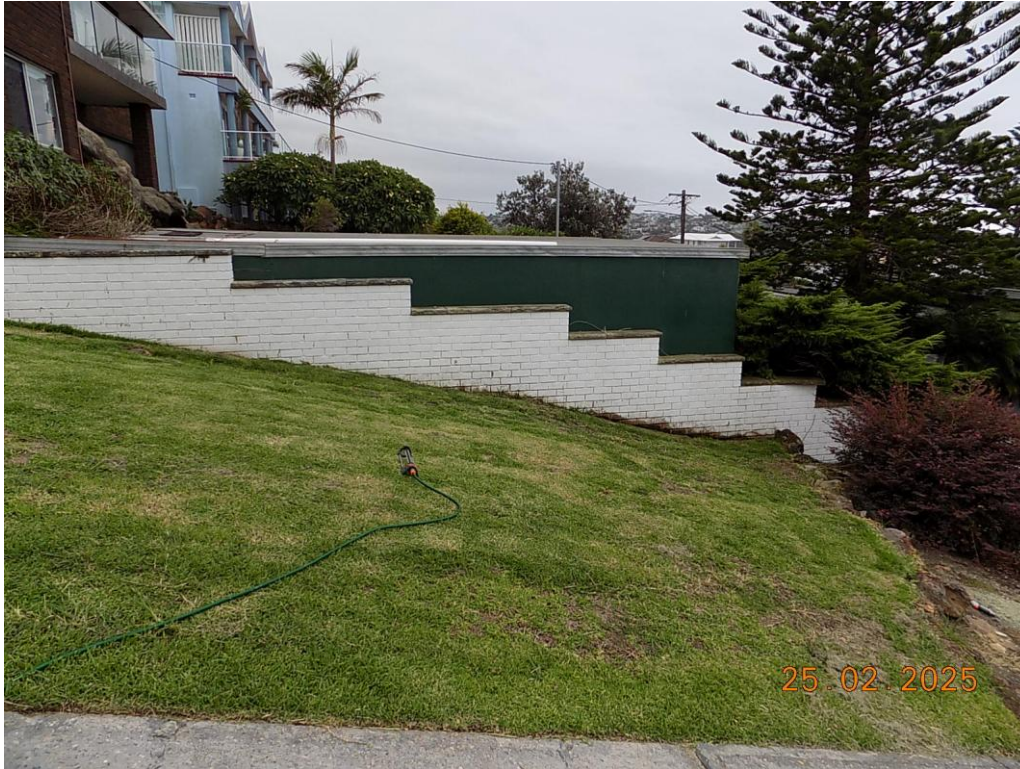
Photo 12

HAZARDS	Hazard Three	Hazard Four
TYPE	A loose boulder, wedge, or similar geological defect toppling onto the work site during the excavation process.	The proposed excavation undercutting the footings of the N brick wall and garage (Photo 12), and S block retaining wall (photo 13), causing damage or failure.
LIKELIHOOD	'Possible' ( $10^{-3}$ )	'Possible' ( $10^{-3}$ )
CONSEQUENCES TO PROPERTY	'Medium' (20%)	'Medium' (35%)
RISK TO PROPERTY	'Moderate' ( $2 \times 10^{-4}$ )	'Moderate' ( $2 \times 10^{-4}$ )
RISK TO LIFE	$6.6 \times 10^{-5}$ /annum	$5.3 \times 10^{-5}$ /annum
COMMENTS	This level of risk to life and property is 'UNACCEPTABLE'. To move risk to 'ACCEPTABLE' levels, the recommendations in <b>Section 13 and 15</b> are to be followed.	This level of risk to life and property is 'UNACCEPTABLE'. To move risk to 'ACCEPTABLE' levels, the recommendations in <b>Section 13</b> are to be followed.

- ~Flush with a block retaining wall on the S neighbouring property (Photo 13).
- ~Flush with a brick wall on the N neighbouring property (photo 12).
- ~0.2m from a garage on the N neighbouring property (Photo 12).

As such, the N brick retaining wall and garage, as well as the S block retaining wall will lie within the zone of influence of the proposed excavation. In this instance, the zone of influence is the area above a theoretical 45° line (from horizontal) from the base of the excavation or top of Medium Strength Rock, whichever is encountered first, towards the surrounding structures and boundaries. This line reduces to 30° through the fill and soil.

Given the shallow depth to rock on the uphill side of the property, we think it is likely the S boundary retaining wall is supported on rock, this is less likely to be the case near the N boundary brick wall and garage where medium strength rock was encountered at a greater depth. However, to be sure, Where the N and S boundary walls fall within the zone of influence of the excavation, exploration pits along the wall will need to be put down by the builder to determine the foundation depth and material. These are to be inspected by the geotechnical consultant.

If the foundations are confirmed to be supported on rock, the excavation may commence. If they are not, the walls will need to be shored prior to the commencement of the excavation with concrete piles or similar. Alternatively, the walls may be underpinned to rock with the neighbours' permission. See the site plan attached for the minimum extent of the required exploration pits/underpinning.

Underpinning is to follow the underpinning sequence 'hit one miss two'. Under no circumstances is the bulk excavation to be taken to the edges of the walls and then underpinned. Underpins are to be constructed from drives that should not exceed 0.6m in width along strip footings and should be proportioned according to footing size for other foundation types. Allowances are to be made for drainage through the underpinning to prevent a build-up of hydrostatic pressure. Underpins that are not designed as retaining walls are to be supported by retaining walls. The void between the retaining walls and the underpinning is to be filled with free-draining material such as gravel.

- The exploration pits to determine the foundation material along the N and S boundary walls (Photos 12 & 13) are to be inspected by the geotechnical consultant to determine if underpinning is necessary. This is to occur before the bulk excavation commences.
- During the excavation process, the geotechnical consultant is to inspect the excavation as it approaches no less than 1.0m horizontally from foundations of the walls/underpins to confirm the stability of the cut to go flush with the footings.

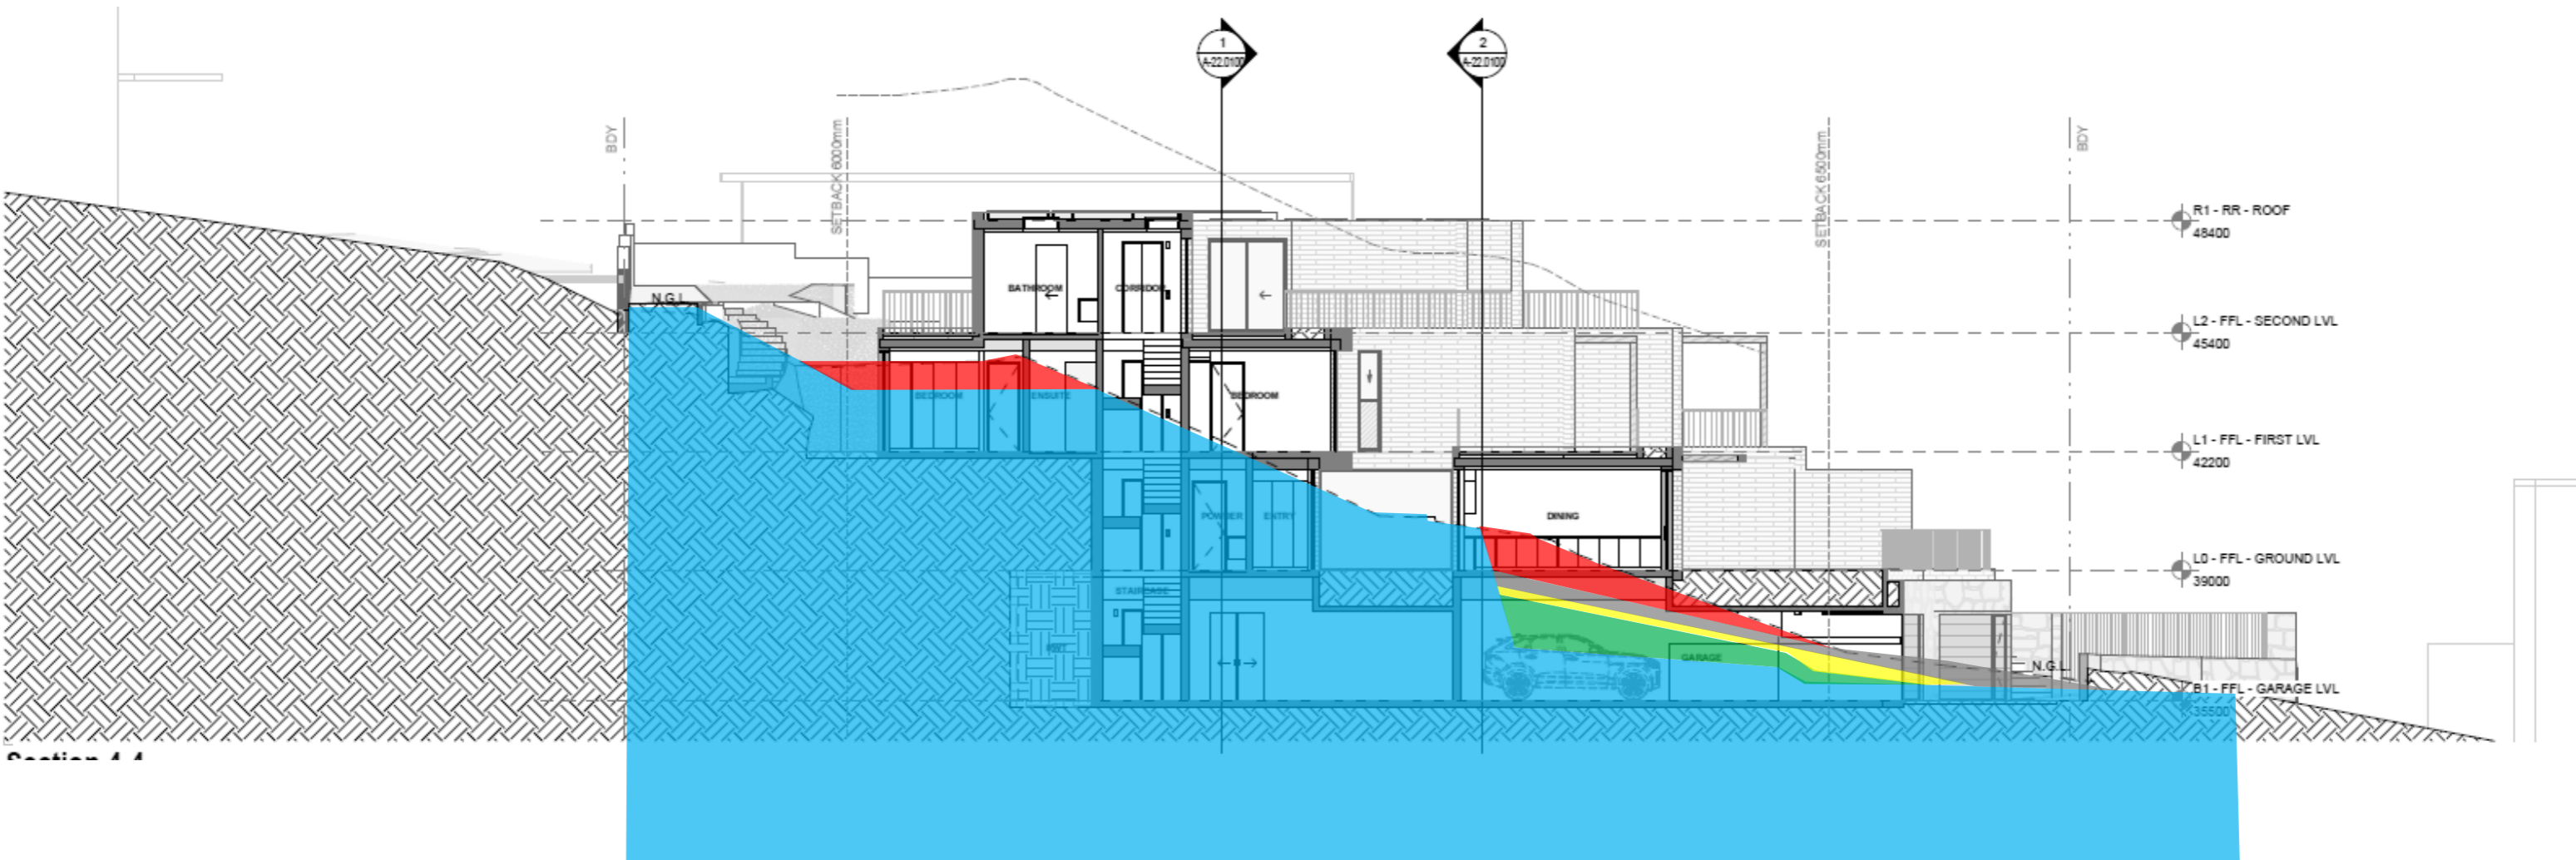
# TYPE SECTION – Diagrammatic Interpretation of expected Ground Materials

The surface features of the block are controlled by the outcropping and underlying sandstone bedrock that steps down the property forming sub-horizontal benches between the steps. Where the grade is steeper, the steps are larger and the benches narrower. Where the slope eases, the opposite is true. Where the rock is not exposed, it is overlain by shallow soils over clays that fill the bench step formation. Filling has been placed to a height of ~1.1m in the location of the proposed works. In the test locations, where the rock is not exposed, it was encountered mainly at shallow depths of between 0.8 to 0.4m below the current surface, with DCP test 3 & 4 encountering rock at between ~1.9 and ~2.7m depth. This variation in depth is due to the presence of fill in some locations, as well as the stepped nature and variable weathering profile of the underlying bedrock. The outcropping sandstone on the property is estimated to be Medium Strength or better and similar strength rock is expected to underlie the entire site as all the DCP tests bounced at refusal. It is interpreted that a thin layer of Very Low Strength Sandstone overlies the buried rock immediately below the house, as the DCP ended after a high blow count for tests 3 & 4. The Very Low Strength Rock is expected to be encountered at depths of between 1.2m and 2.1m below the current surface. See Type Section attached for a diagrammatical representation of the expected ground materials.
