Report Title: Geotechnical Report <b>20 Sunrise Road, Palm Beach</b>
Report Date: <b>23/9/24</b>
Author: <b>BEN WHITE</b>
Author's Company/Organisation: <b>WHITE GEOTECHNICAL GROUP PTY LTD</b>

## **GEOTECHNICAL INVESTIGATION:**

### **New Secondary Dwelling and Inclined Lift at 20 Sunrise Road, Palm Beach**

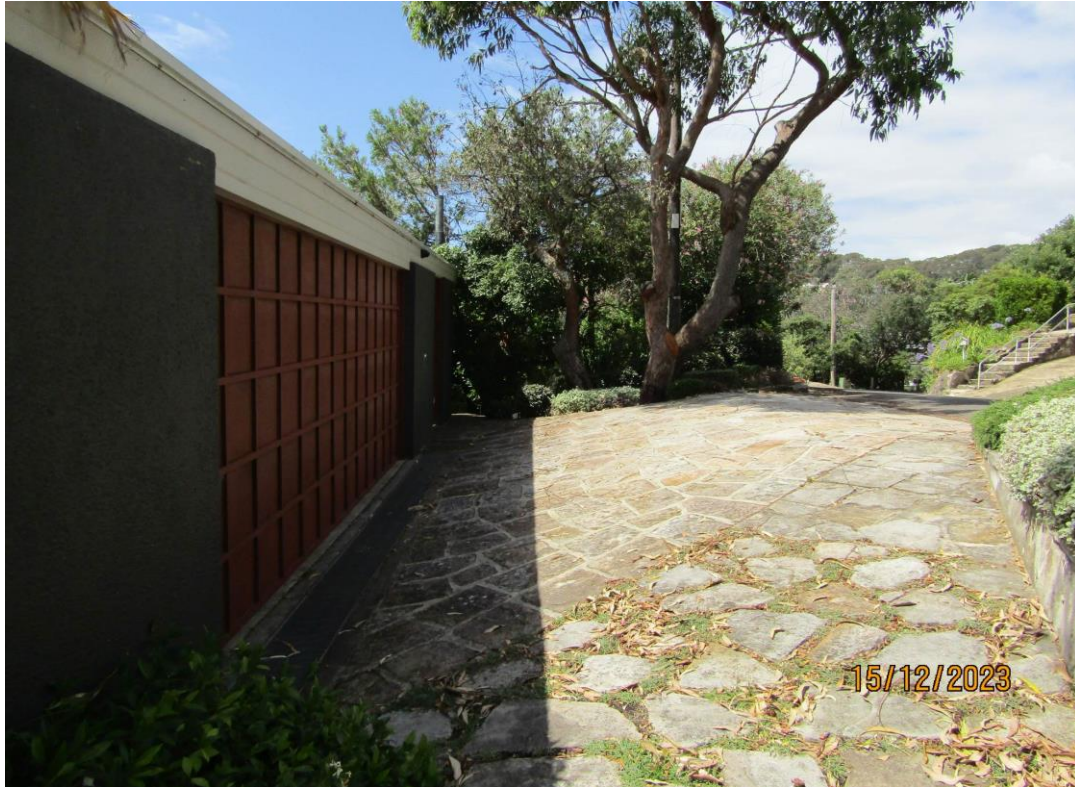
Photo 1

- 2.3** At the road frontage to Sunrise Road, a stone-paved driveway runs to a garage attached to the uphill side of the house (Photo 1). The part three-storey house is supported on brick and concrete block walls and concrete columns (Photo 2). The supporting walls display no significant signs of movement and the supporting columns

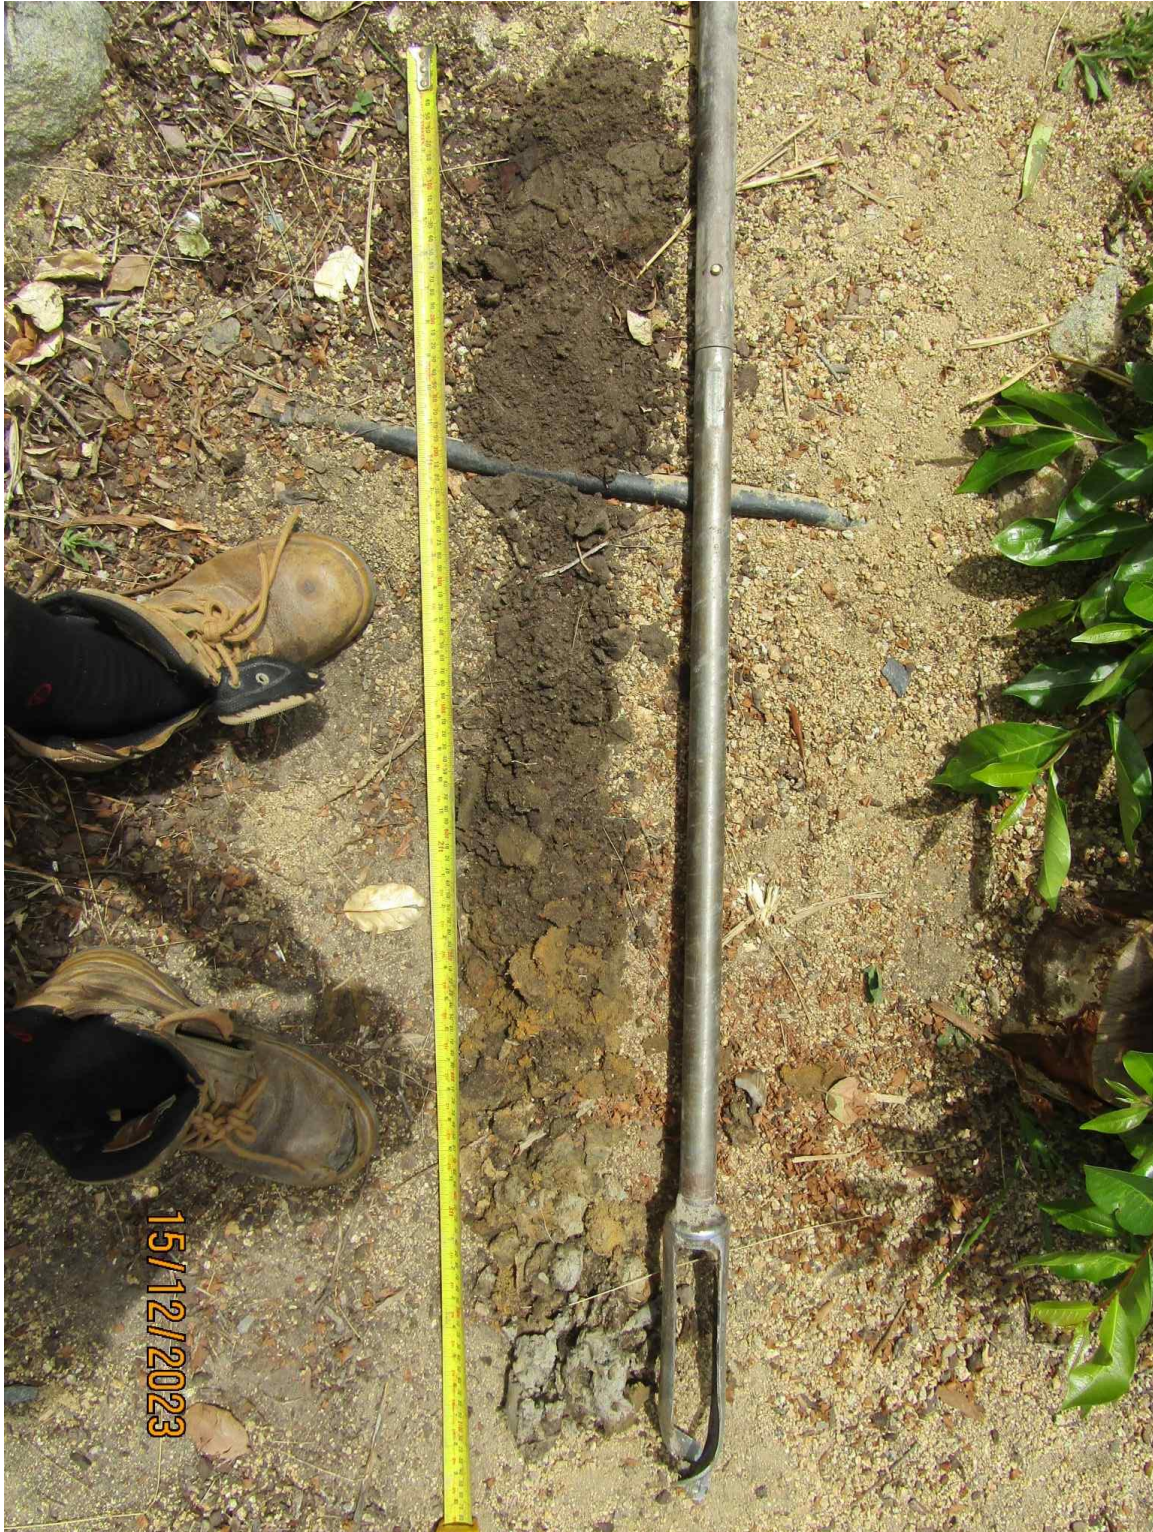
Depth (m)	Material Encountered
0.0 to 0.7	<b>FILL</b> , sandy soil, with some rock fragments, dark brown, dry to moist, fine to coarse grained.
0.7 to 0.9	<b>COLLUVIUM</b> , sand, brown orange, damp, fine to medium grained.
0.9 to 1.1	<b>CLAY</b> , grey, firm to stiff, moist.

End of hole @ 1.1m in firm to stiff clay. No water table encountered.

Photo 8: AH1 – Downhole is from top to bottom.

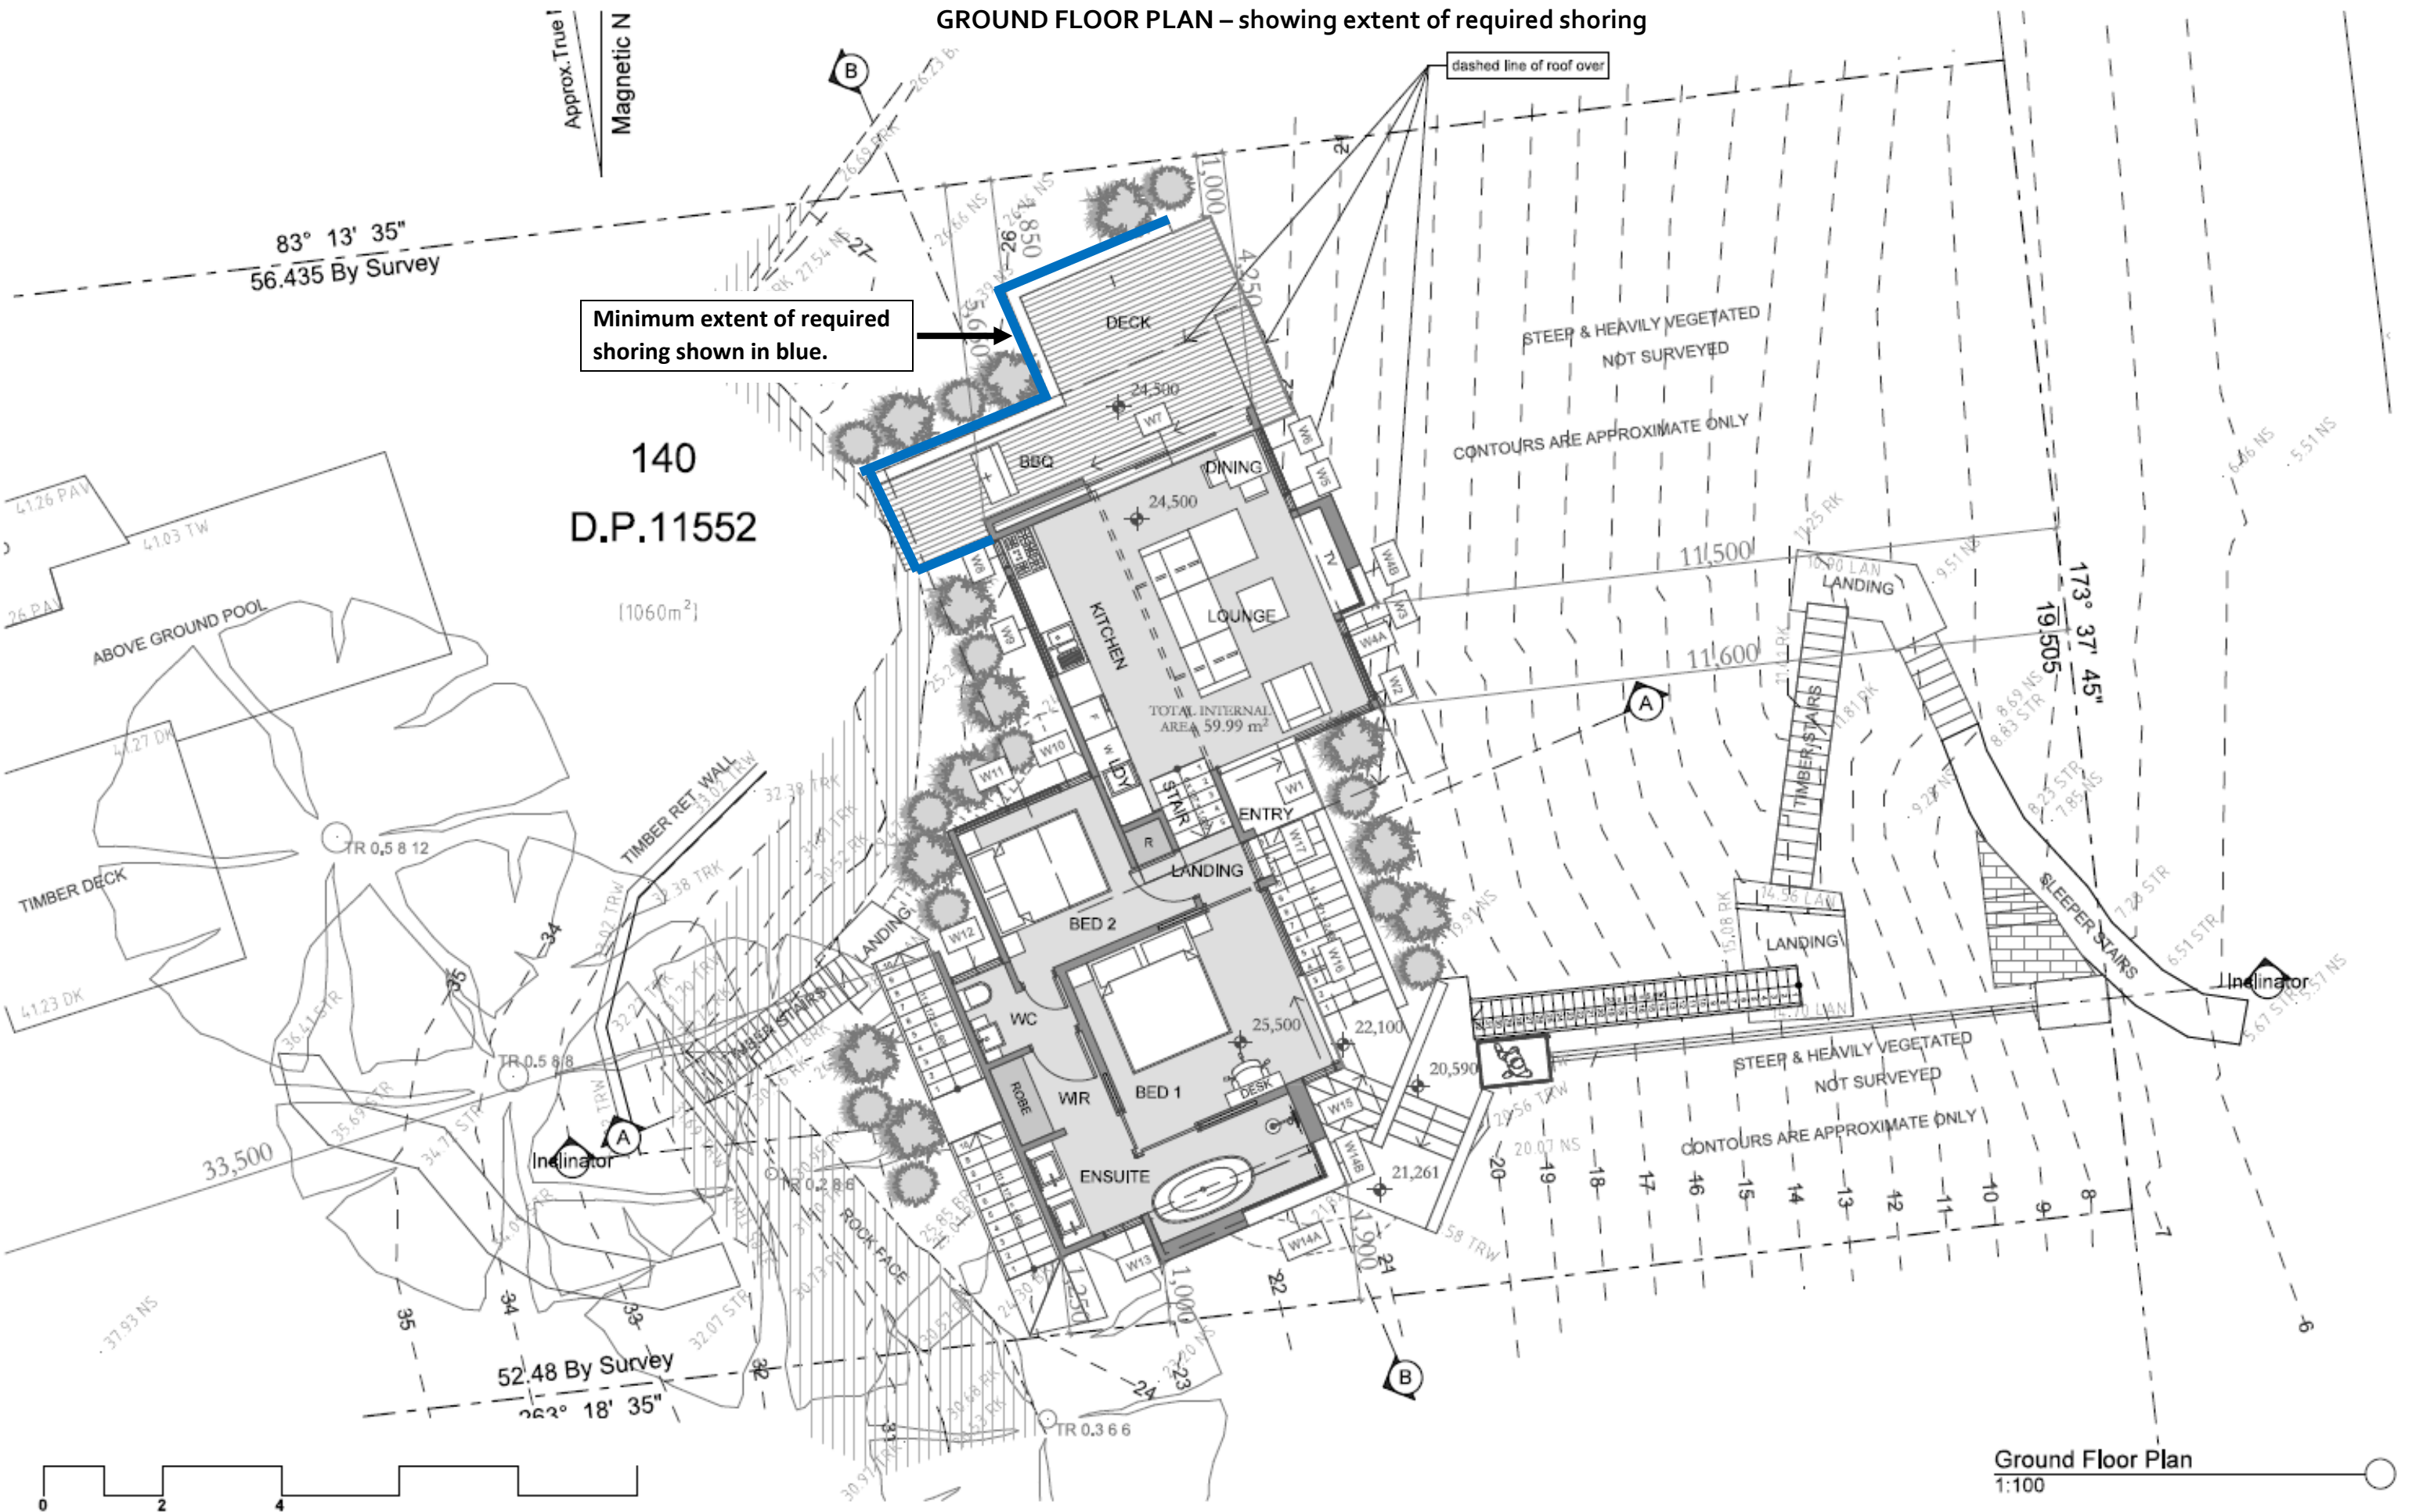
GROUND FLOOR PLAN – showing extent of required shoring

Due to the steep grade of the slope and the proximity to the N common boundary, all sides of the excavation will need to be temporarily or permanently supported prior to the commencement of the excavation, or during the excavation process in a staged manner, so cut batters are not left unsupported. The support will need to be designed by the structural engineer. See the Ground Floor Plan attached for the minimum extent of the required shoring shown in blue.

Minimum extent of required shoring shown in blue.
