J3283A. 15th March, 2021 Page 1.

GROUND TESTING:

Proposed Pool at 80 Peacock Street, Seaforth

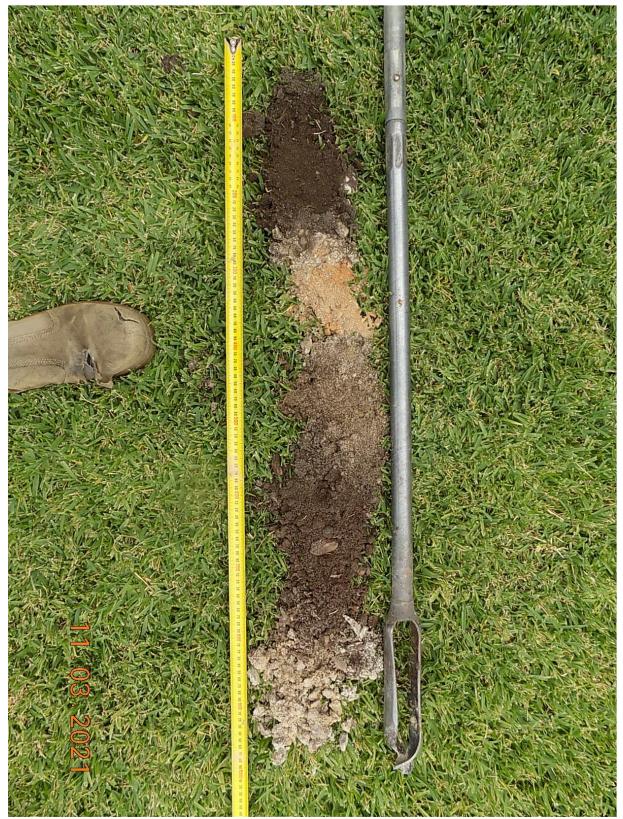
AUGER HOLE 1 (~RL99.4) – AH1 (Photo 1)

| Depth (m) | Material Encountered |
|---|---|
| 0.0 to 0.2 | FILL, disturbed sandy soil, dark brown, medium dense to dense, dry, fine to medium grained with fine trace organic matter and trace silt. |
| 0.2 to 0.4 | FILL, disturbed crushed sandstone, white and orange, medium dense |
| 0.4 to 0.8 | FILL , disturbed gravelly soil, dark brown, medium dense to dense, dry, medium to coarse grained with fine trace organic matter. |
| 0.8 to 1.0 | VERY LOW STRENGTH SANDSTONE , grey and light brown, dry, fine to medium grained. |

Refusal @ 1.0m on rock. No water table encountered.

Photo 1: AH1 – Downhole is from left to right.
