Geotechnical Assessment

Project: Proposed New Dwelling
307 Whale Beach Road, Palm Beach, NSW.

REF: AG 19092
12th June, 2019.

For Proposed New Dwelling at
307 Whale Beach Road, Palm Beach, NSW

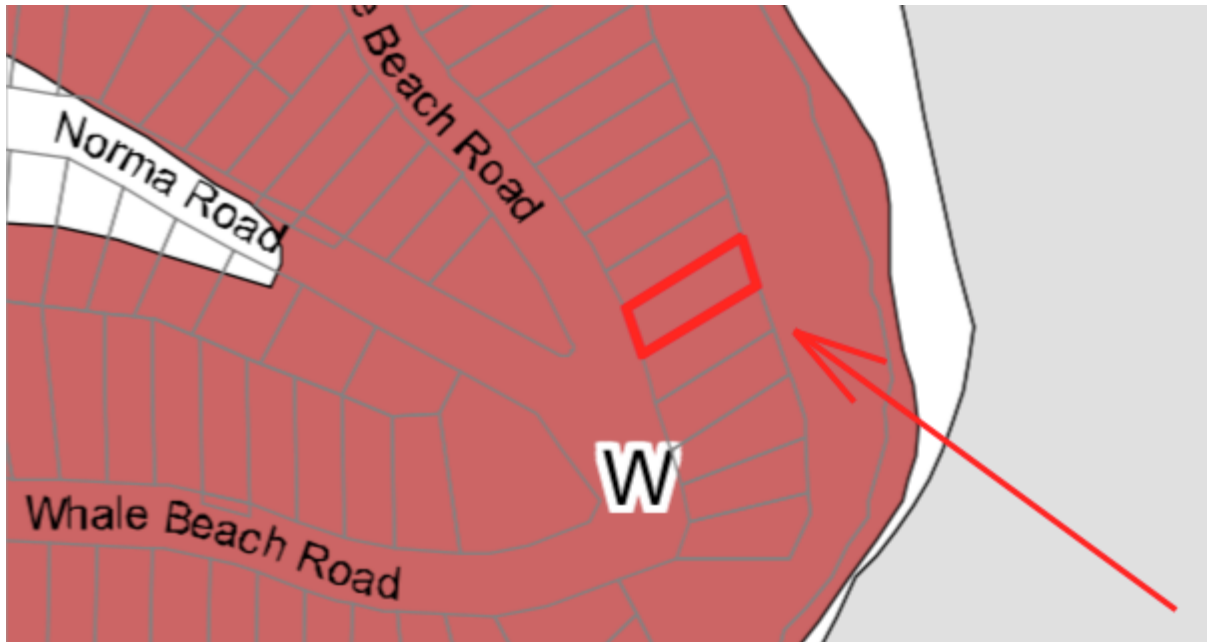
- No evidence of significant soil creep, tension cracks or other indicators of slope instability were identified at the time of our visual assessment.
- The existing retaining wall displayed no evidence of significant cracking or settlement that could be attributed to slope instability.
- The property is classified '**Geotechnical Hazard H1**' in Northern Beaches Council PLEP Geotechnical Hazard Map Sheet GTH_015 (PLEP Geotechnical Hazard Map **Image 2** below).

- W Geotechnical Hazard H1
- AE Geotechnical Hazard H2

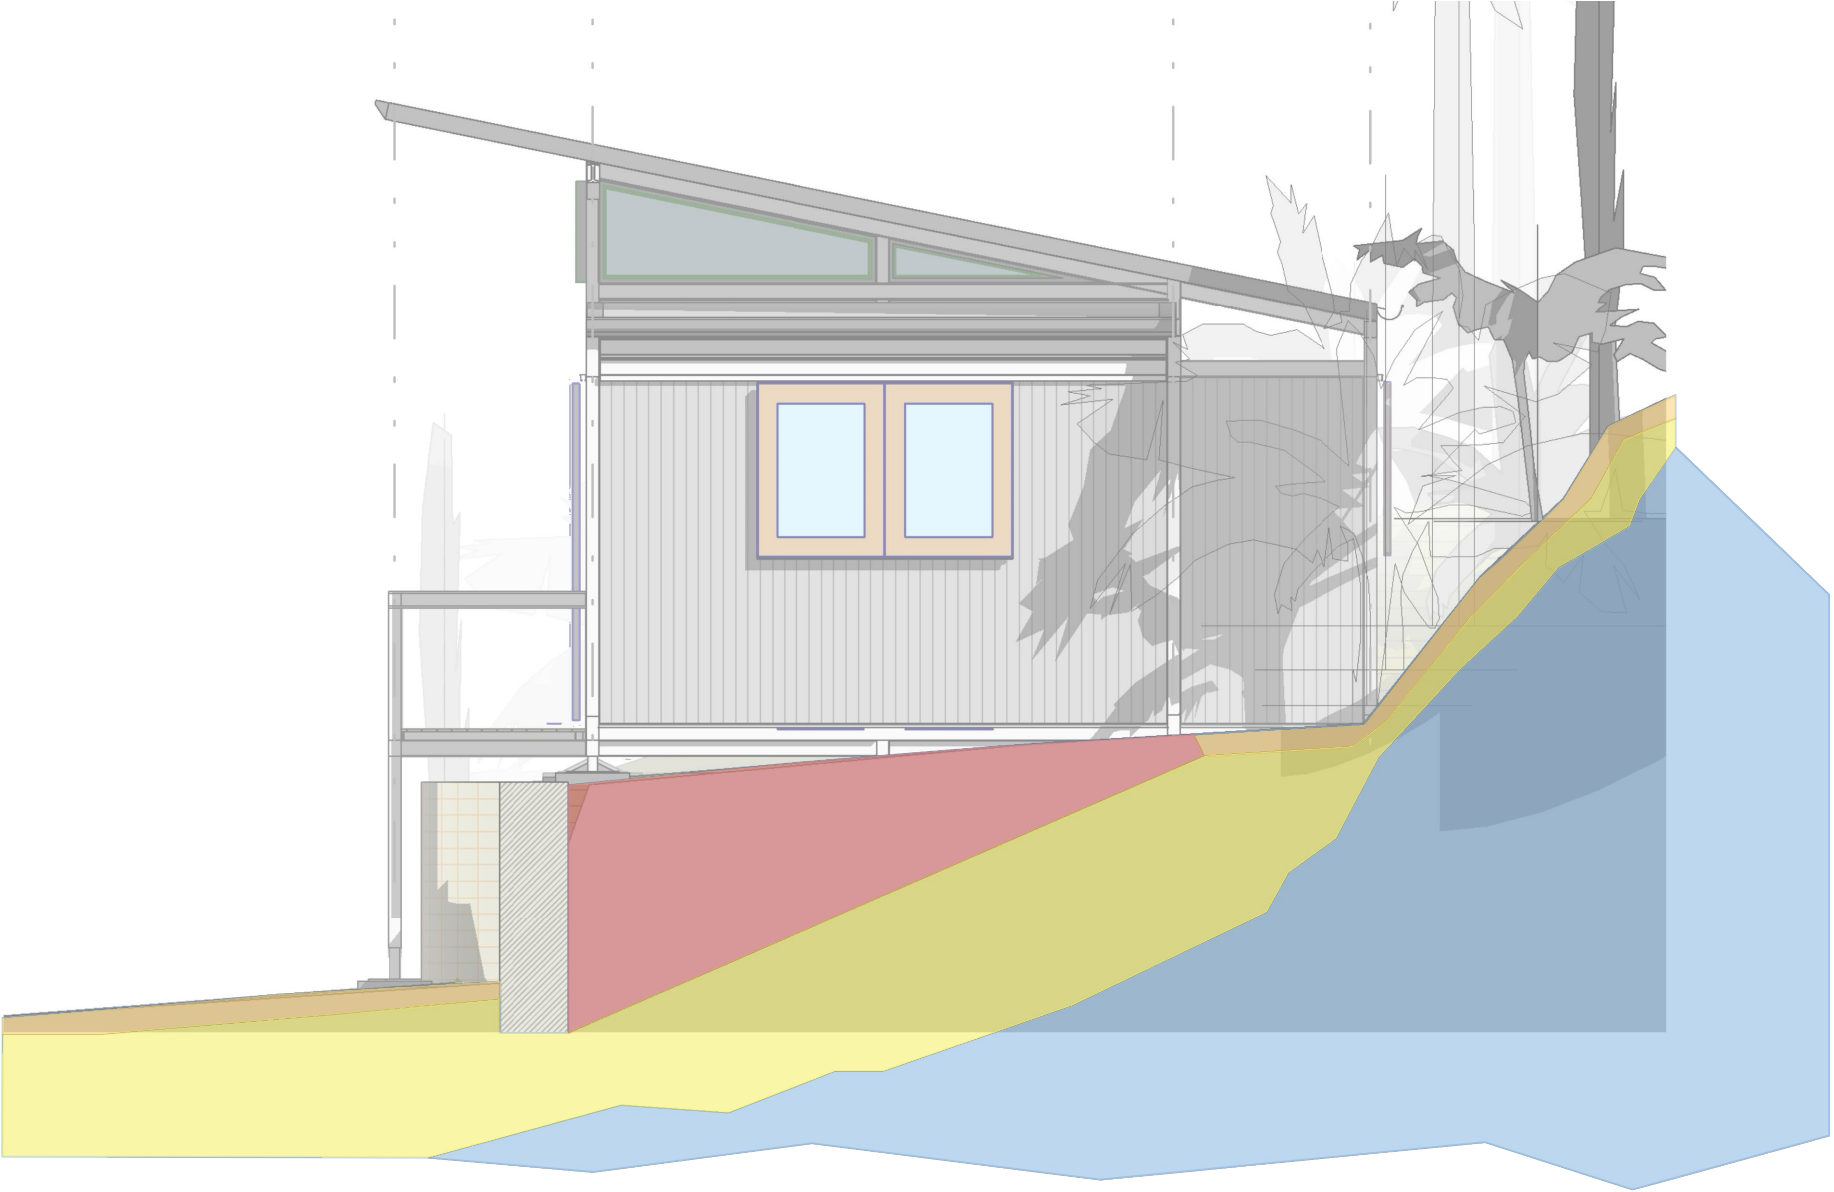
INFERRED GEOLOGICAL SECTION

INTERPRETED SUBSURFACE SECTION ONLY.
ACTUAL GROUND CONDITIONS MAY VARY.
