Geotechnical Assessment

Project: Alterations & Additions
1 Phyllis Street, North Curl Curl NSW

Prepared for:
Shane & Ceinwen Lawrence

Ref: AG 25058
19 February 2025

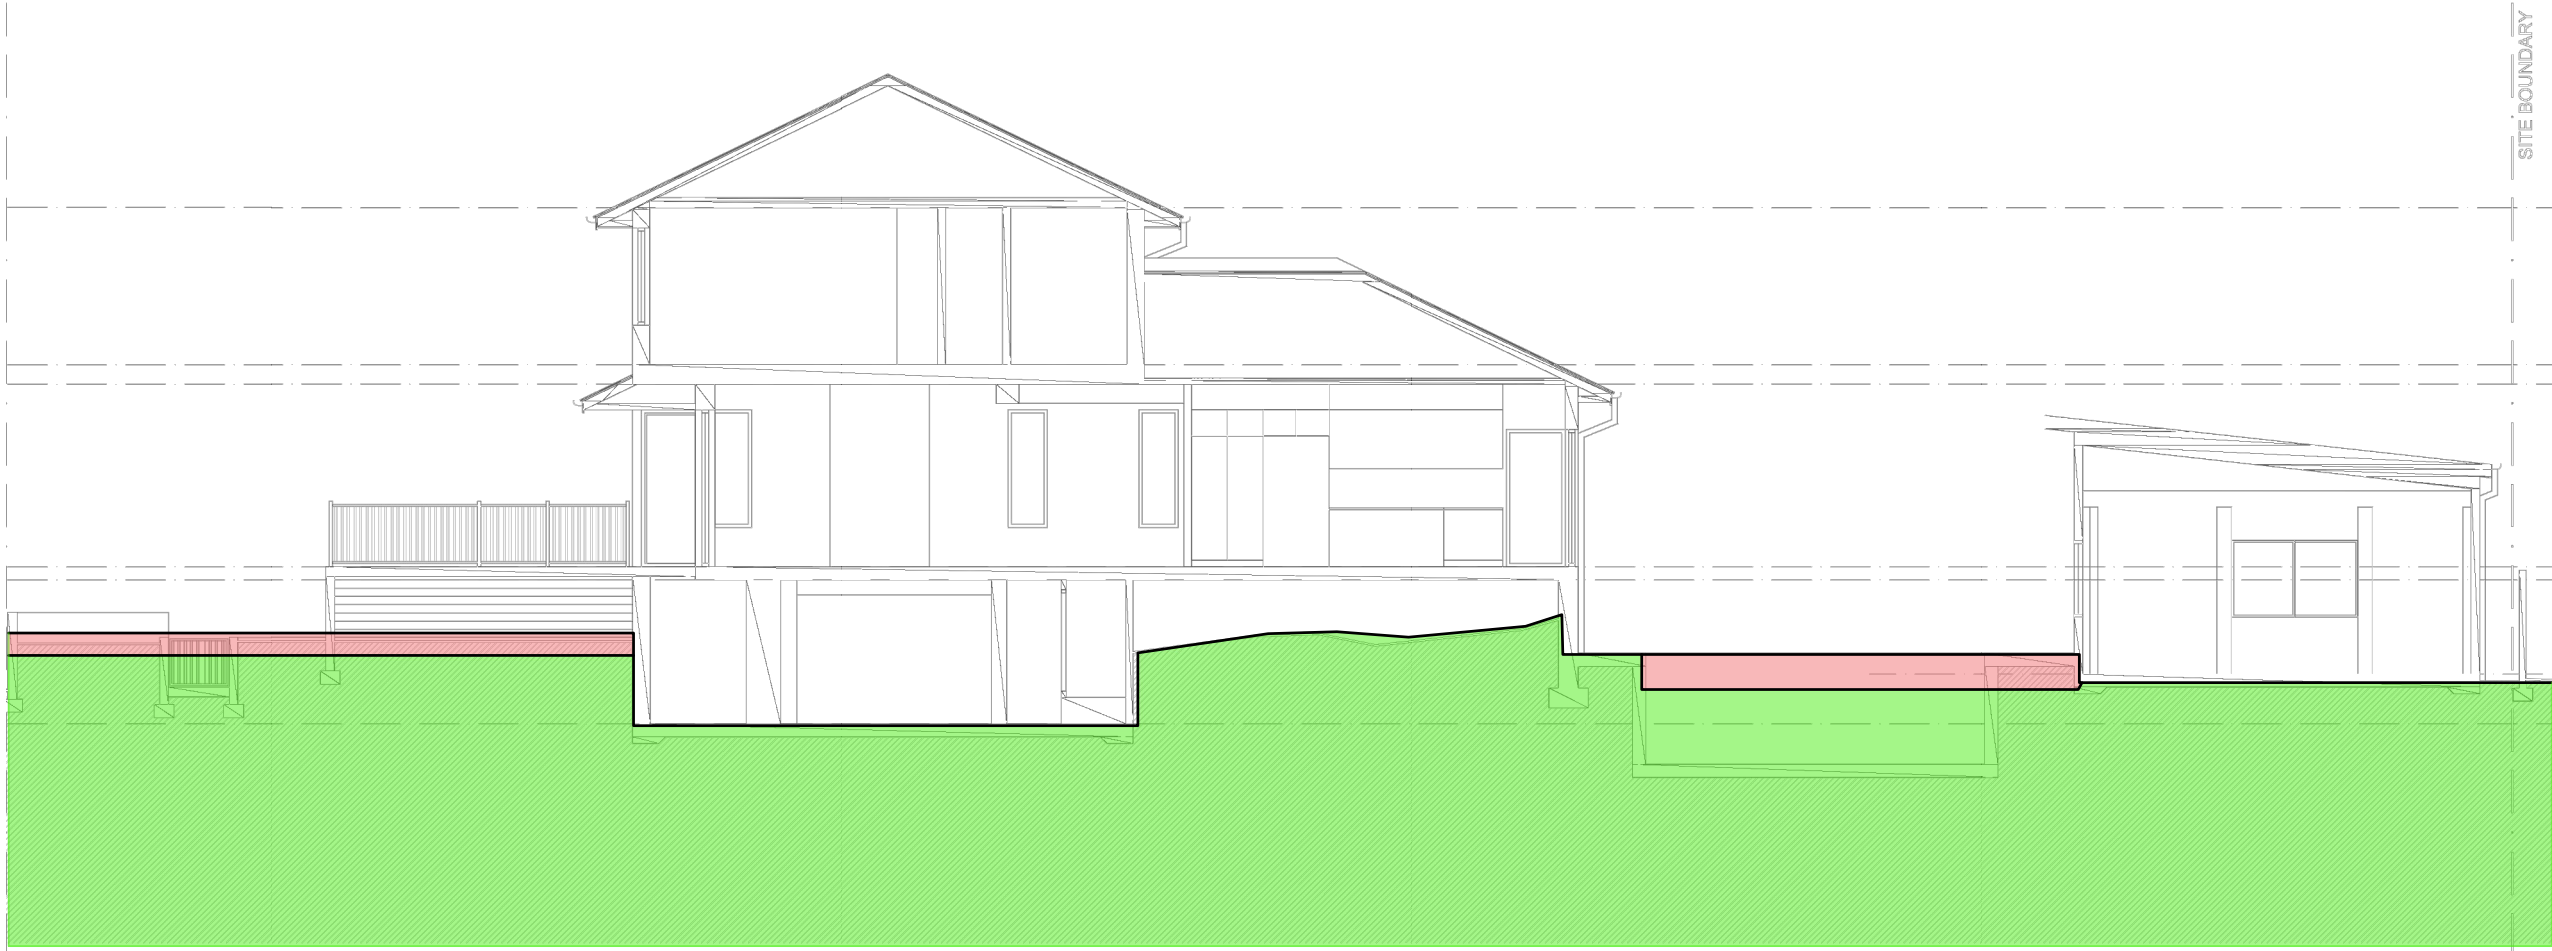
INFERRED GEOLOGICAL SECTION

INTERPRETED SUBSURFACE SECTION ONLY.
ACTUAL GROUND CONDITIONS MAY VARY.

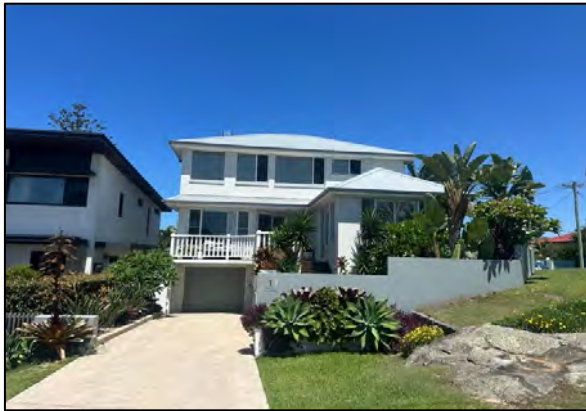
Photo 1: Site frontage, looking south.

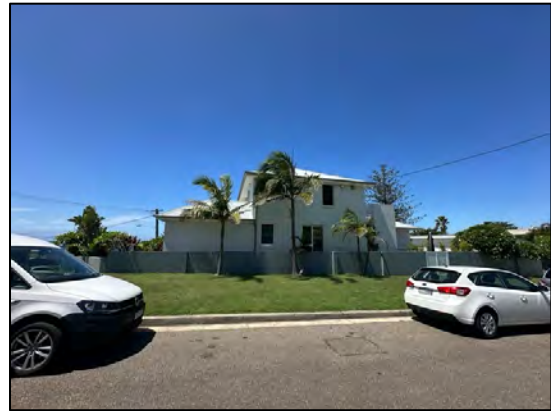
Photo 2: Western boundary of site, looking east.

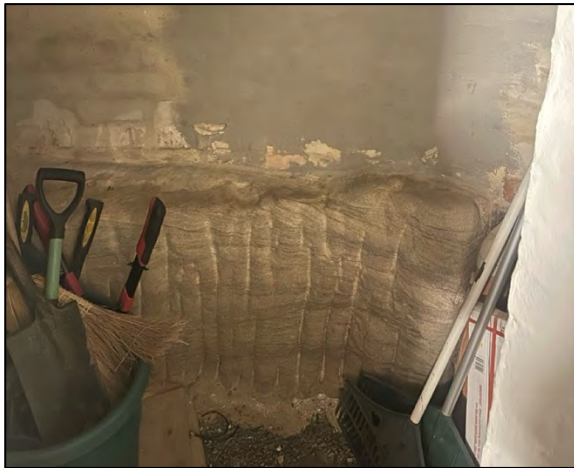
Photo 3: Photo showing sandstone bedrock at lower ground level.

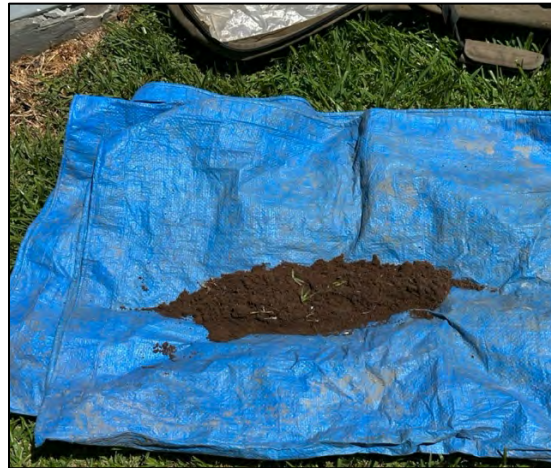
Photo 4: Subsurface soil profile of BH01.
