Project 35470.08
26 August 2019
35470.08.R.001.Rev1
DEM:mm

**Geotechnical Assessment for New Boat Shed
967 Barrenjoey Road, Palm Beach**

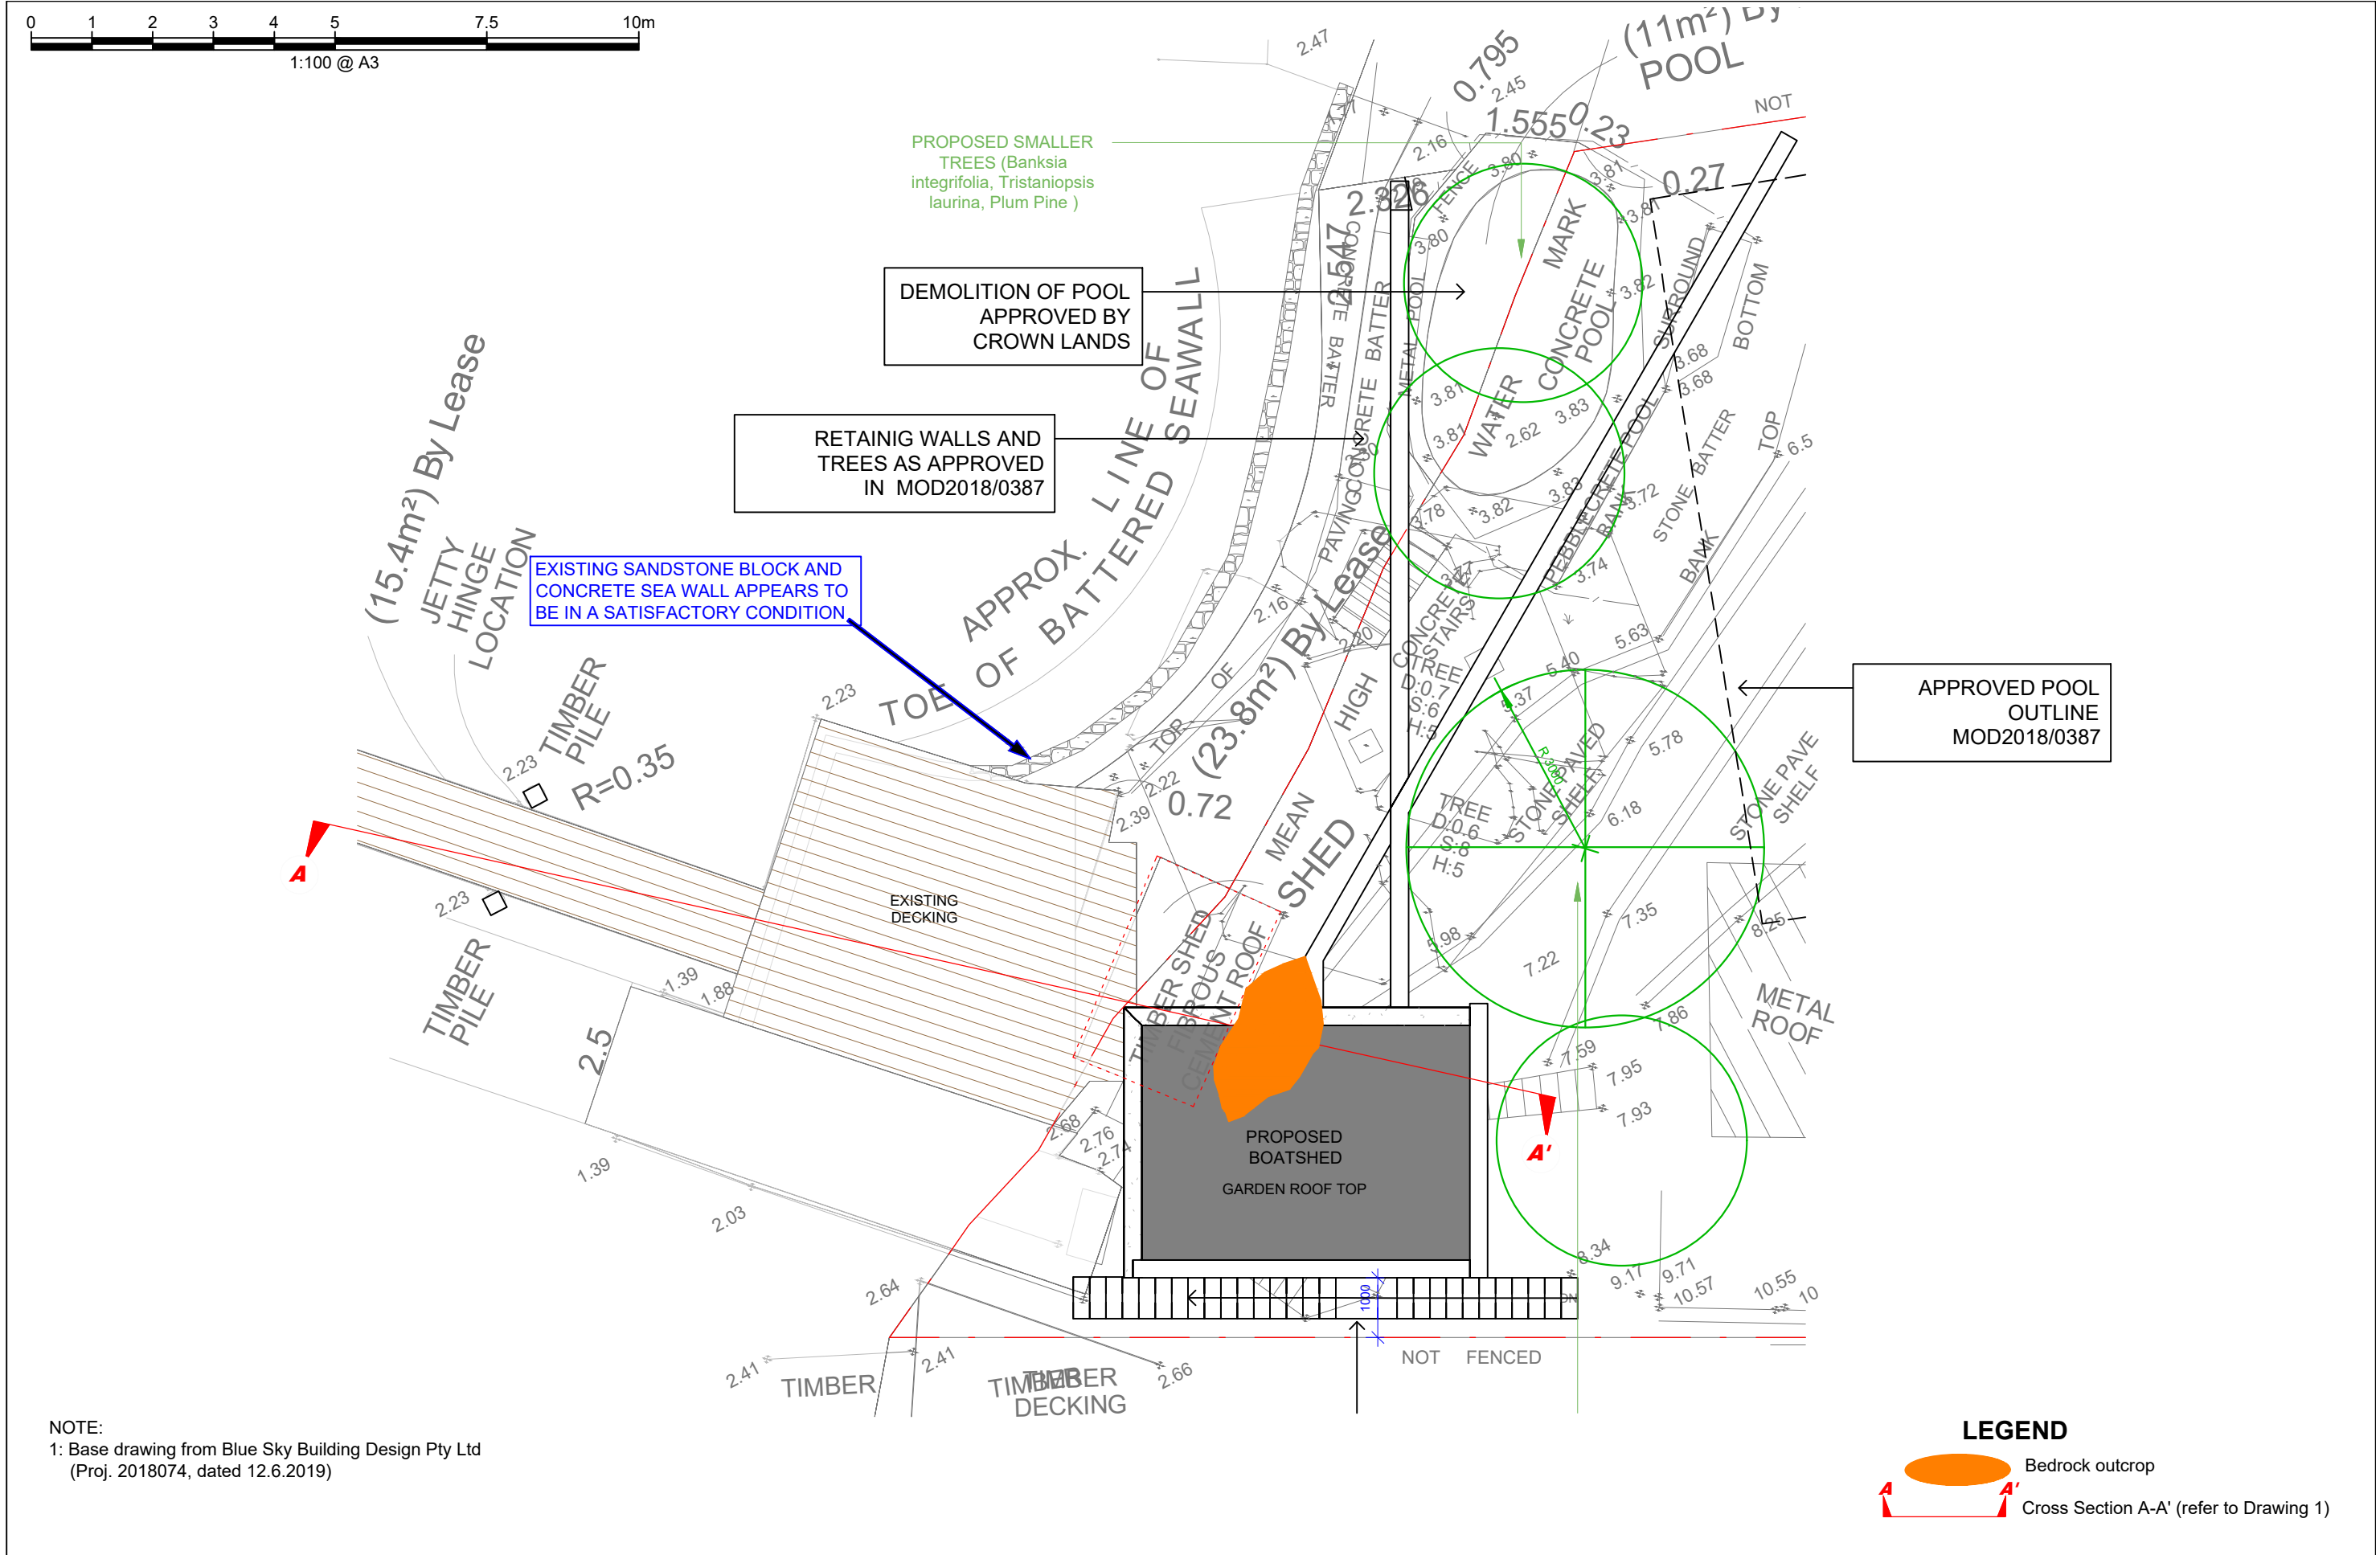
Douglas Partners Geotechnics Environment Groundwater	CLIENT: Mr Stephen Girdis		TITLE: Geotechnical Features Proposed Boat Shed 967 Barrenjoey Road, PALM BEACH

The locations of selected site features in the near-vicinity of the proposed boat shed are shown on Drawing 1.

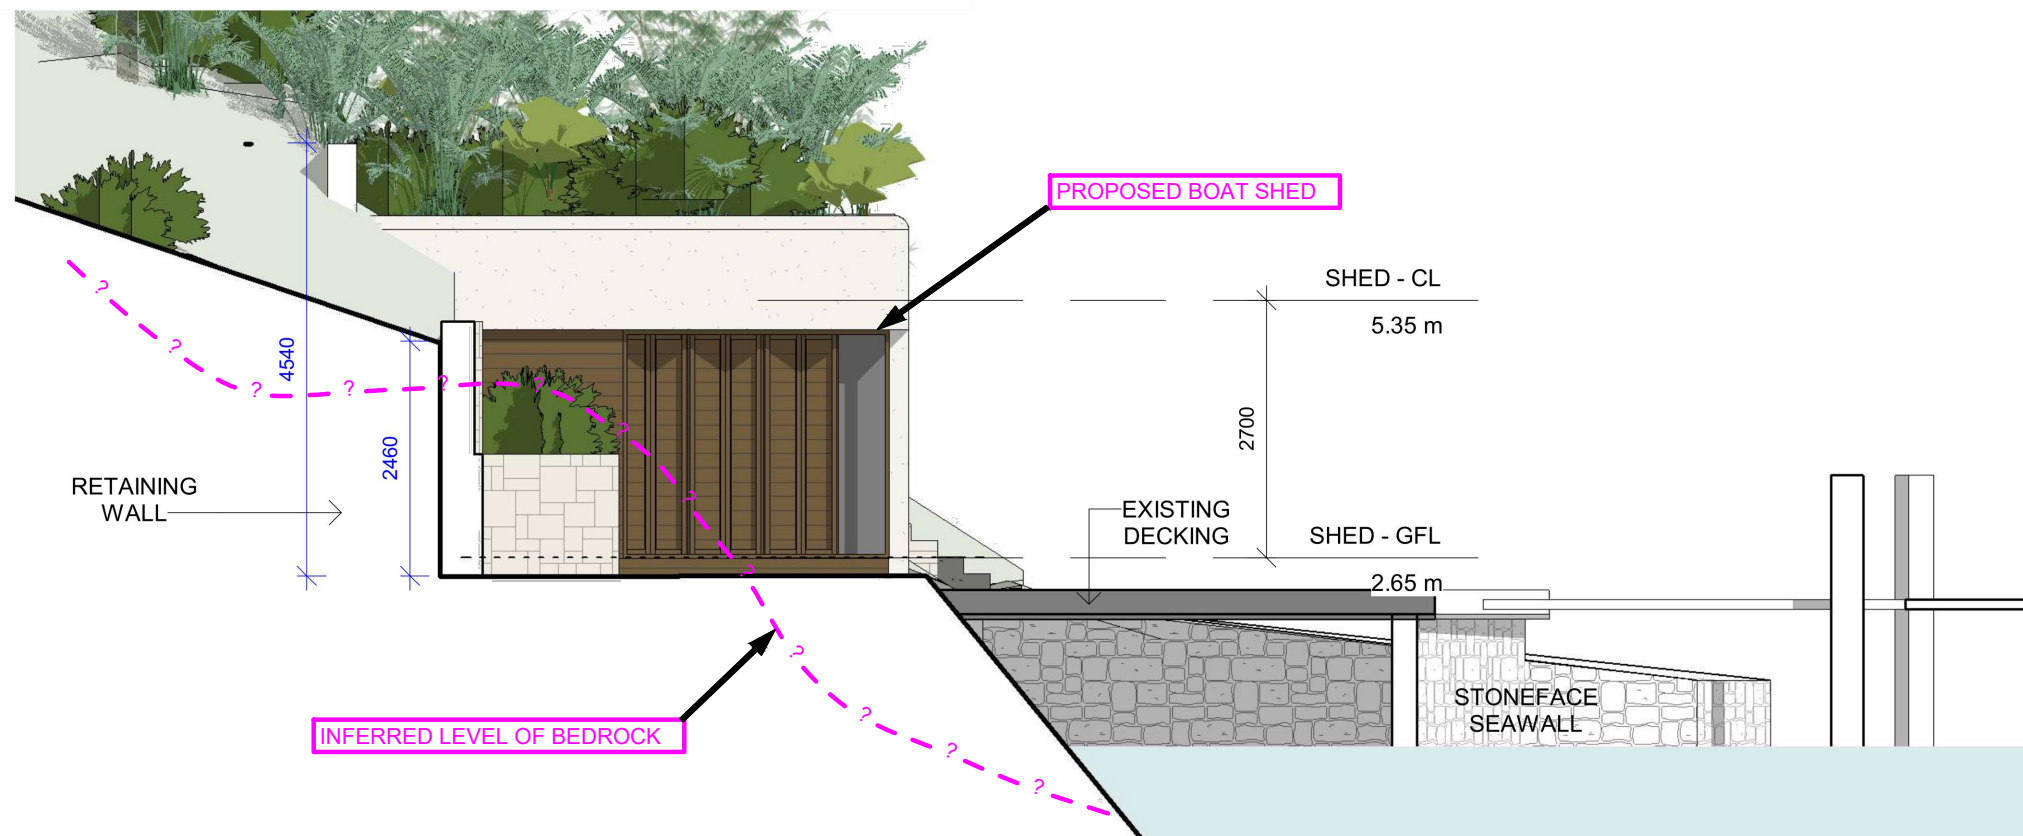
Refer to Drawing 2 for an inferred geological section through the location of the proposed new boat shed.
