Geotechnical Assessment

Project: Alterations & Additions
61 Dolphin Crescent, Avalon Beach NSW

Prepared for:
Matthew Dent

Ref: AG 24528
5 December 2024

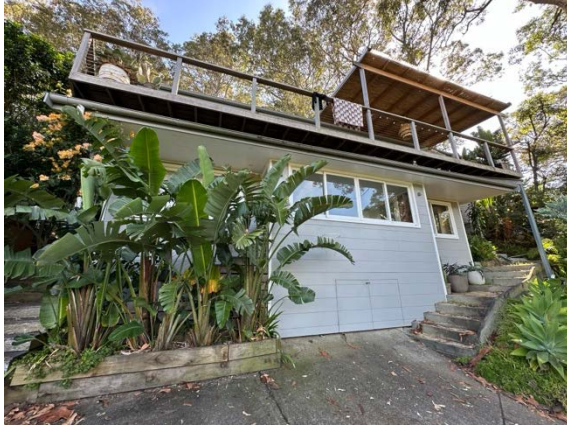
Photo 1: Frontage of the dwelling facing north-east.

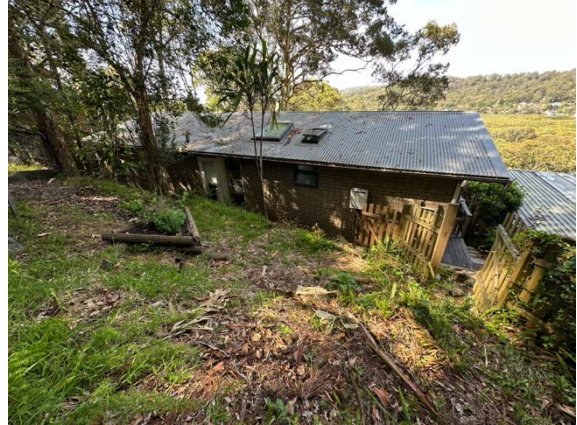
Photo 2: Rear of the dwelling facing south.

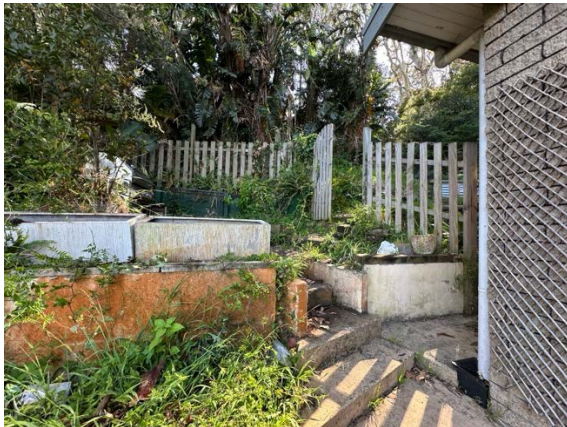
Photo 3: Area of proposed works facing north-east.

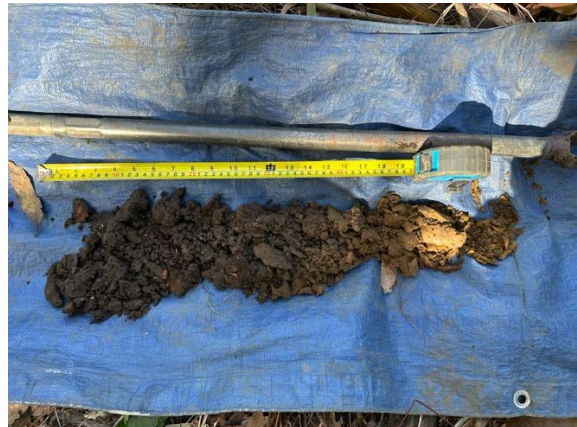
Photo 4: Subsurface soil profile seen in BH2.

Natural Silty CLAY CL-CI: firm, low to medium plasticity, dark brown orange, inorganic, moist.	F		CL-CI
1				BH2 refusal at 0.5m (Auger tip grinding on highly weathered bedrock.)			
2
