Arboriculture Assessment & Construction Impact Statement

July 2021

Site: Lot 36 in DP 10648
23 Hay Street
COLLARROY, NSW

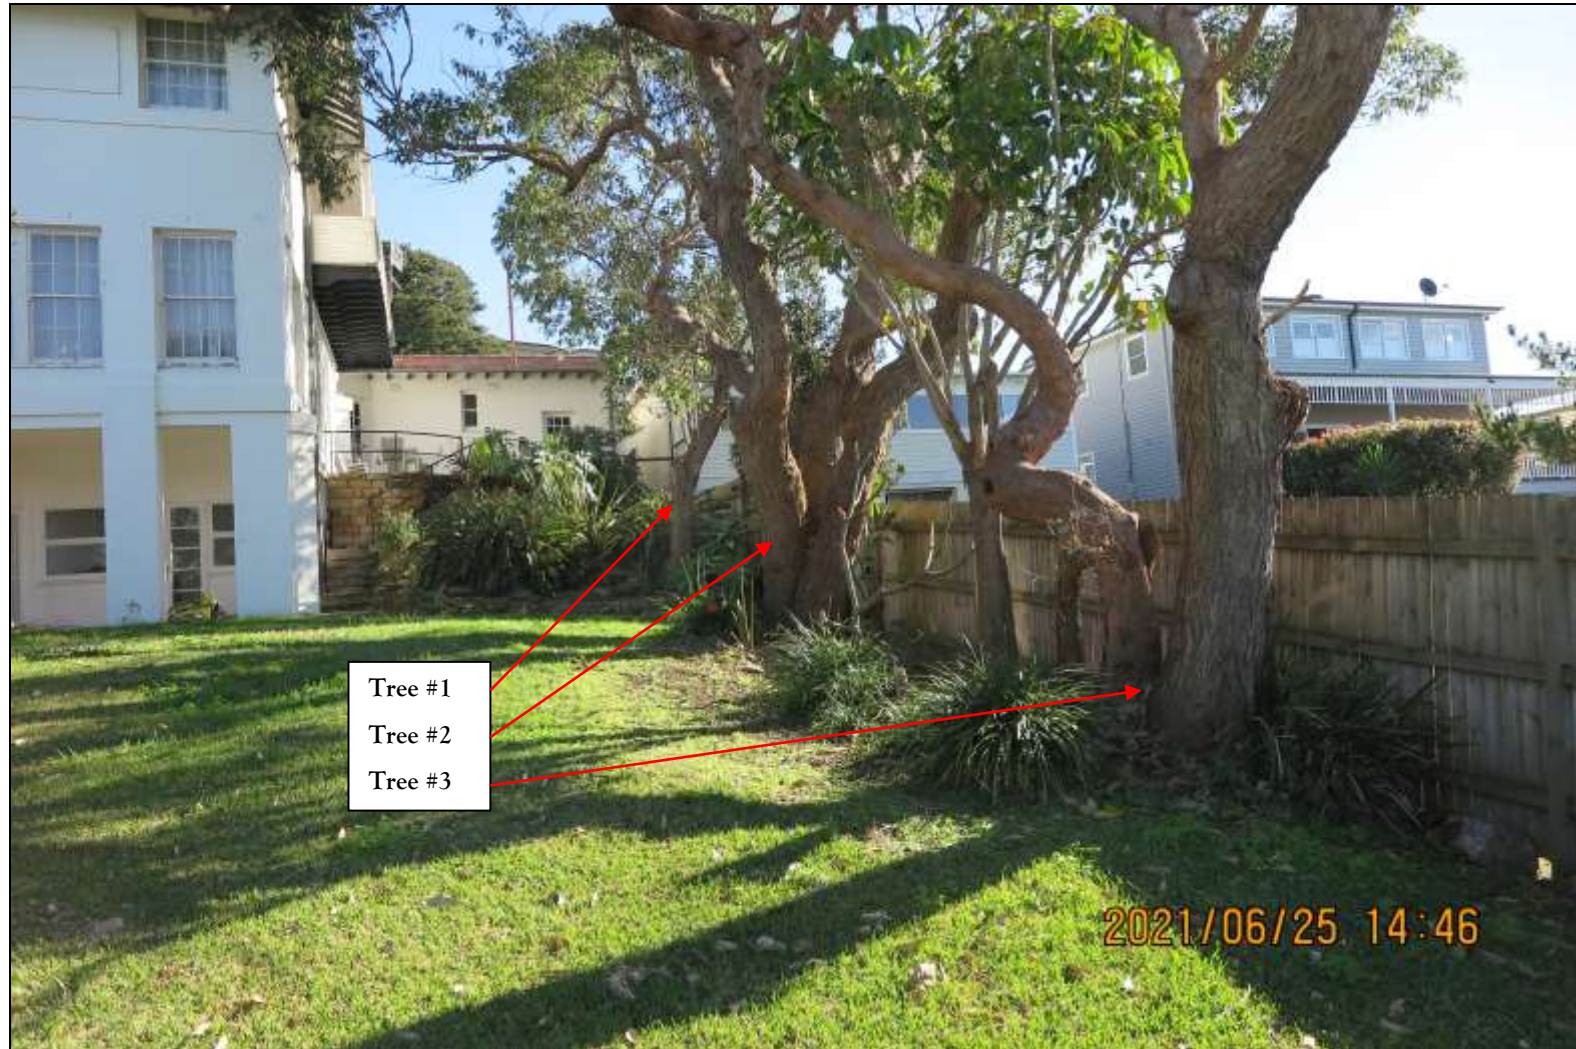
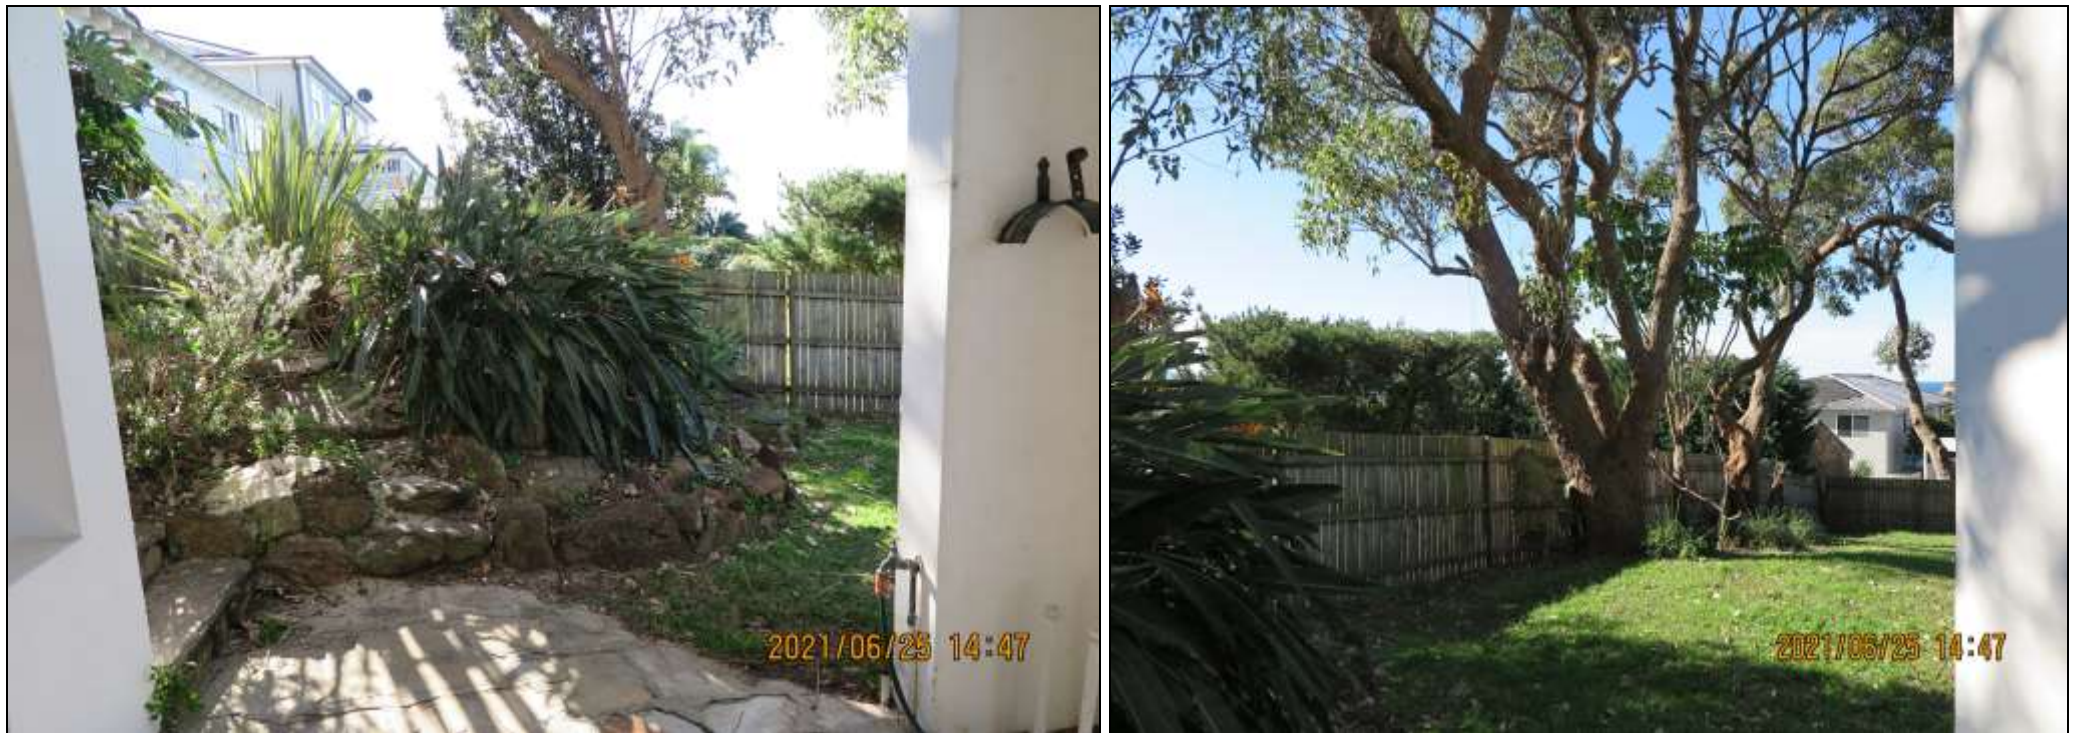
Figure 5: Illustrates the three (3) discussed tree locations.

Tree #2 & Tree #3 display canopy stress, dead/dying branches up to in excess of 100mm diameter. Tree #2 & Tree #3 also display a concerning number of dead upper canopy branch tips. This is a concern as it is often an indicator of 'live root' & certainly an indicator of 'change of environment'. It is noted tree trunk bases appear vertically out of the existing ground level which is a classic indicator of original soil levels being raised. Such changes are accepted to often be the primary cause of a shortened Useful Life Expectancy (from herein ULE) & almost always consistent with upper canopy branch tip dieback.

Tree #1 is supported by this document to be replaced. The now proposed ground level disturbance, general health & vigour in our assessment do not justify this tree being attempted to be retained.

Tree #2 is supported by this document to be replaced. The now proposed ground level disturbance, general health & vigour plus significant canopy pruning to create a reasonable new built form/canopy separation distance of a minimum of two & a half (2.50m) to three (3.00m) meters in our assessment do not justify this tree being attempted to be retained.

Tree #3 is specified to be retained in a manner that could reasonably be expected for it to not have its Useful Life Expectancy compromised by the as proposed works (especially any new 'landscaping concept & the construction of swimming pool & pool surrounds.

- *Temporary Australian Standard (AS4970-2009 Protection of trees on development sites) compliant 'metal mesh fencing panels (2.40m x 1.80m) supported by above ground blocks' are required to be instated, then confirmed in writing with supporting photographic evidence so as to isolate Tree #2 & Tree #3 (as a group planting) from the proposed works. (See Chapters 3, 4 & 5.) These must be as far from the tree trunk centres as the proposed works/site characteristics allow. This document must be provided to the appointed Principle Certifying Authority.*

- *Any excavation required for any works within the calculated TPZ radial distance of 7.80m must be completed manually, (this implies the line of excavation closest to the tree trunk centre not the full swimming pool/pool surrounds footprint). The end result must be confirmed in writing with supporting photographic evidence & provided to the appointed Principle Certifying Authority.*
