Report Title: Geotechnical Report 197 McCarrs Creek Road, Church Point
Report Date: 15/9/22

GEOTECHNICAL INVESTIGATION:

New Extension, Deck, Swim Spa & Spa at **197 McCarrs Creek Road, Church Point**

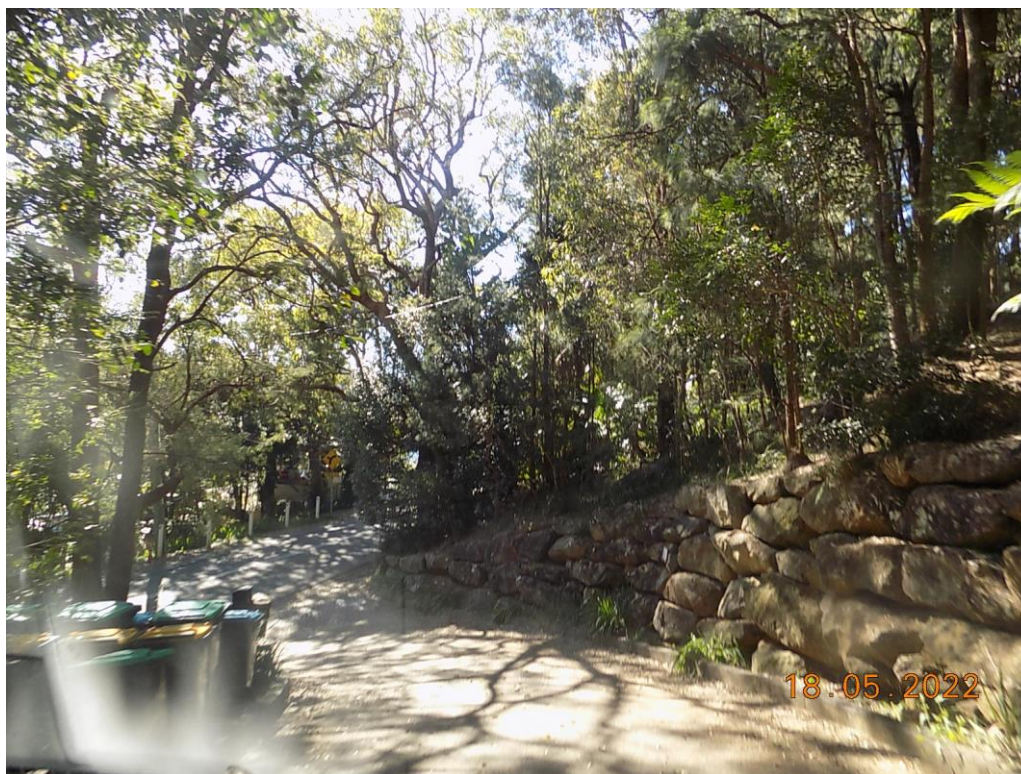
Photo 1

- 2.3** The property is accessed by a ROW off the uphill side of the road. The cut for the ROW is supported by large dimensioned sandstone boulders (Photo 1). A concrete driveway diverts off the downhill side of the ROW to a suspended carport on the uphill side of the property (Photo 2). In between the ROW frontage and the house is a steeply sloping embankment (Photo 3). The toe of the slope has been cut vertically to heights of up to some ~0.8m. See **Section 16** for advice regarding this cut. The two-storey clad house is steel framed and supported on steel posts. The steel posts appear to stand

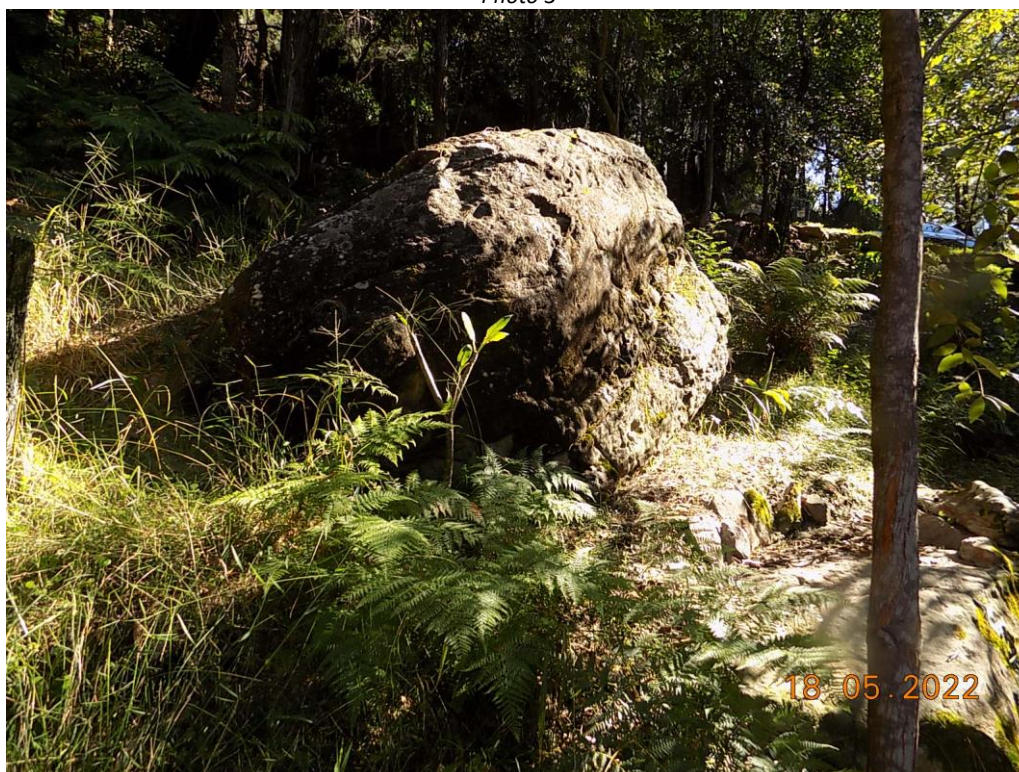
Photo 4

vertical. Several large boulders are embedded in the slope in stable positions (Photo 4). A level lawn area extends off the N side of the house to the N boundary. The fill for the level lawn area is supported by a stable ~1.2m high stack rock retaining wall and a stable ~1.2m high timber retaining wall (Photo 5). The retaining walls and lawn area are to be demolished as part of the proposed works. A steeply sloping lawn area extends from the downhill side of the house to the lower boundary (Photo 6). The lower two-thirds of the property is densely vegetated and was unable to be assessed in terms of stability (Photo 7 & 8).

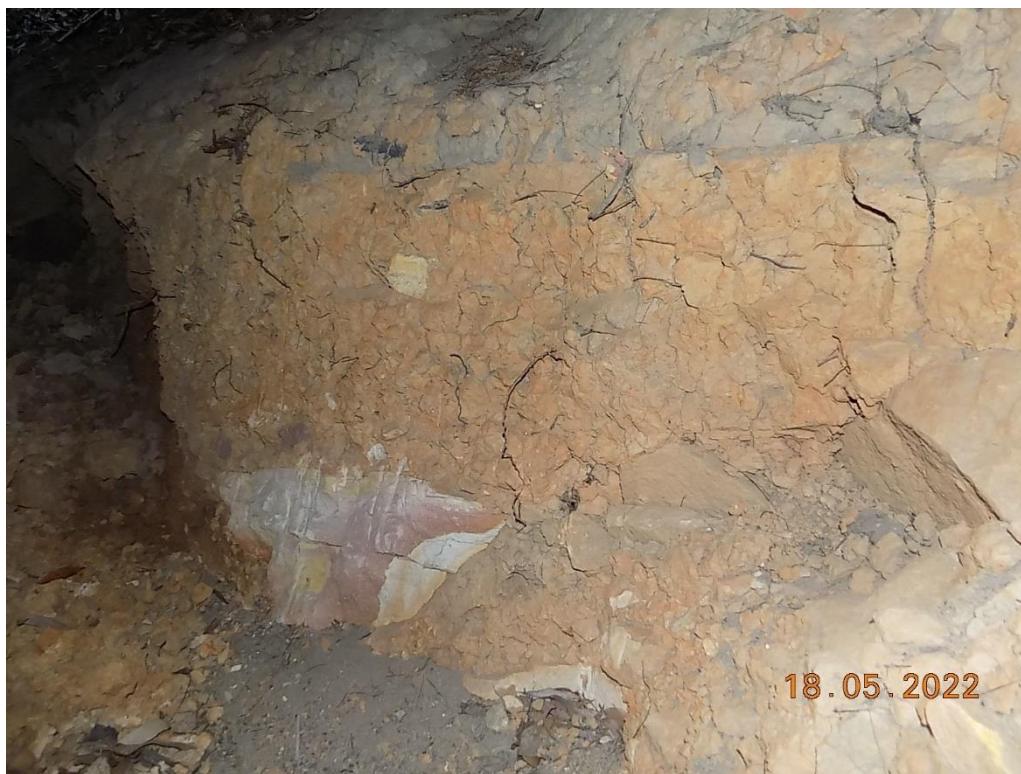
Photo 9

EXPOSED CUT BATTER (~RL66.2) – AH1 (Photo 9)

Depth (m)	Material Encountered
0.0 to 0.2	TOPSOIL , dark brown clayey soil, medium grained, loose, fine trace of organic matter, dry.
0.2 to 0.5	Colluvium , orange, fine grained, dry.
0.5 to 0.7	FLOATER , fine grained sandstone.

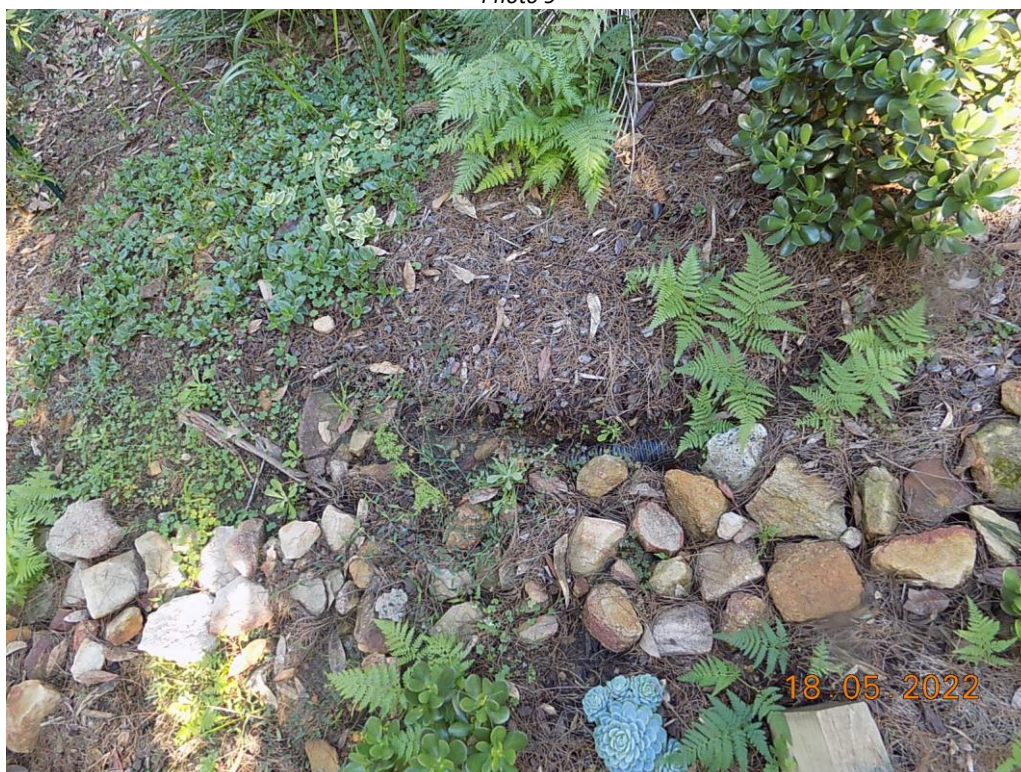
Photo 10

Minor scour channels had been cut into the topsoil above the drainage pipe below the house (Photo 10) and under the house.

As the weather on the east coast is modelled to become more extreme in the future, on steep slopes such as this, it is recommended that a dish drain at least 0.5m be installed. This is to be installed behind the proposed retaining wall across the uphill side of the house. Any pits and piping to direct flows to the stormwater system for the road are to be oversized (min. 150mm ø pipe) and designed to cope with extreme rainfall events. The drain is to be designed by a stormwater/civil engineer in consultation with the geotechnical consultant. It is a condition of the risk assessment in **Section 8** that this be done.

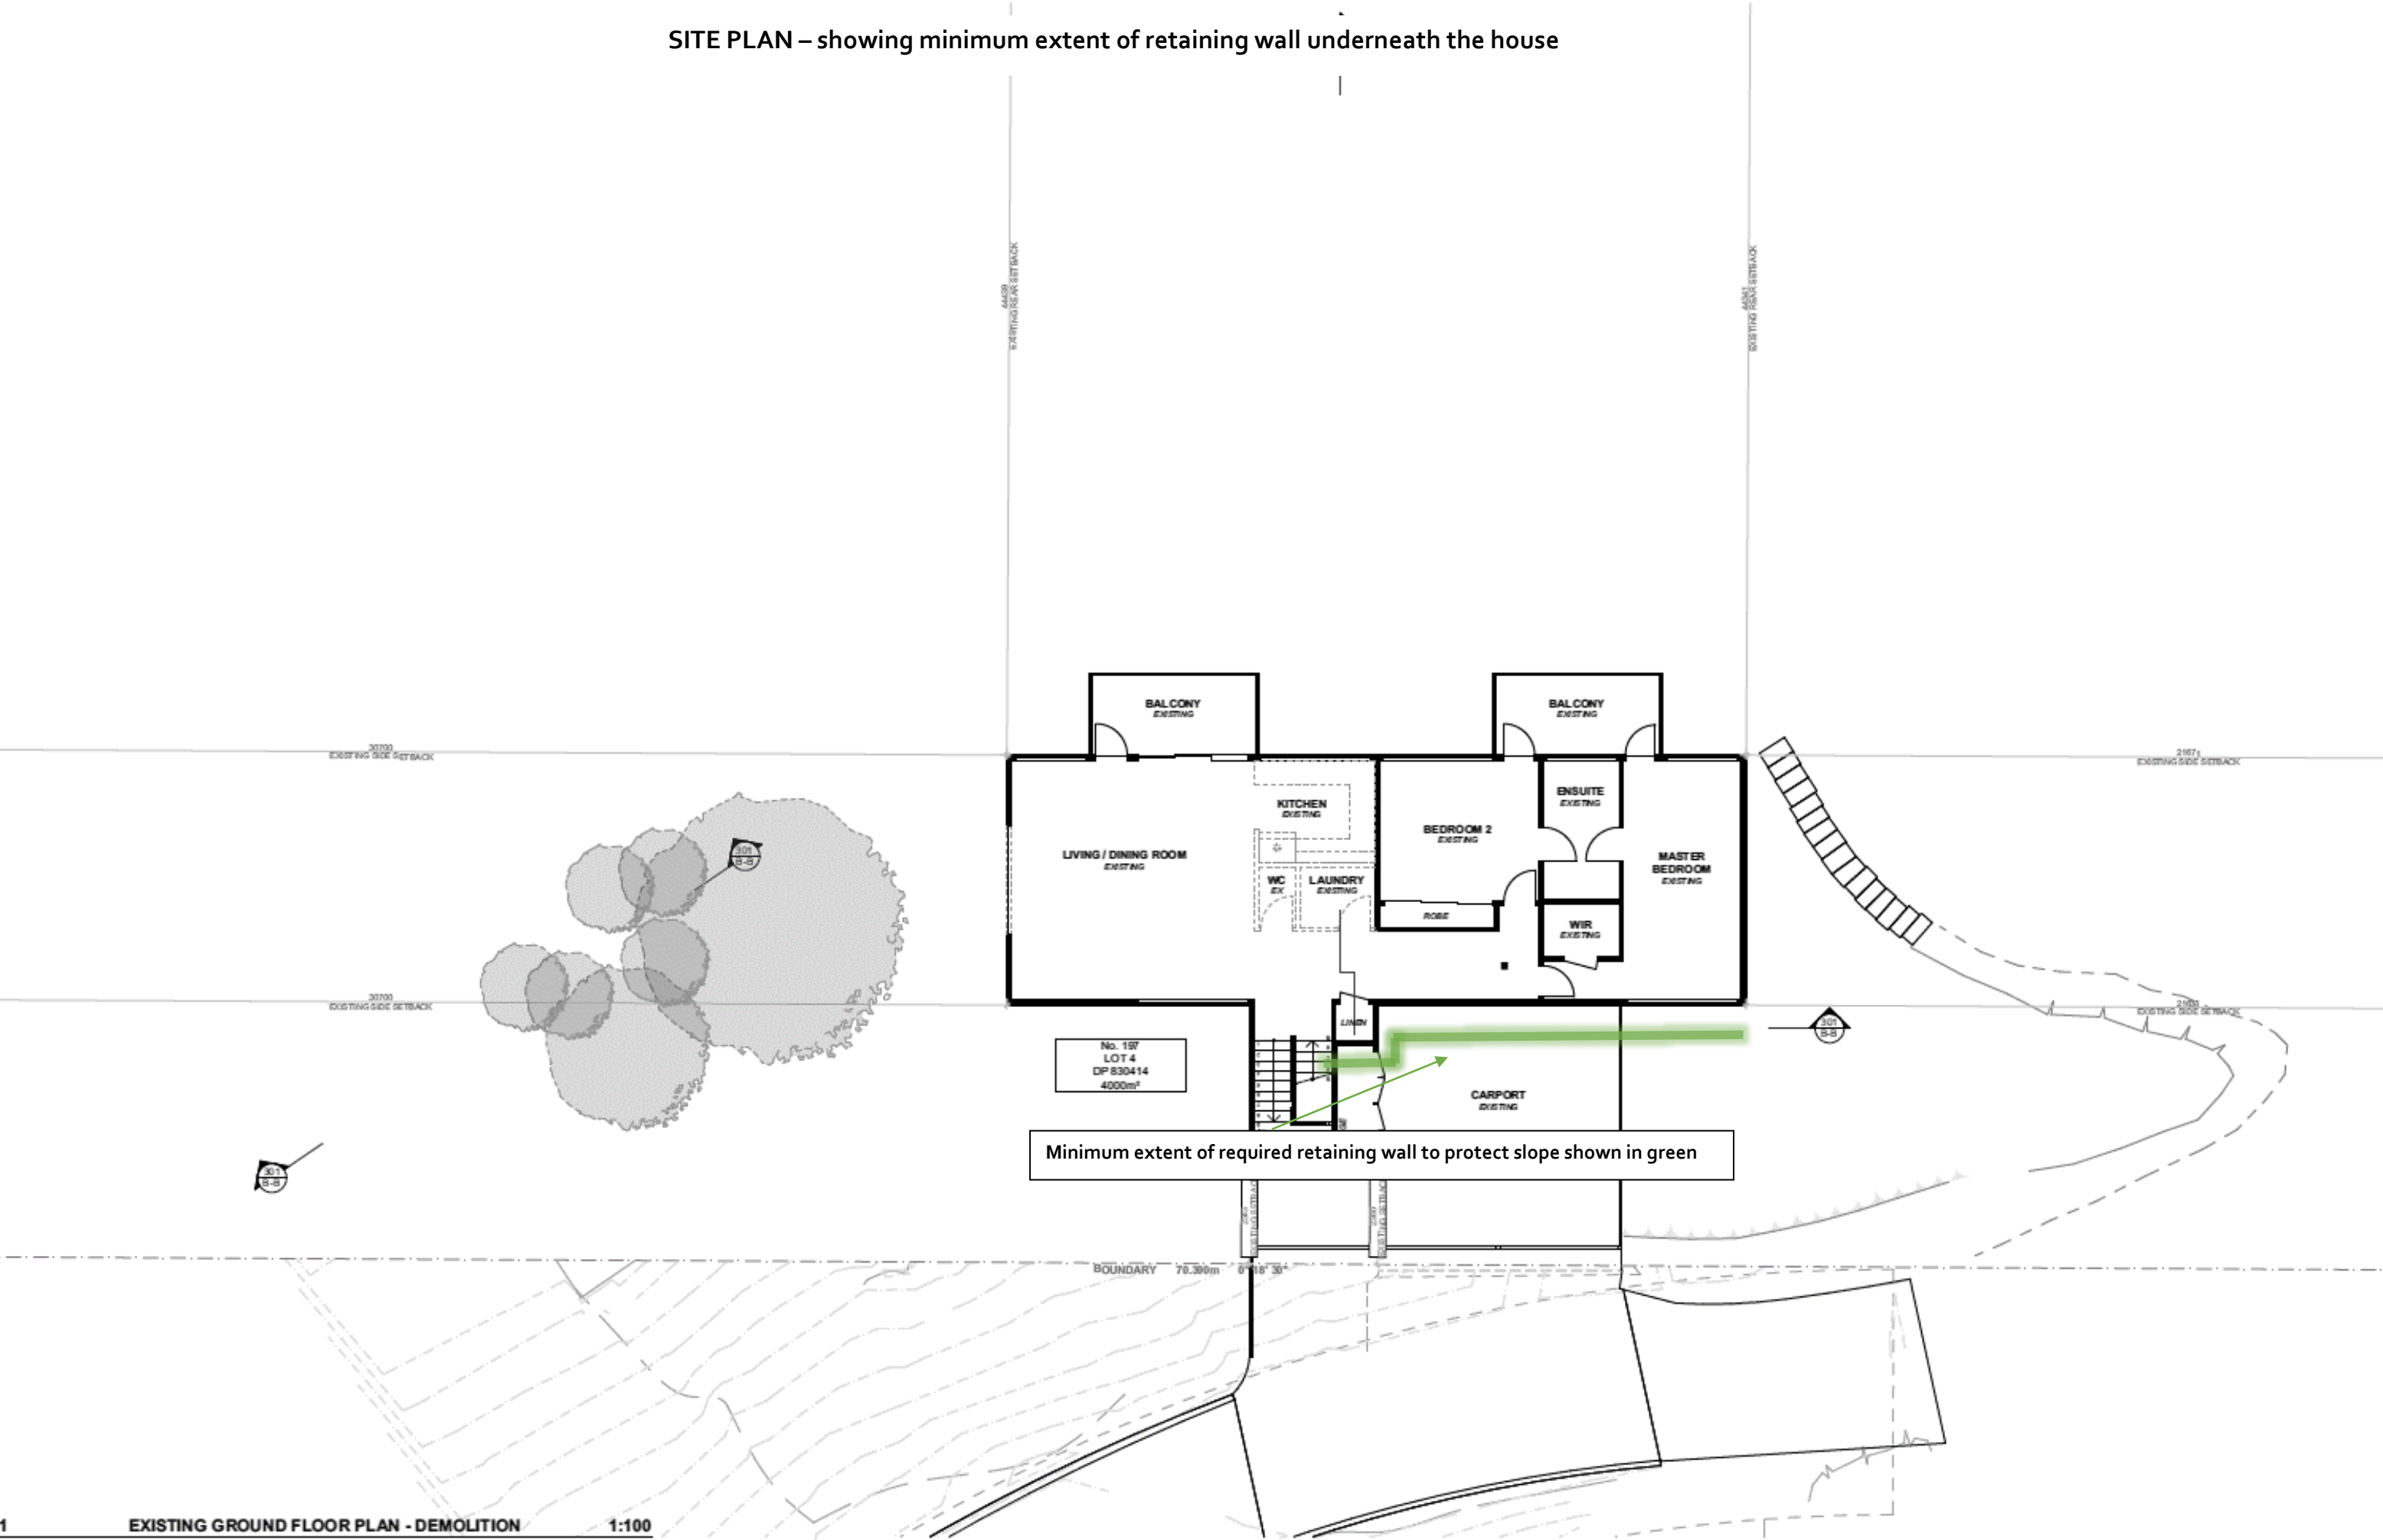
SITE PLAN – showing minimum extent of retaining wall underneath the house

(Hazard Two). The unsupported fill batter under the driveway is a potential hazard (Hazard Three).

A) The steep unsupported fill batter underneath the driveway requires a retaining wall constructed across the toe of the slope to prevent and limit failure. This wall is to be built some ~0.4m higher than the slope level to 'catch' any localised soil movement. The wall is to be designed by a structural engineer to cope with surcharge loads from the steep slope above.

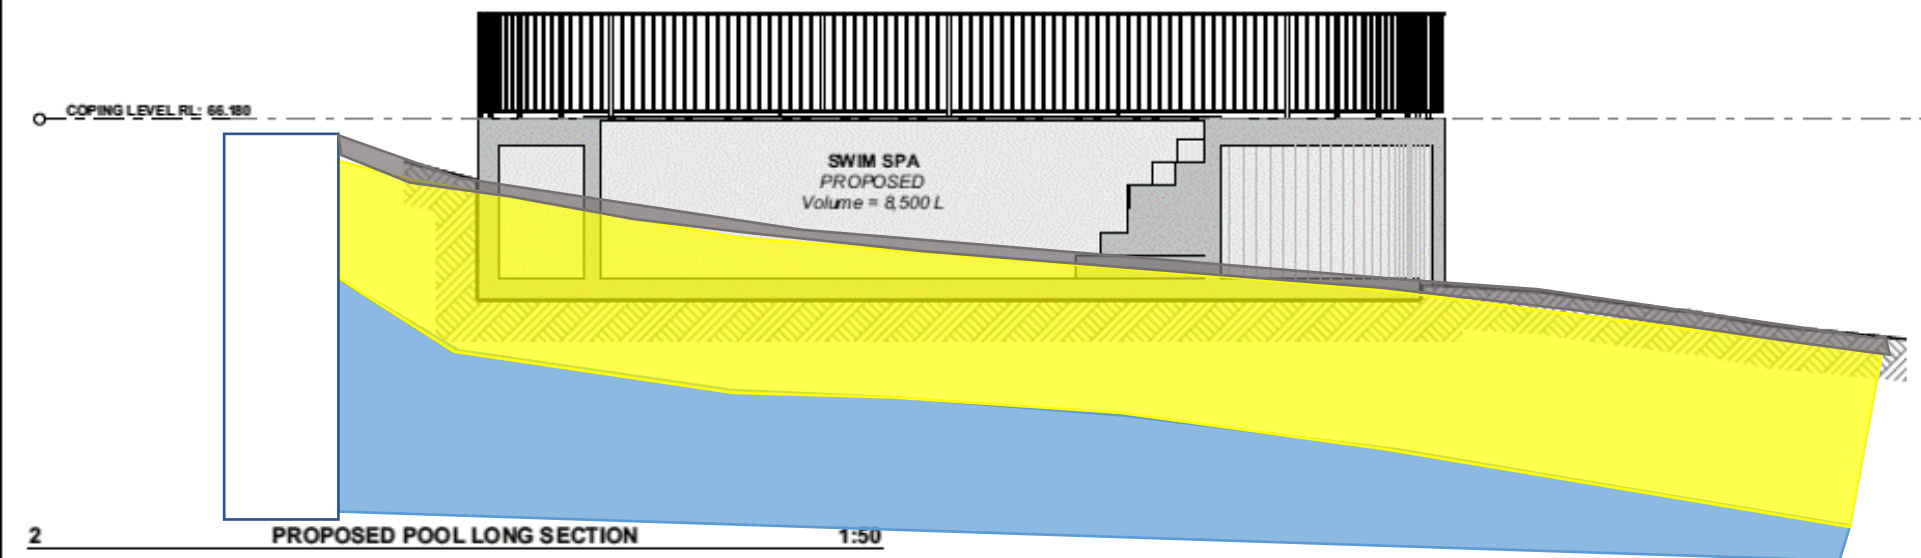
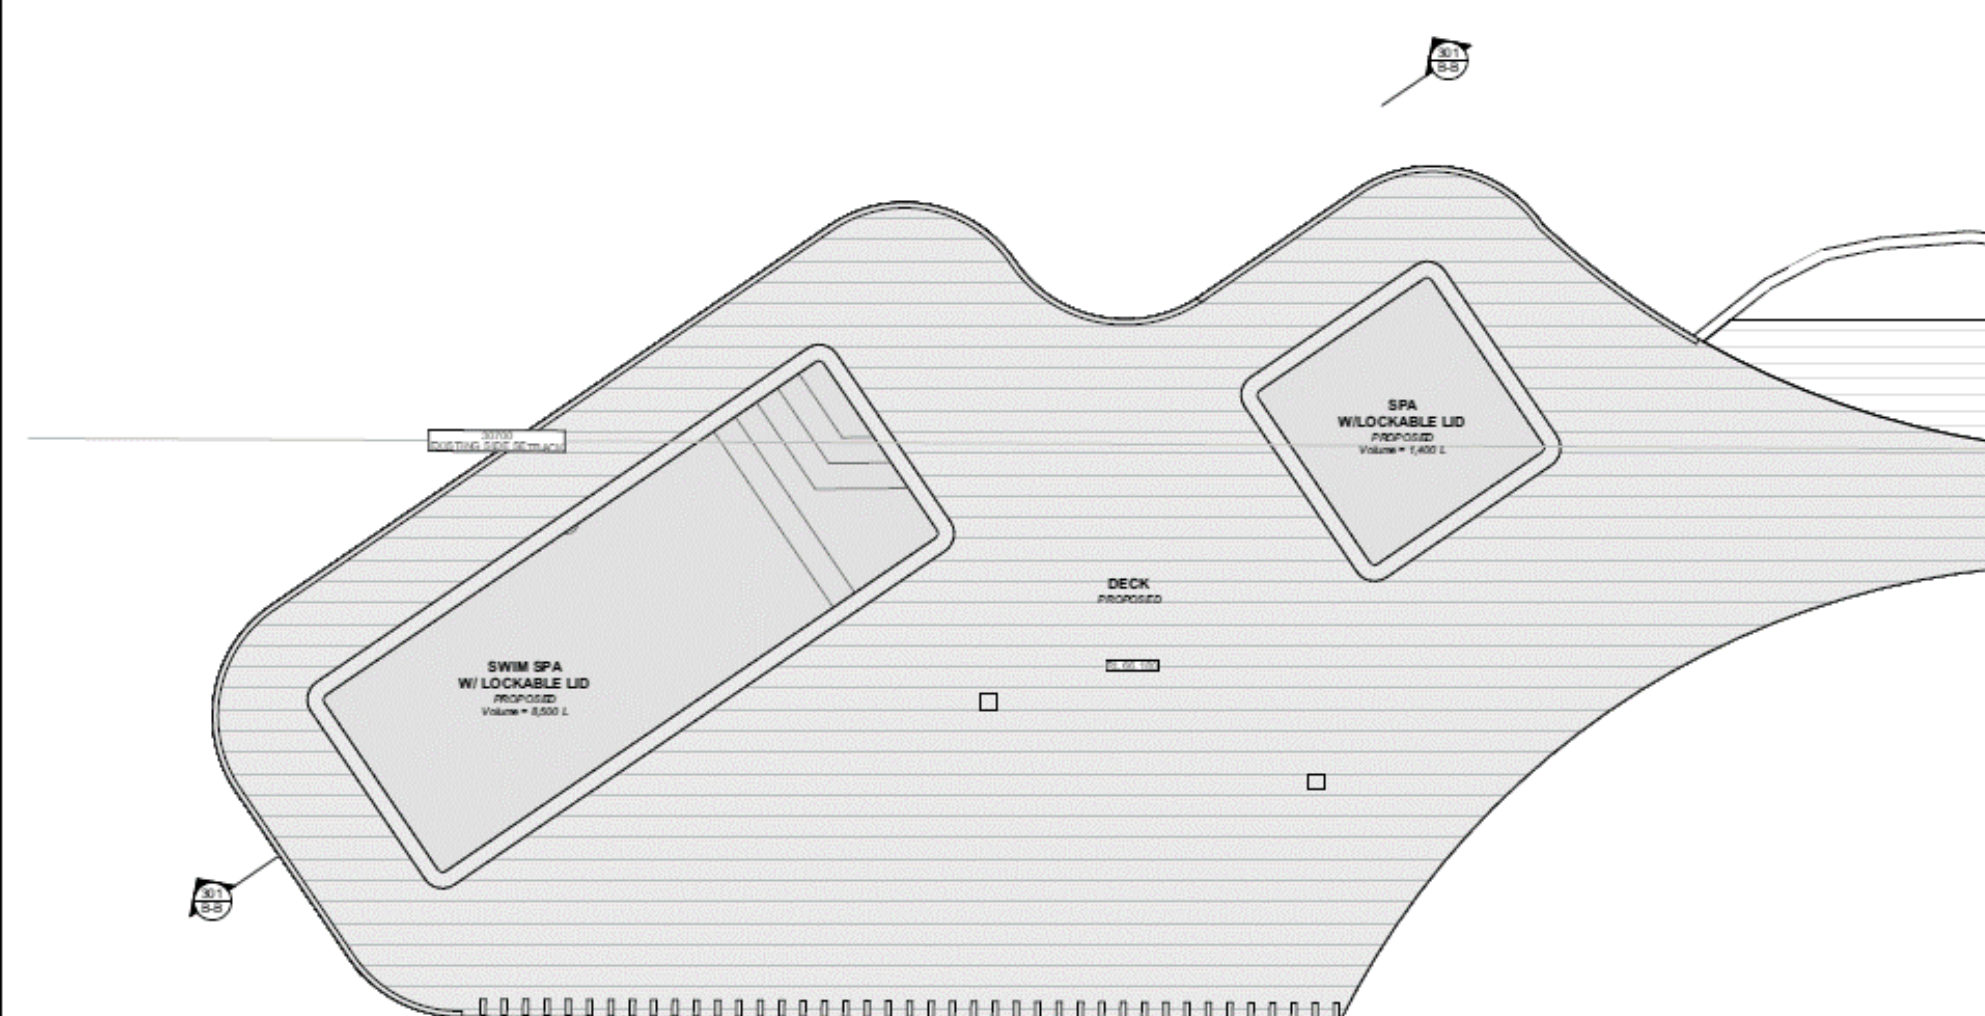
TYPE SECTION – Diagrammatical Interpretation of expected Ground Materials

The slope materials are colluvial to depths of at least ~0.8m under the driveway and house. This colluvium on the uphill side of the house is unsupported and battered at angles of 30°+. In the test locations, the ground materials consist of fill and soil over clays. The clay merges into the underlying weathered rock at depths of between ~1.5m to ~1.8m below the current surface. The weathered zone is interpreted to be Extremely Low Strength Shale. See Type Section attached for a diagrammatical representation of the expected ground materials.

- Fill
- Topsoil
- Clay – Firm to Stiff
- Narrabeen Group Rocks – Extremely Low Strength Shale - *after being cut up by excavation equipment can resemble a stiff to hard clay.*
