REPORT ON GEOTECHNICAL ASSESSMENT

PROPOSED NEW RESIDENCE

106A WAKEHURST PARKWAY, ELANORA HEIGHTS, NSW

Project No.: 2019-207

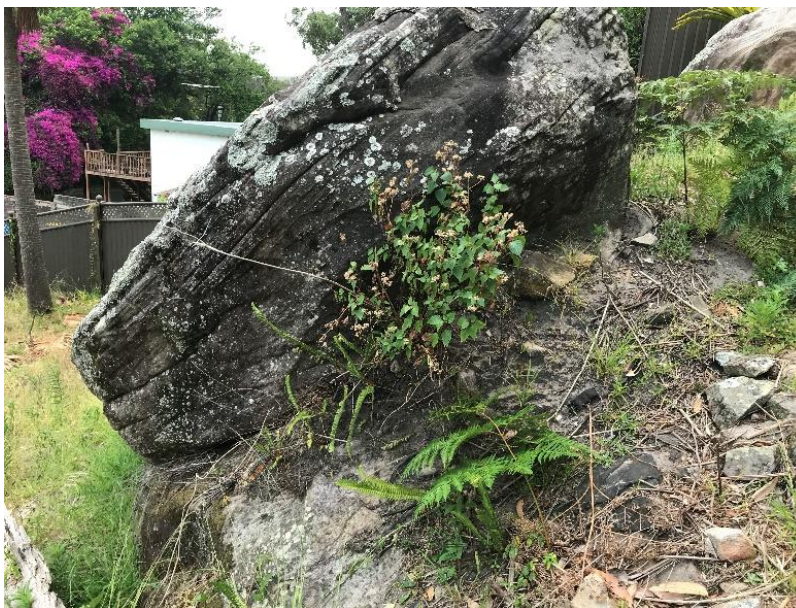
Most of the boulders are buried in soil and are generally stable at present. However, it was identified that Boulder 1 and Boulder 2 as shown in Photograph 2 and 3 below and marked in Figure 1 appeared situated on top of other boulders along defects of $>30^\circ$. Therefore, these boulders are prone to instability when the foundation is disturbed or under extreme weather conditions.

Photograph: 2 – Boulder 1 situated along unfavourable defect, facing east

Within the slope, boulders directly overlying other boulders along unfavourable defects were identified and are considered relatively unstable. Stabilising measures or the removal of these boulders are recommended, whilst stabilising measures to other boulders can be determined based on the proposed development design. All footings are recommended to be founded to bedrock. As such, a geotechnical investigation is required to confirm bedrock levels.

It is recommended that loose soils and unstable boulders be removed in the area of the proposed development prior to a more detailed inspection. Unstable boulders within a 1.0V:1.5H influence zone of excavation are recommended to be removed or secured by way of rock bolts and/or grout underpinning prior to any excavation on site. This will help to prevent potential movement both during and after excavation works. It is also recommended that further investigation be undertaken to confirm subsurface condition and depth to bedrock. All new footings should be inspected by a geotechnical professional.

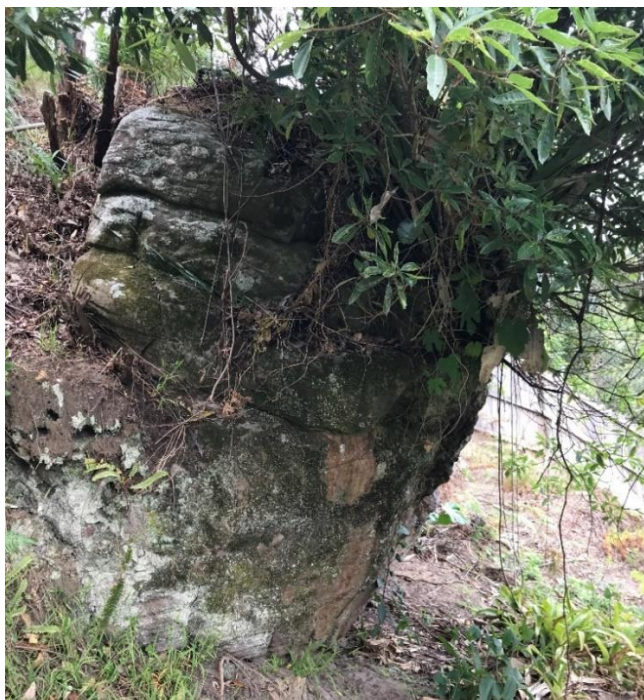
Photograph: 3 – Boulder 2 situated along unfavourable defect, facing west

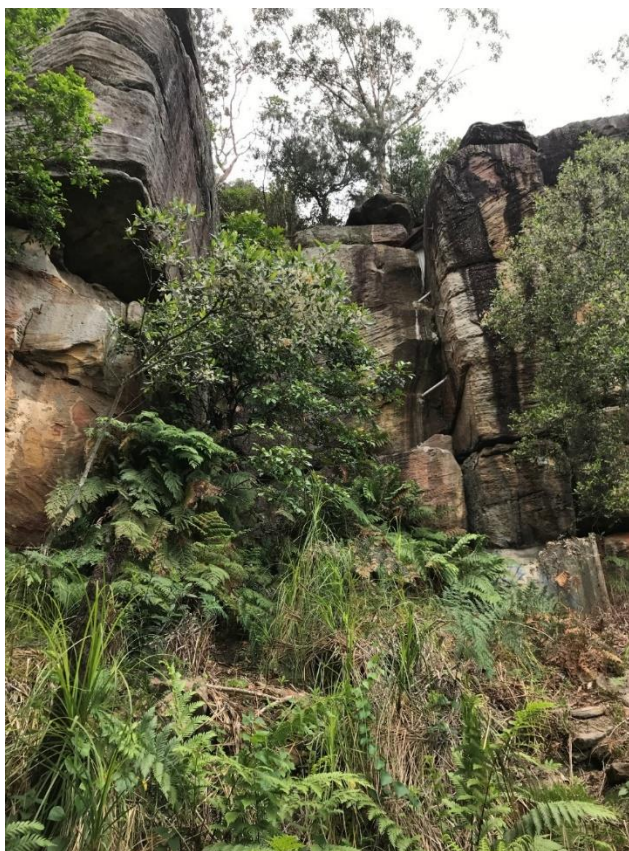
The cliff line at the middle of the property comprised detached sections/boulders directly overlying the bedrock and other boulders. It appears that these boulders have not recently moved and are situated on sub-horizontal bedding defects. A column of detached boulders at the front of the cliff face have been previously stabilised as shown in Photograph 4 below. A few boulders were identified at the cliff crest and were overhanging..

Photograph: 4 – A column of detached rock sections bolted, facing north

Although the ‘Very High’ Risk to Property for Hazard A is considered to be ‘Unacceptable’ the assessments were based on excavations with no support or planning and the existing bolted column remaining unchecked until bolt failure following house construction. Provided the recommendations of this report are implemented including regular detailed geotechnical mapping of the excavation and installation of determined support systems in timely manner the likelihood of any failure becomes ‘Rare’ and as such the consequences reduce and risk becomes within ‘Acceptable’ levels when assessed against the criteria of the AGS. As such the project is considered suitable for the site provided the recommendations of this report are implemented.
