REPORT ON GEOTECHNICAL SITE INVESTIGATION

PROPOSED DEVELOPMENT

LOT 3, 1110 BARRENJOEY ROAD, PALM BEACH

Project No.: 2020-232

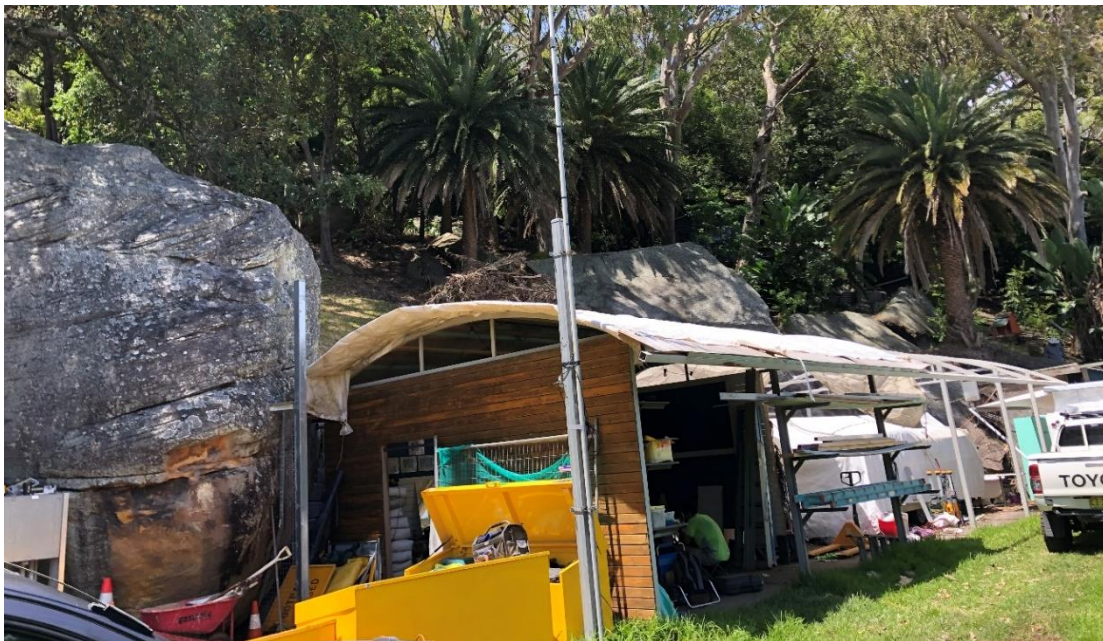
Photograph-2: View of the front of the site, looking south east from Lot 2

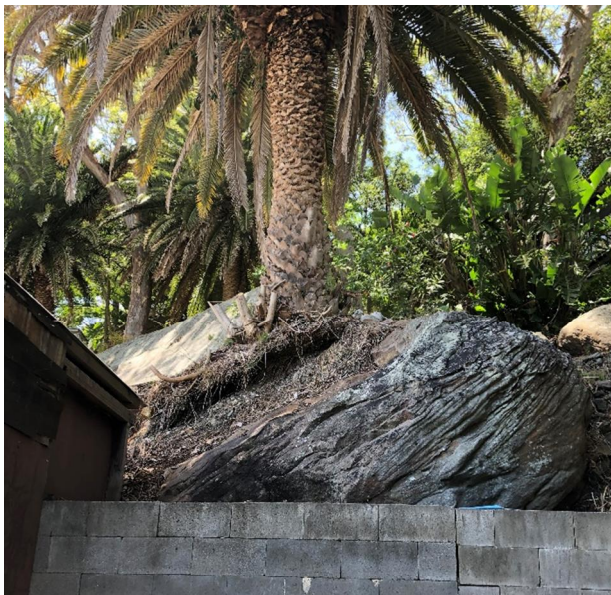
exposed. The tree appears to be positioned partially on top of a large sandstone boulder, this is shown in Photographs 3 and 4.

Photograph-3: Wash out under roots of palm tree, looking east

It is recommended that loose soils and small, unstable boulders be removed in the area of the proposed development prior to any construction work. Unstable boulders within a 1.0V:1.5H influence zone of an excavation base are recommended to be removed or secured by way of rock bolts and/or grout underpinning prior to any excavation on site. This will help to prevent potential movement both during and after excavation works. It is also recommended that further investigation including core drilling be undertaken to confirm the depth and nature of bedrock underlying the site.

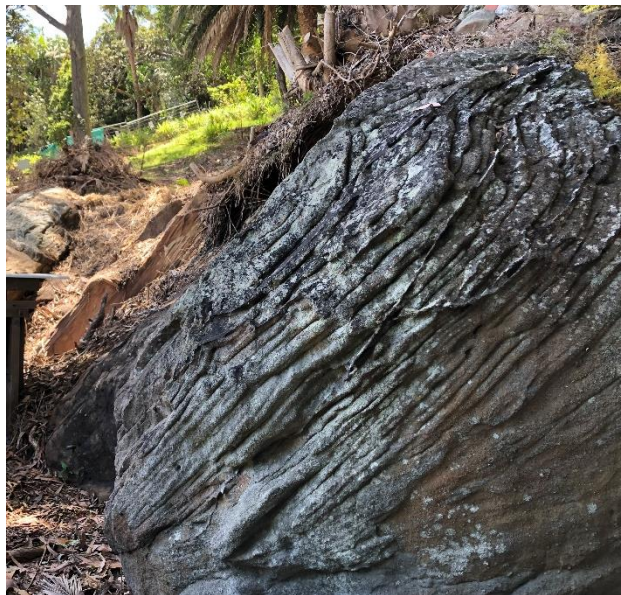
Photograph-4: Sandstone boulder and wash out under roots of palm tree, looking north east

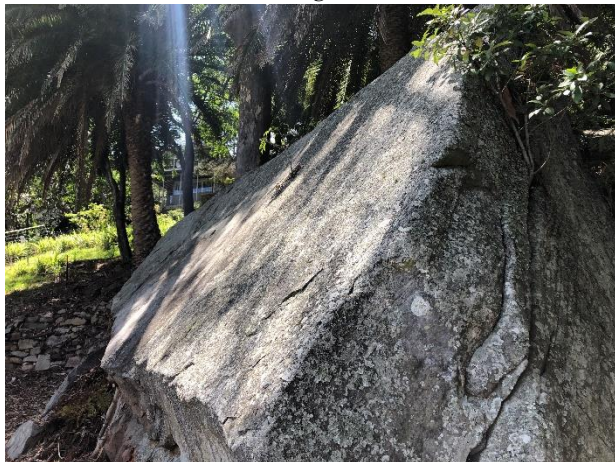
A middle-terraced level exists just to the east of the front terraced area at approximately R.L. 16.5m, this region is located between large sandstone boulders. A large (≈48m³) angular, north east ó south west striking, west north west dipping (≈65°) sandstone boulder is located on the high east side of this middle-terraced level. A dry stack, subvertical sandstone rock retaining wall is located on the northern side of this boulder. This retaining wall appears to be stable, however it is not engineer designed and subject to poor construction methodology. The boulder and retaining wall are shown in Photograph 5 and 6.

Photograph-5: Massive, angular sandstone boulder within the middle-terraced region, looking north east

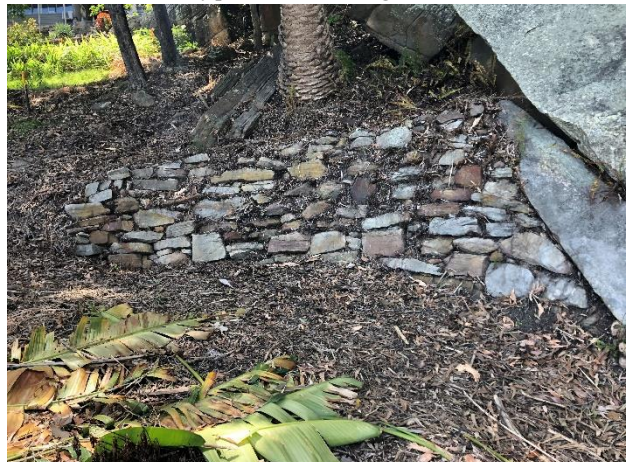
Photograph-6: Retaining wall to the north of sandstone boulder along the eastern edge of the middle-terraced region, looking east

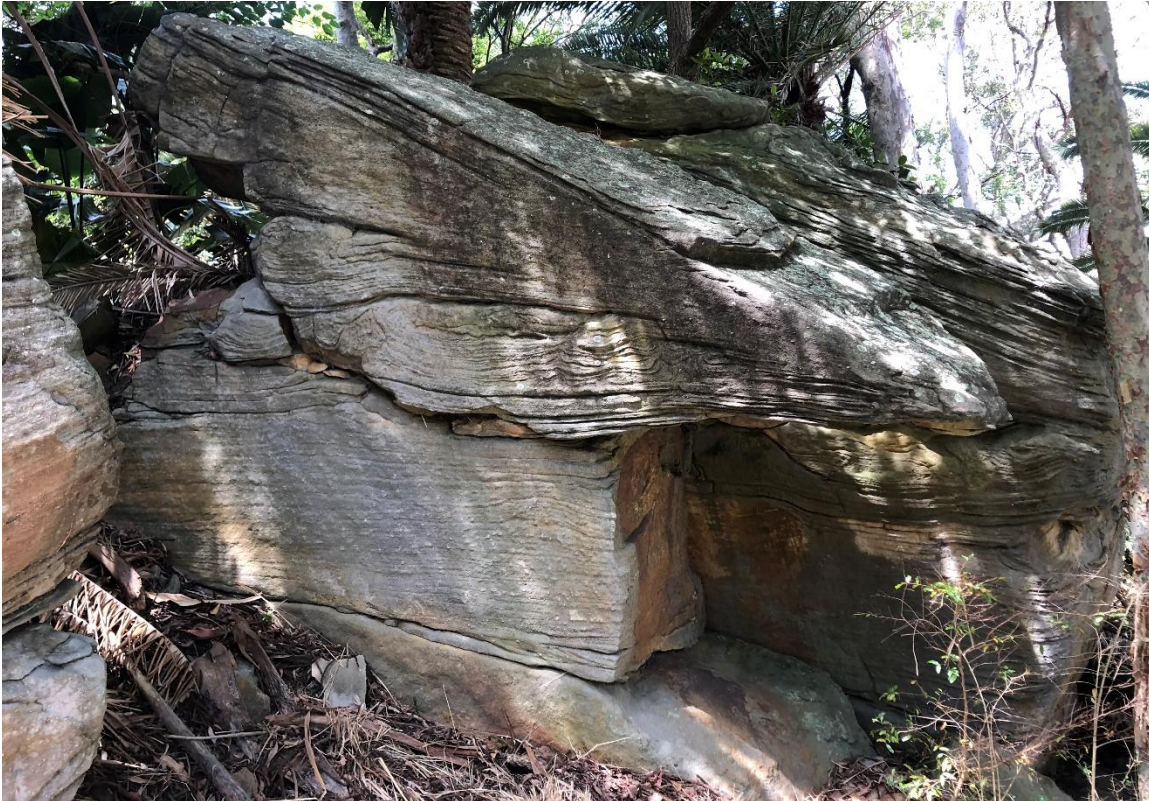
A series of large sandstone boulders are positioned within the north eastern corner of the site, with one large boulder extending an approximate 12m into the neighbouring property to the north east (No.140 Pacific Road). Within this series of boulders, a detached angular boulder was identified resting on top of another detached unit, both units are orientated down slope bearing onto a largely buried boulder. The upper and possibly lower detached units are interpreted as being susceptible to instability due to sliding or overturning failure. These boulders are shown in Photograph 7.

Photograph-7: Two detached units bearing onto a mostly buried sandstone boulder, looking south

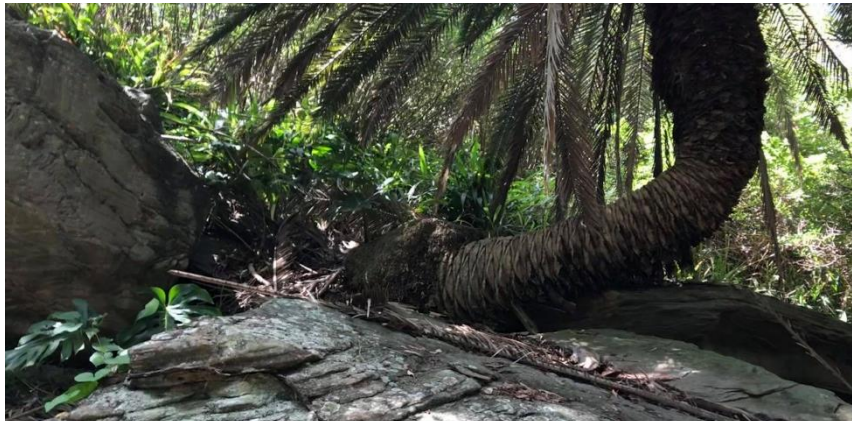
The neighbouring properties to the east (No. 138 ó 140 Pacific Road) are located close to the crest of the ridge with their steeply west sloping backyards extending to the common boundaries with the site. The stepped backyards of these properties are densely vegetated and are retained by dry packed stone walls of variable heights. Only the site visible sections of the backyards of these neighbouring properties were inspected and there were no signs of excessive surface erosion or any tension crack/deformation over the soil slope or within the retaining walls to suggest any movement or underlying geotechnical issues. However, a palm tree orientated sideways and resting on sandstone boulders within No.138 appeared to show signs of previous instability, this is shown in Photograph 8.

Photograph-8: Palm tree within No.138 Pacific Road with horizontally orientated base, looking south east

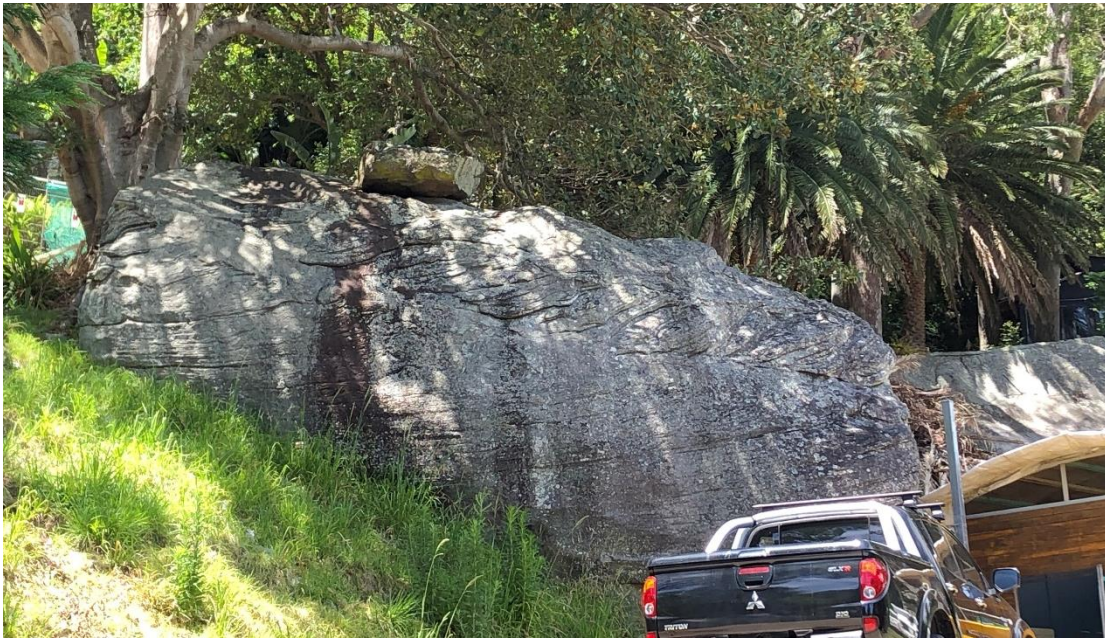
The neighbouring lot to the north (Lot 2, 1110 Barrenjoey Road) forms the middle portion of the vacant block and is situated within very similar topography. A very large sandstone boulder (€200m³) is located within the south western corner of the lot and extends into the site. Resting on top of this boulder is a smaller detached unit, which appears to be stable at present, this is shown in Photograph 9.

Photograph-9: Large sandstone boulder with smaller detached unit on top, within Lot 2, looking south east
