# Site Report

## GEOTECHNICAL INSPECTION

### SLOPE INSTABILITY FOLLOWING STORM EVENT ON 8 MARCH 2022 65-67 HILLTOP ROAD, AVALON BEACH, NSW

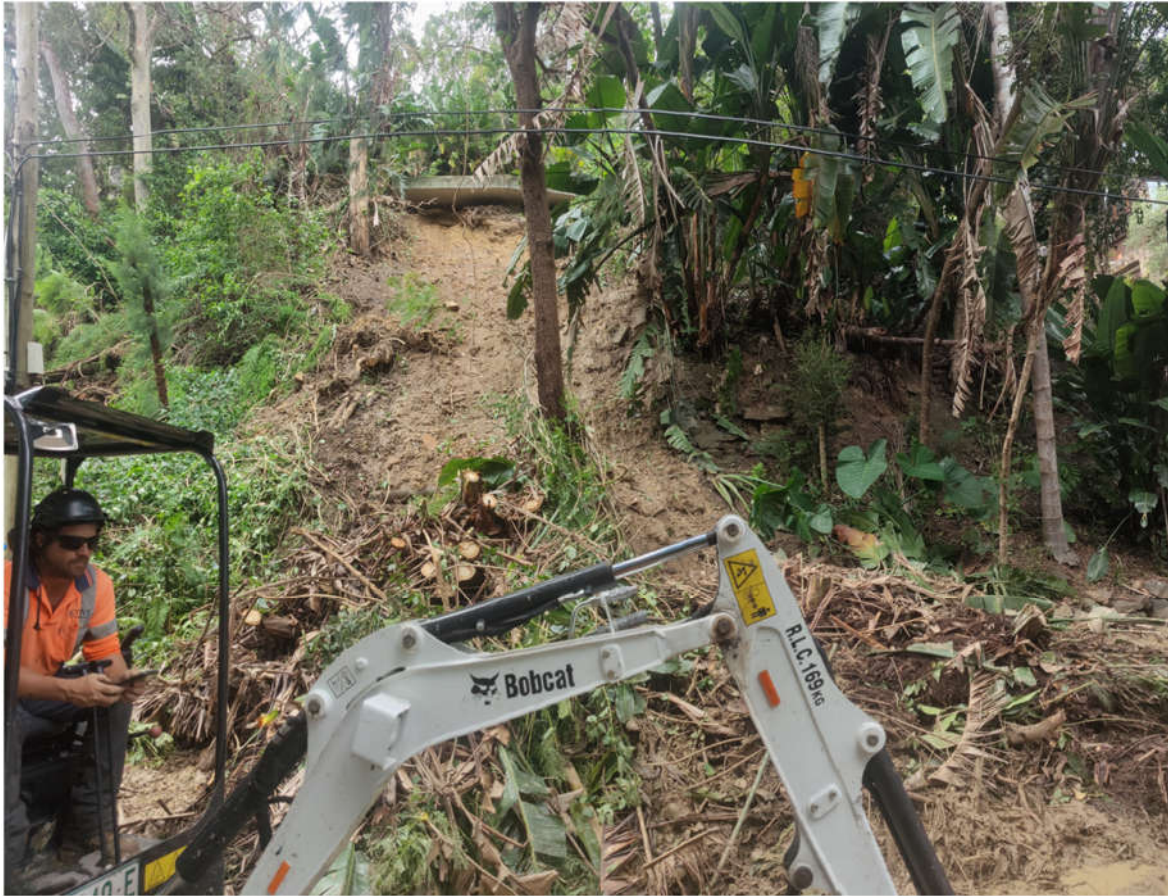
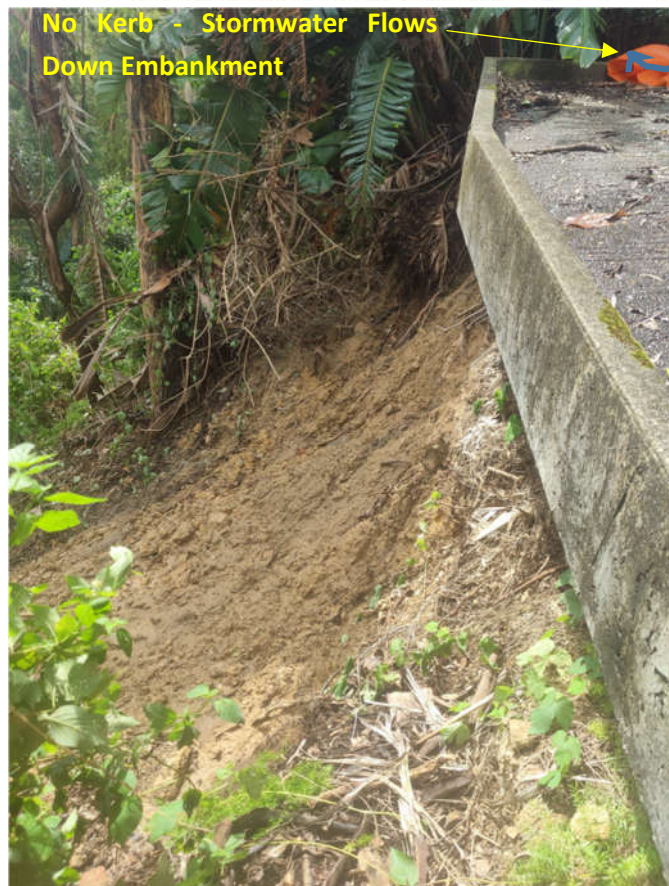
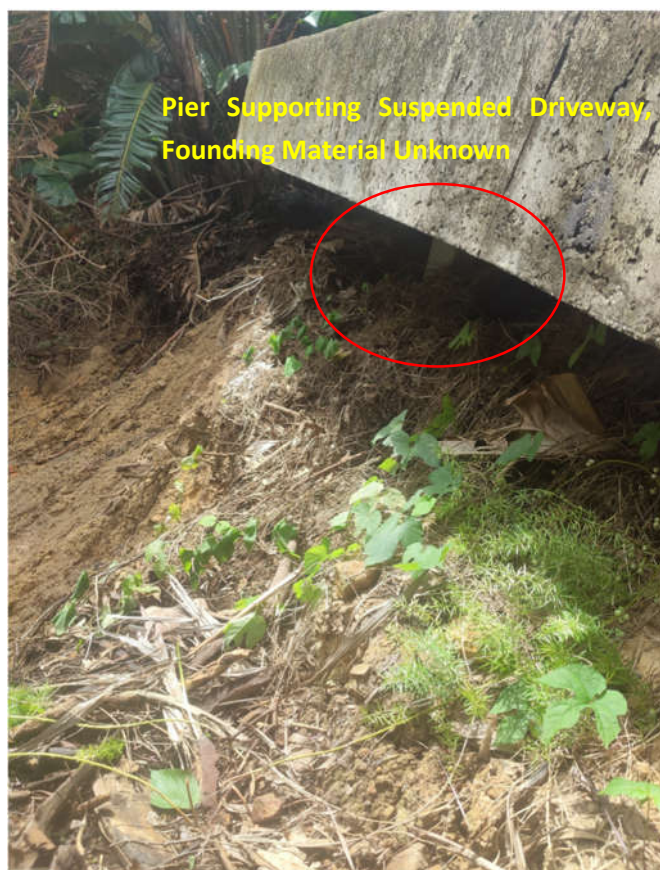
Plate 2: Northern Landslide

Below is a brief description observed at the northern landslide as shown on Plate 2:

- The landslide or debris flow had a width of about 5m and a total length of about 17m to 19m, which extends from the backscarp to the foot or zone of accumulation of the slide.
- The backscarp extends up to about 0.5m below the concrete driveway and exposed a pier, suggesting that the driveway has been designed as a suspended driveway. It was unclear the depth or materials the pier was supported on. The driveway appeared to be in good condition. There was no kerb on the northern side or downslope of the driveway and it appears stormwater flows from the driveway and then onto the embankment as shown on Plate 2.
- The materials exposed at the surface appeared to be a mixture of clay and cobbles.

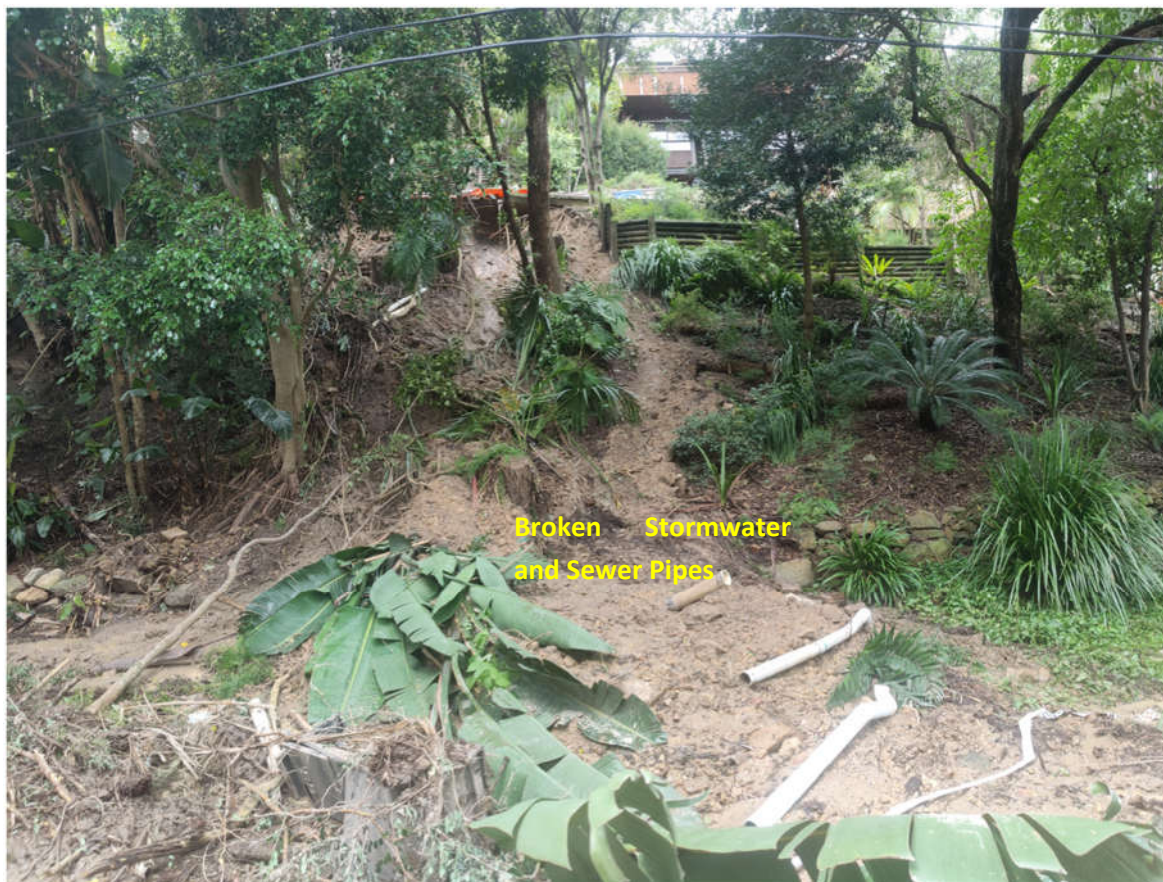
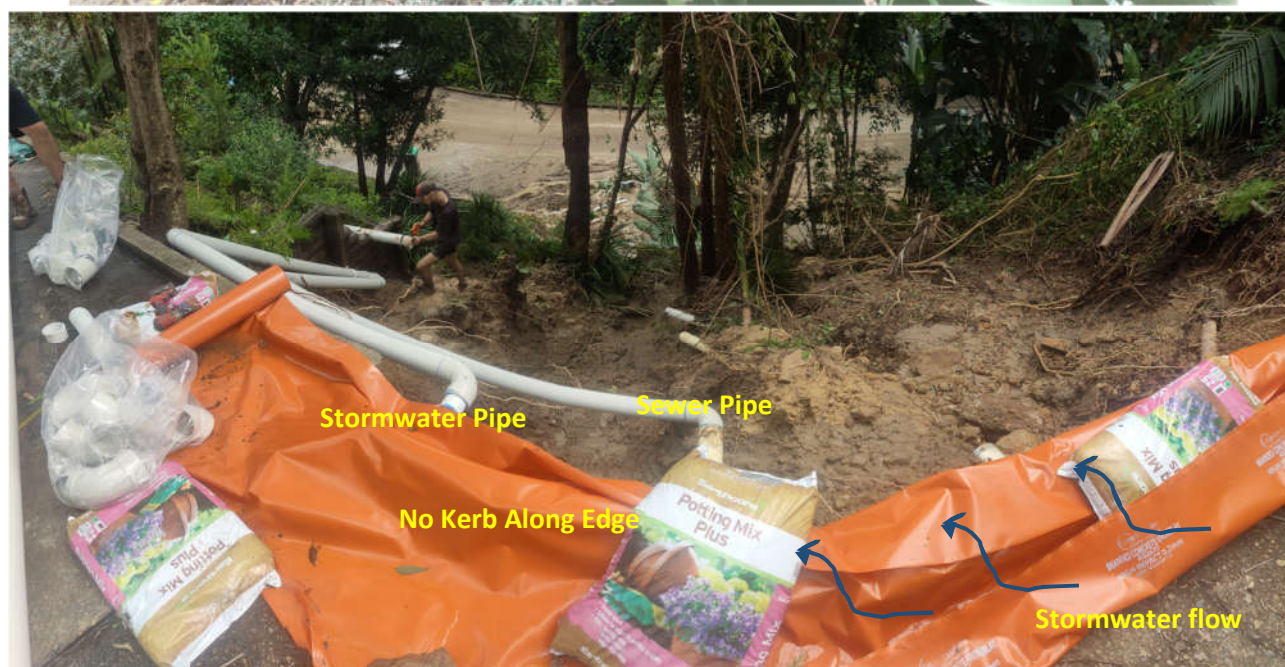
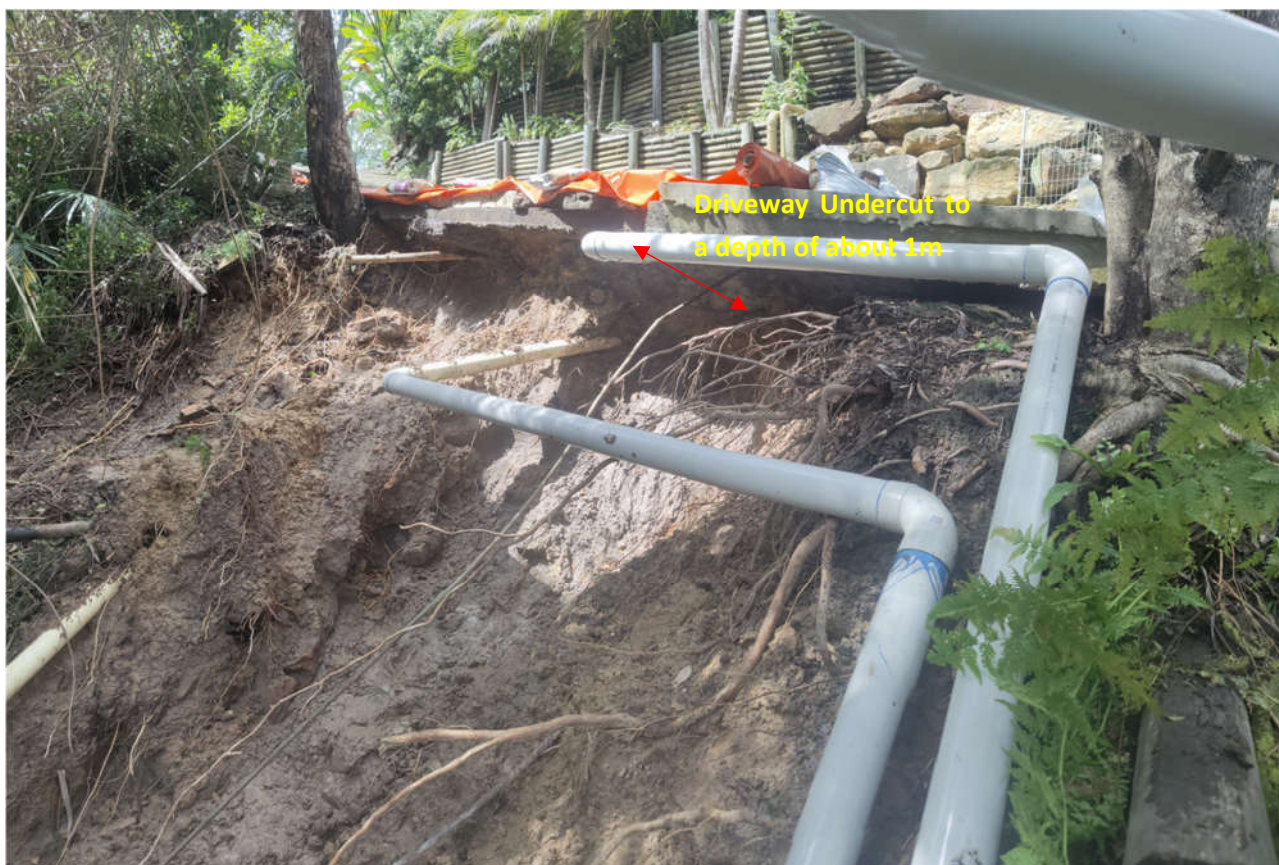
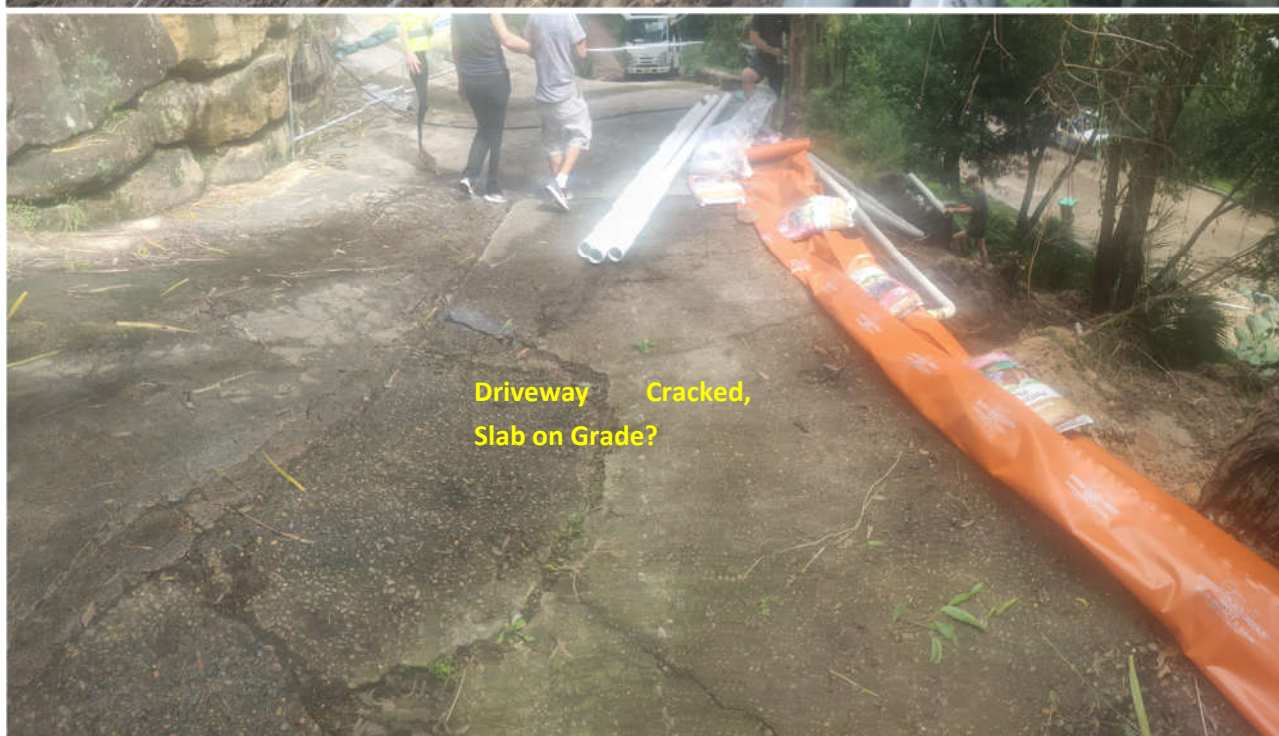
Plate 2: Southern Landslide

Below is a brief description observed at the southern landslide as shown on Plate 3:

- The landslide had a width of about 6m and a total length of about 14m to 16m, which extends from the backscarp to the foot or zone of accumulation of the slide.

- The concrete driveway appears to be in poor condition, showing signs of distress in the form of cracking. It also appears that the driveway is not suspended but has been constructed as a slab on grade, although this should be confirmed by a structural engineer. The backscarp of the landslide has undercut the slab to a depth of about 1m. There was no kerb on the edge of the driveway and it appears stormwater flows from the driveway directly onto the embankment, as shown on Plate 3.

- At its narrowest the driveway has a width of about 4.6m.
- The materials exposed at the surface appeared to be a mixture of clay and cobbles.
- Stormwater and sewer PVC pipes were broken prior to or during the landslide and water was flowing from the services on our arrival on site. These services were repaired whilst we were on site as shown on Plate 3.
