Address of site 104 Cabarita Road, Avalon

Report Title: Geotechnical Report 104 Cabarita Road, Avalon

GEOTECHNICAL INVESTIGATION: **New Jetty at 104 Cabarita Road, Avalon**

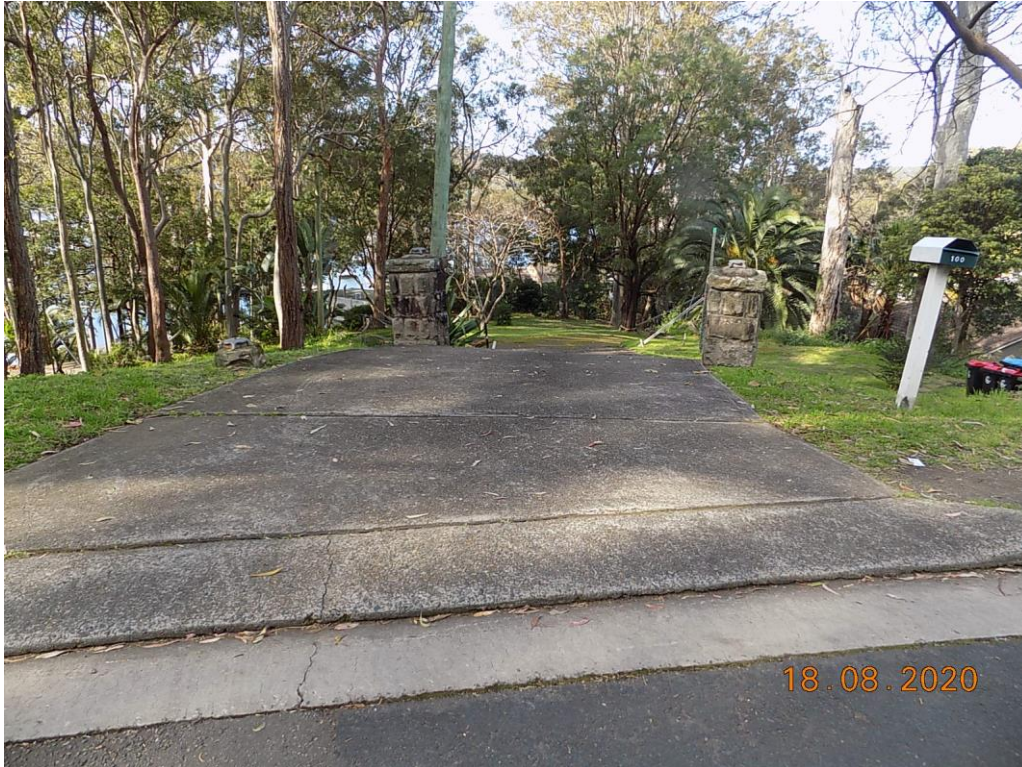
Photo 1

- 2.3** The property is accessed by a concrete Right of Carriageway (ROW) off Cabarita Road (Photo 1). A concrete driveway diverts off the ROW and runs to a carport under the house and to a parking area on the uphill side of the house (Photos 2 & 3). The fill for the parking area is supported by a stable rendered masonry retaining wall reaching ~2.0m high (Photo 4). The old part two-storey house is supported on steel posts (Photo 5). Some of the supporting posts have rusted and tilted but have been remediated with additional supports (Photo 6). The area surrounding the house is lawn and garden-covered. These gardens slope steeply to the waterfront below the house (Photo 7). Three buildings have been constructed at the W end of the waterfront (Photo 8). An excavation has been made in the slope to create a level platform for the upper level of the larger building. The cut is supported by a stable sandstone block retaining wall ~1.1m (Photo 9). The larger building is a two-storey

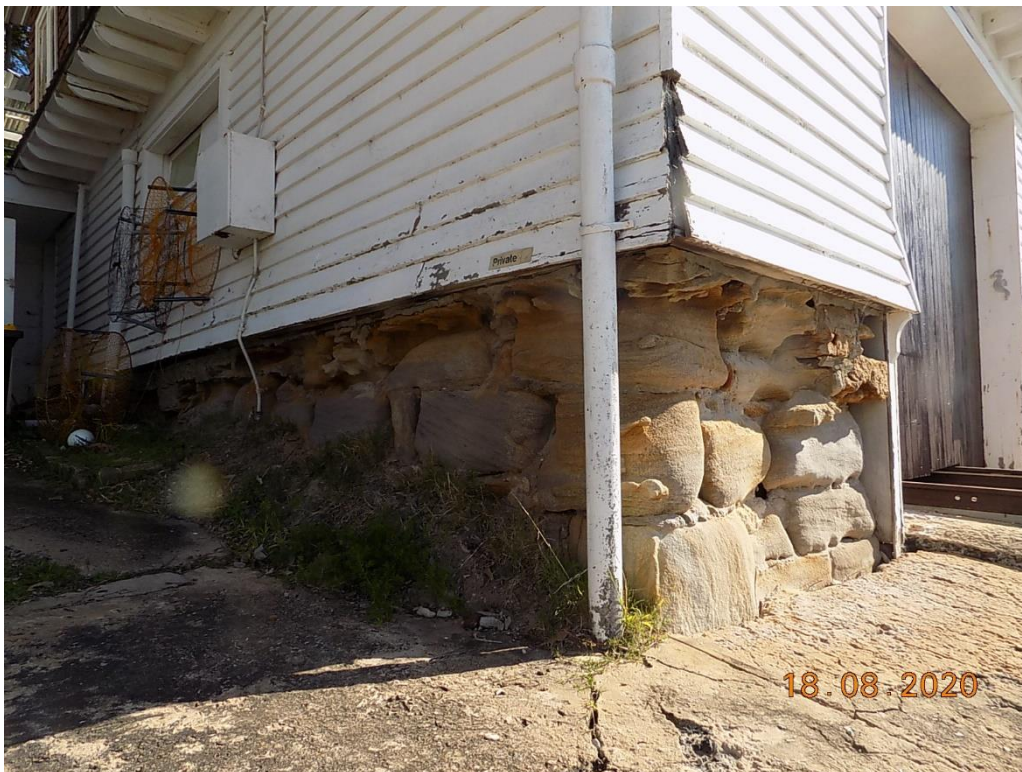
Photo 10

boathouse supported on sandstone block foundations. The sandstone block foundation walls have weathered to a point where deterioration is occurring rapidly and this process is undercutting the walls above (Photo 10). One portion of a small brick building upslope and to the E of this building displays significant settlement downslope (Photo 11). We recommend these buildings be assessed by a structural engineer to determine the details of the required remedial works. Until this inspection is carried out, we recommend no one spend time in these structures. Another stable sandstone block boathouse has been constructed at the E end of the waterfront (Photo 12). Between the boathouses is a near-level lawn (Photo 13). The cut for the lawn and E boathouse is supported by a stable ~1.8m high sandstone block retaining wall (Photo 14). The fill for the lawn is supported by a ~1.6m high sandstone block seawall (Photo 15). The seawall was observed to be supported directly onto Low to Medium Strength Shale at the waterfront. Some of the sandstone block components of the seawall were also observed to be weathered (Photo 16). We recommend the more weathered components be replaced.

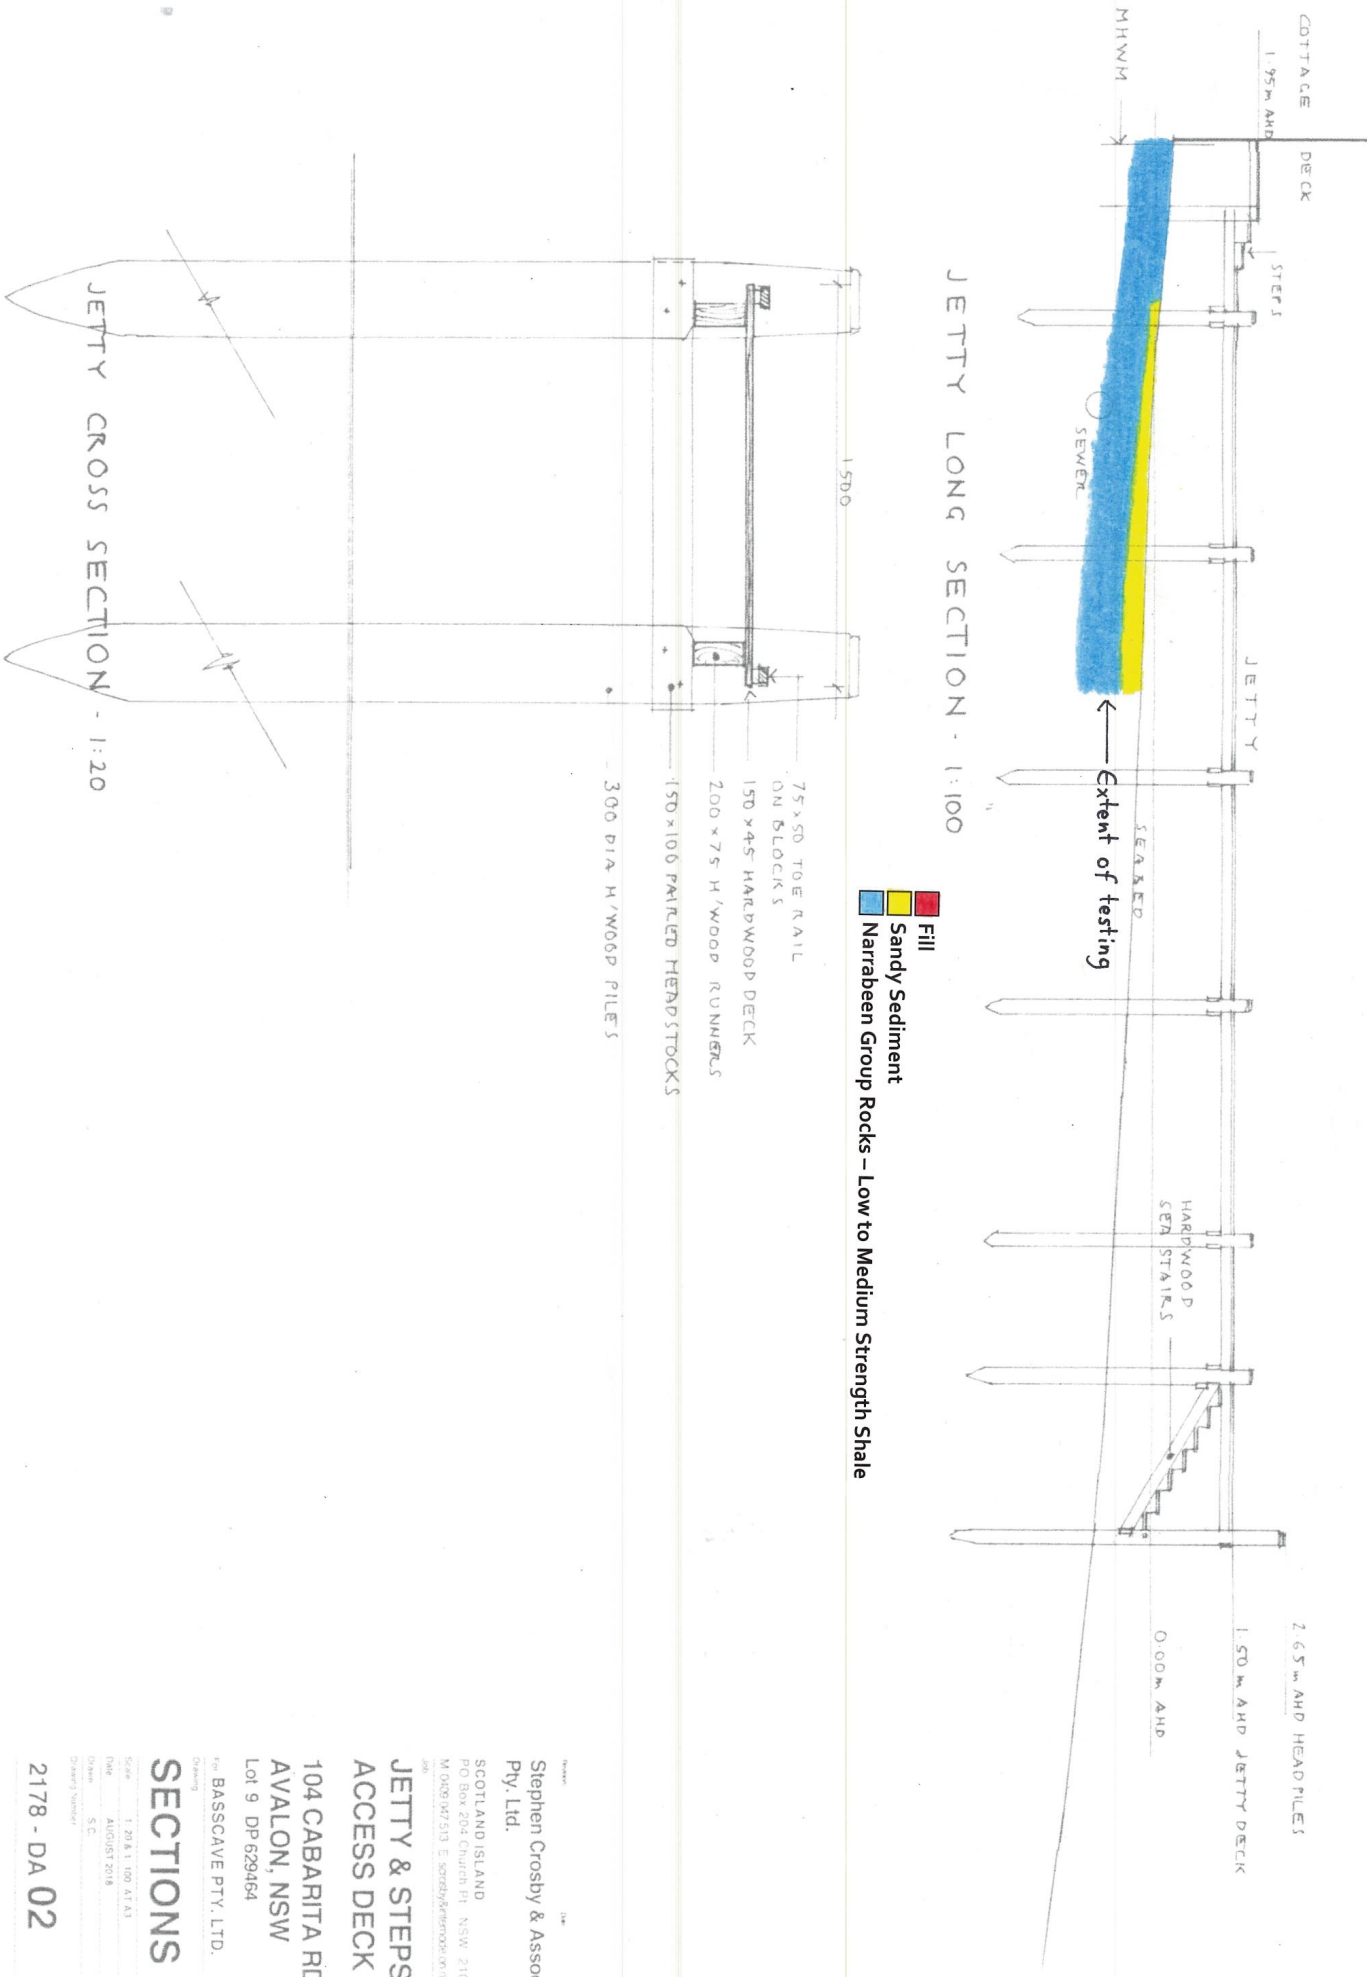
TYPE SECTION – Diagrammatical Interpretation of expected Ground Materials

The site is underlain by a typical shale profile with clays to a maximum depth of ~0.4m before encountering Low to Medium Strength Shale. In the location of the proposed works, most of the foundations will be located below the mean water mark and were located below the water body of Pittwater at the time of the inspection. Here the shale profile is overlain by sediments of an unknown depth.

Testing in DCPs 1 & 2 indicate that near shore the sediment is at least 0.4m deep and is expected to get deeper further from the shore.

Estimating the depth of the sediment below the waterline is beyond the scope of this report. However, testing done in the water ~6m out from the shore indicates the sediment is at a maximum depth of 0.4m. We expect the sediment to get progressively deeper with an increased distance from shore. Within ~6m of the shore, Low to Medium Strength Shale was encountered at the surface or at shallow depths. The piles for the proposed jetty may be supported on concrete pads embedded in this material. Beyond ~6m, it is envisaged the jetty will be supported on driven piles, subject to sediment depth, as is typical of jetties in Pittwater.
