## **3 Bakers Road, Church Point**

### Geotechnical Comments for Section 4.55.

## **GEOTECHNICAL INVESTIGATION:**

### **Alterations and Additions at 3 Bakers Road, Church Point**

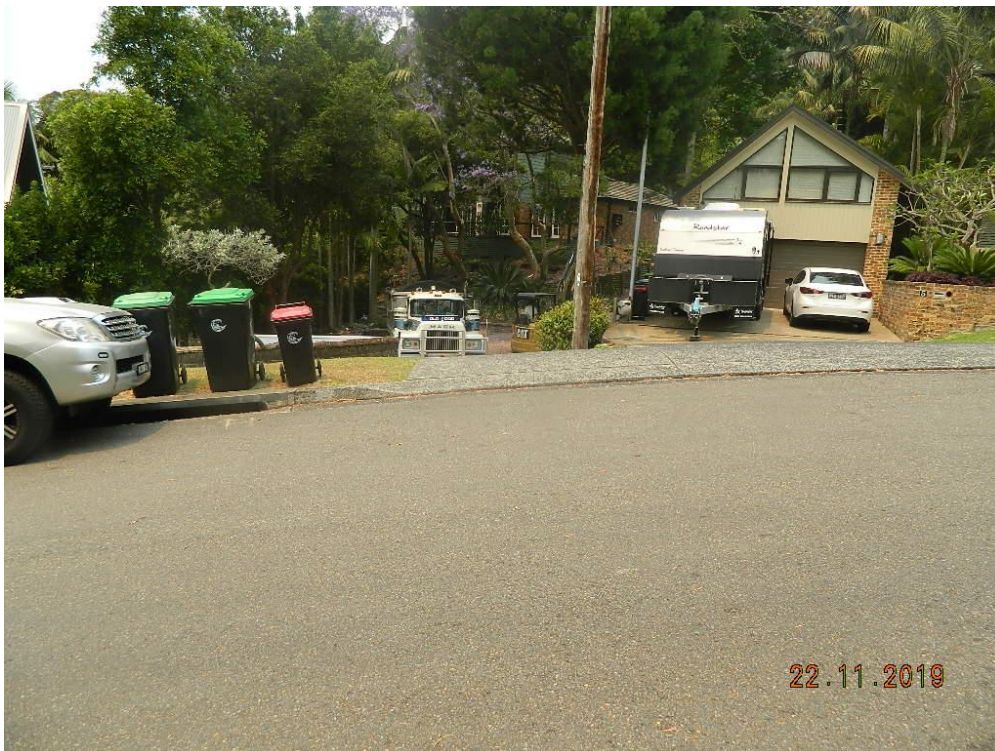
Photo 1

- 2.3** From the road frontage a concrete driveway runs down the slope to a level paved area (Photo 1). A low brick retaining walls lines the toe of the hillslope that rises to the house (Photo 2). A treated timber retaining wall in good condition terraces the hillslope and the cut batter for the driveway (Photos 3 & 4). The treated timber retaining wall extends from the level area up to the other side of the slope beside the house and extending to a paved parking area on the uphill side of the house. The retaining walls appear to be in good condition and show no significant signs of movement. The brick and timber clad house is supported on brick walls

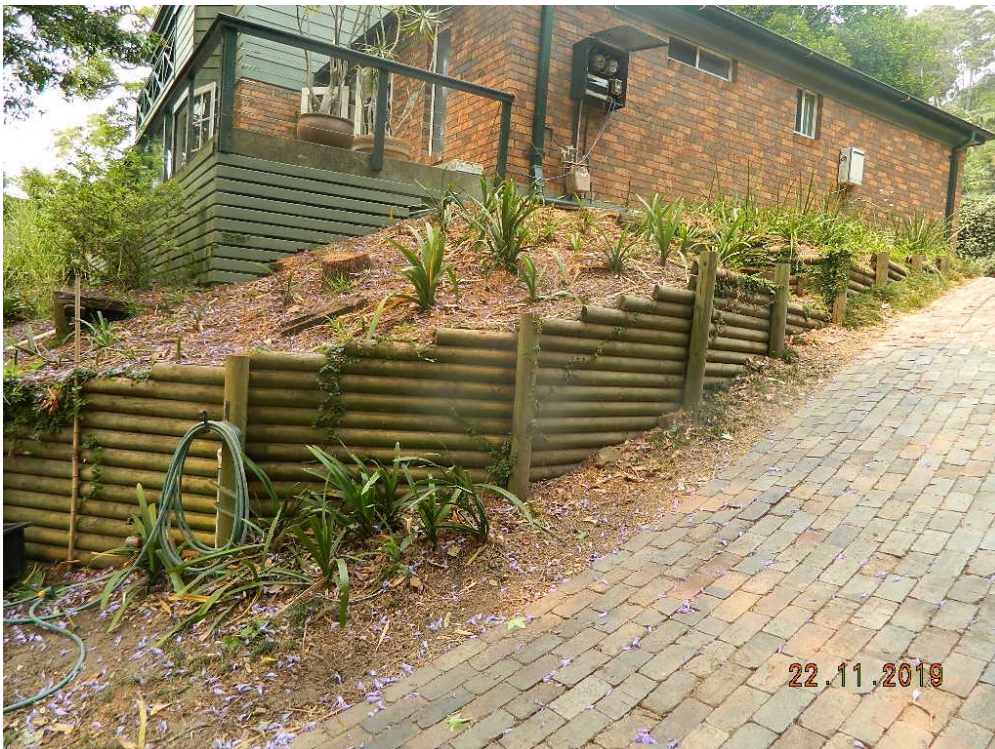
Photo 4

(Photos 5 & 6). The external brick supporting walls show no significant signs of movement. A suspended concrete deck extends off the downhill side of the house and shows no significant signs of movement (Photos 4, 7 & 8).

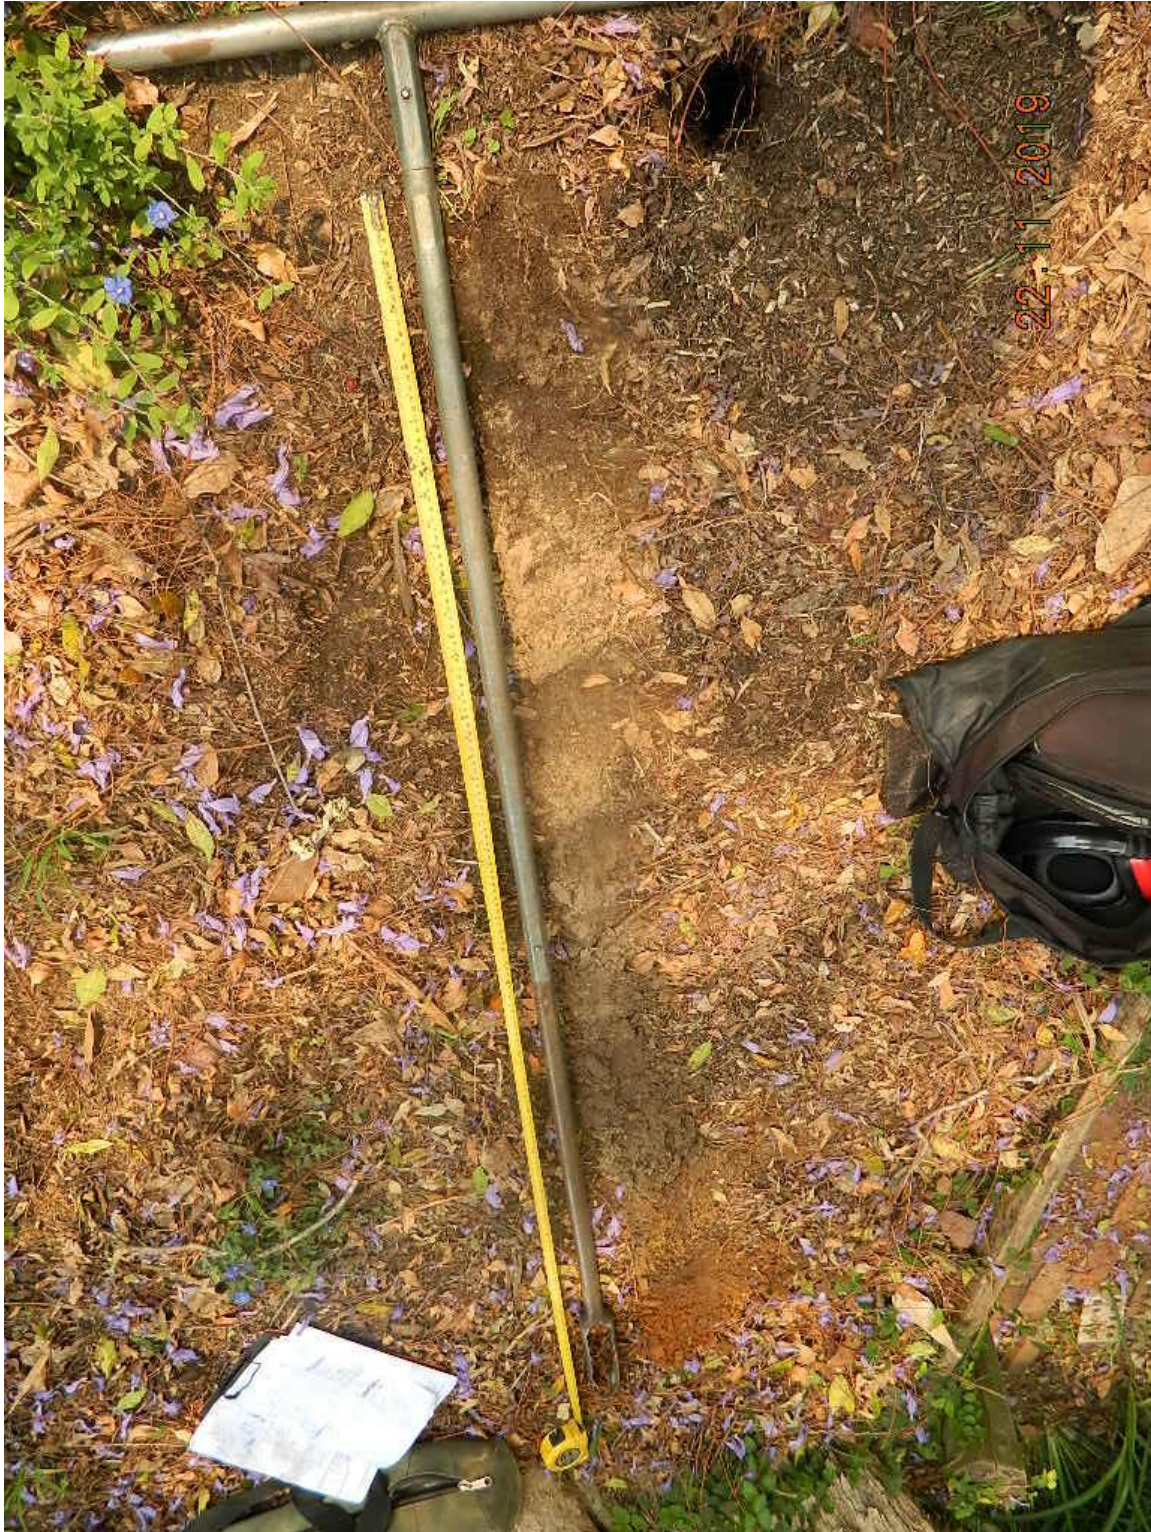
#### AUGER HOLE 1 (~RL9.2) – AH1 (photo 9)

Depth (m)	Material Encountered
0.0 to 0.3	<b>SANDY SOIL</b> , brown, fine grained.
0.3 to 0.9	<b>SAND</b> , grey brown, fine grained.
0.9 to 1.5	<b>SAND</b> , grey brown, medium grained.
1.5 to 1.8	<b>SANDY CLAY</b> , orange brown, firm, moist.

End of hole @ 1.8m in firm sandy clay. No watertable encountered.

Photo 9: AH1 – Downhole is from top to bottom

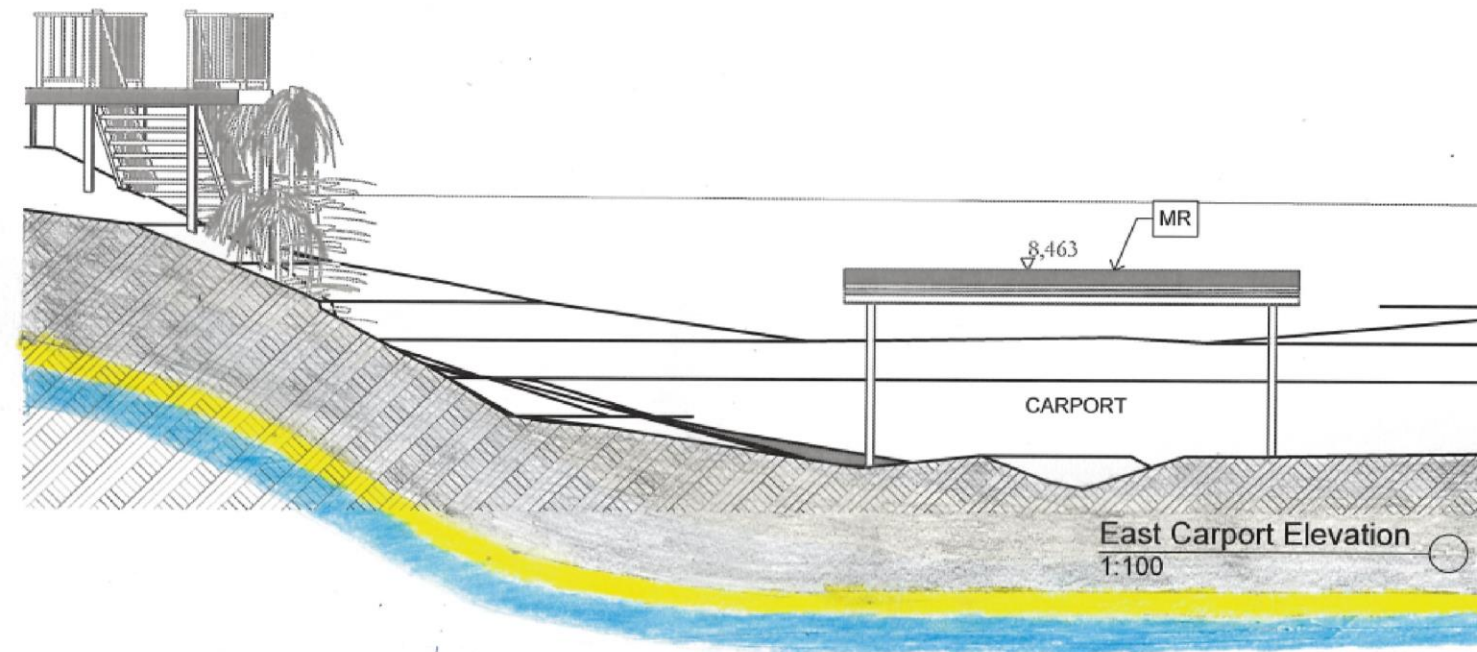
TYPE SECTION – Diagrammatic Interpretation of expected Ground Materials

The slope materials are colluvial at the near surface and residual at depth. In the test locations, the ground materials consist of very loose to loose sands over sandy clays. Loose sand is expected to transition to sandy clay at a maximum depth of ~1.8m below the current surface. The clays merge into the weathered zone of the underlying rock at a maximum depth of ~2.1m below the current surface. DCP4 likely refused on an obstruction in the profile. The weathered zone is interpreted as Extremely Low Strength Shale. It is to be noted that this

material can appear as a mottled stiff clay when it is cut up by excavation equipment. See Type Section attached for a diagrammatical representation of the expected ground materials.

- Sand – Very Loose to Loose
- Sandy Clay – Firm to Stiff
- Narrabeen Group Rocks – Extremely Low Strength Shale - after being cut by excavation equipment can resemble a stiff to hard clay.
