Report Title: Geotechnical Report 39 Attunga Road, Newport
Report Date: 5/3/21

GEOTECHNICAL INVESTIGATION:

New House and Pool at **39 Attunga Road, Newport**

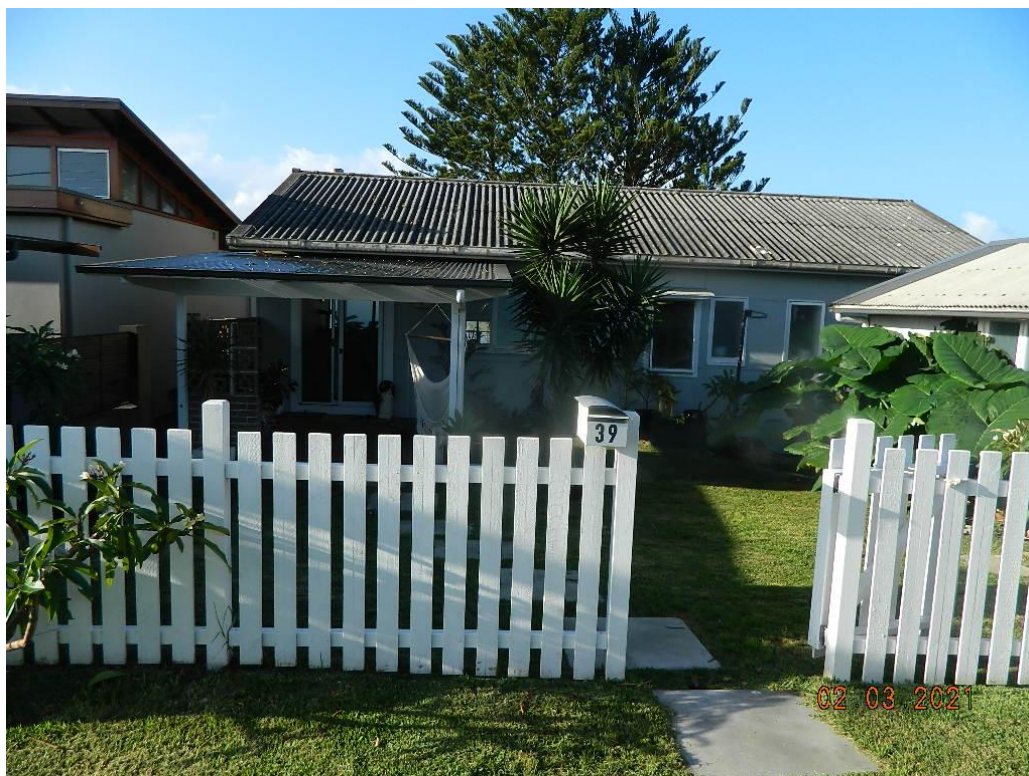
Photo 1

- 2.3** Between the road frontage and the house is a fibro garage and near level lawn (Photo 1). Fill levels the lawn area. The part two storey brick and fibro house is supported by brick walls and brick piers (Photos 1 & 2). The supporting walls and piers stand vertical and show no significant signs of movement (Photo 3). A brick

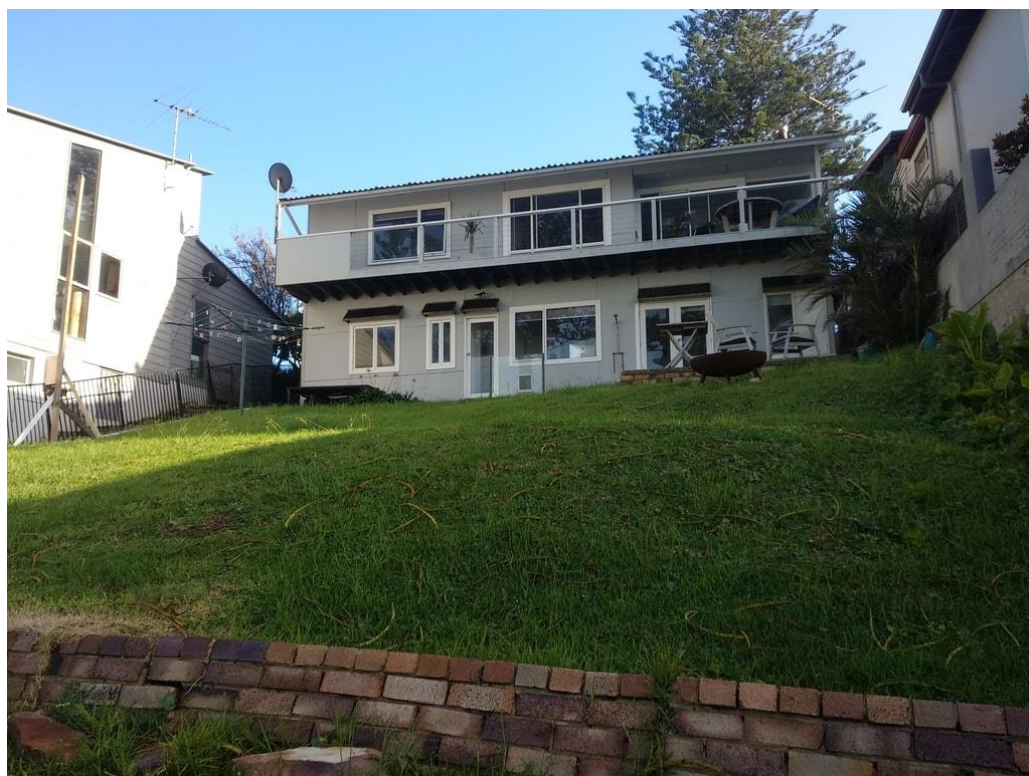
Photo 2

wall/retaining wall ~1.8m high supports a low cut in the foundation space and the fill for the lawn on the uphill side of the house (Photo 3). A moderately sloping lawn extends off the downhill side of the house (Photos 2 & 4). Fill supported by a low brick retaining wall has been placed on the upper area of the slope (Photo 2). A brick retaining wall up to ~2.0m high along the E common boundary supports fill on the E neighbouring property (Photo 5). The wall displays cracks up to ~30mm wide and has separated the brickwork up to ~60mm from vertical downslope (Photos 6 & 7). See 'Section 16 Ongoing Maintenance'. Apart from the cracked retaining wall supporting fill, no signs of slope instability were observed on the property.

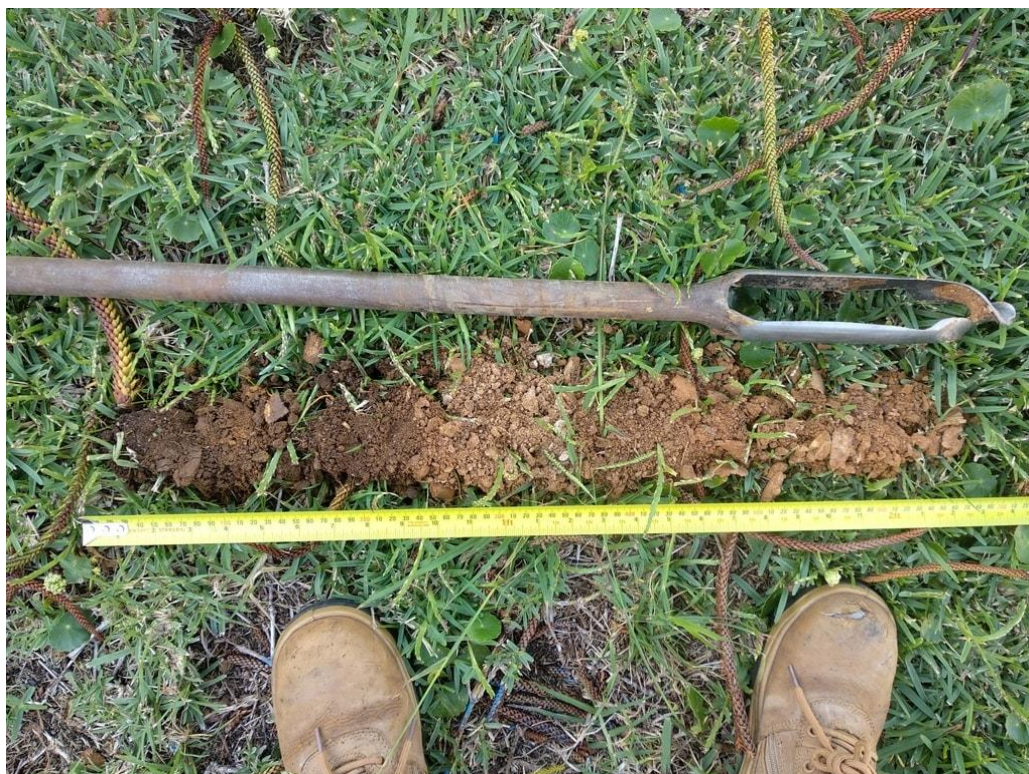
AUGER HOLE 1 (~RL50.5) – AH1 (photo 8)

Depth (m)	Material Encountered
0 to 0.5	FILL , topsoil, dark and light brown, dry, fine to medium grained with fine trace organic matter.
0.5 to 0.7	SILTY CLAY , orange brown, firm to stiff, dry.

End of Hole @ 0.7m in firm to stiff silty clay. No watertable encountered.

Photo 8: AH1 – Downhole is from left to right.

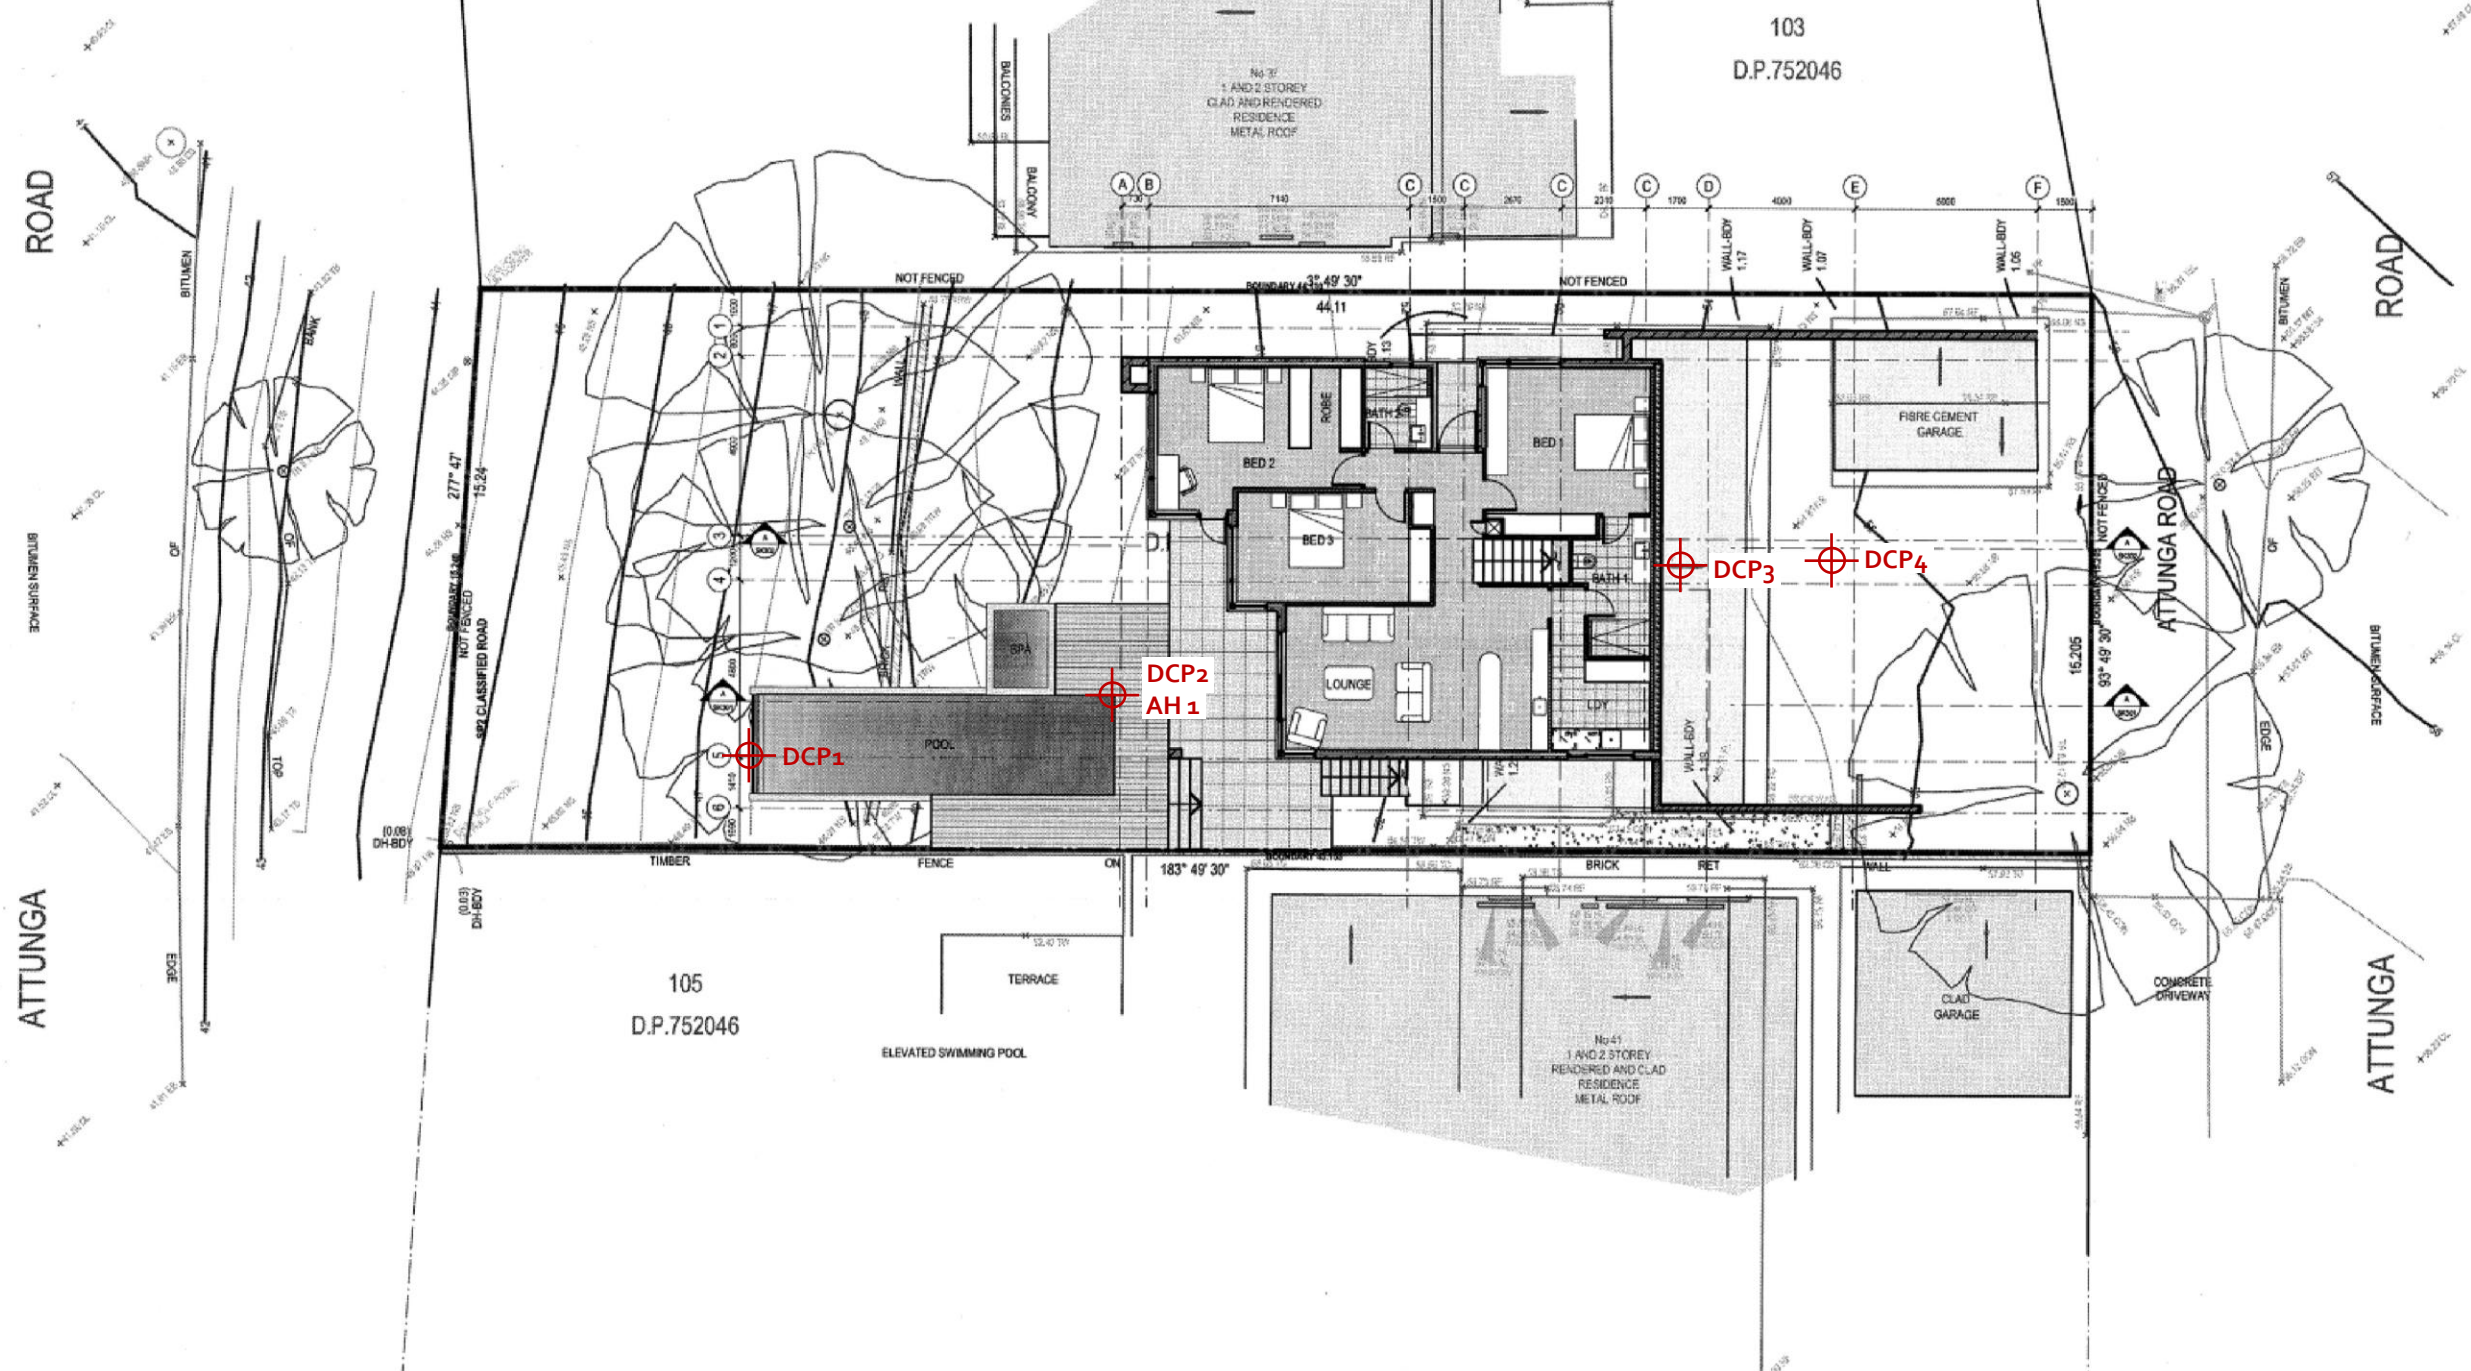
SITE PLAN – showing test locations

One Auger hole was put down to identify the soil materials. Four Dynamic Cone Penetrometer (DCP) tests were put down to determine the relative density of the overlying soil and the depth to weathered rock. The locations of the tests are shown on the site plan. It should be noted that a level of caution should be applied when interpreting DCP test results. The test will not pass through hard buried objects so in some instances it can be difficult to determine whether refusal has occurred on an obstruction in the profile or on the natural rock surface. This may have occurred for DCP3. Due to the possibility that the actual ground conditions vary from our interpretation there should be allowances in the excavation and foundation budget to account for this. We refer to the appended "Important Information about Your Report" to further clarify. The results are as follows:

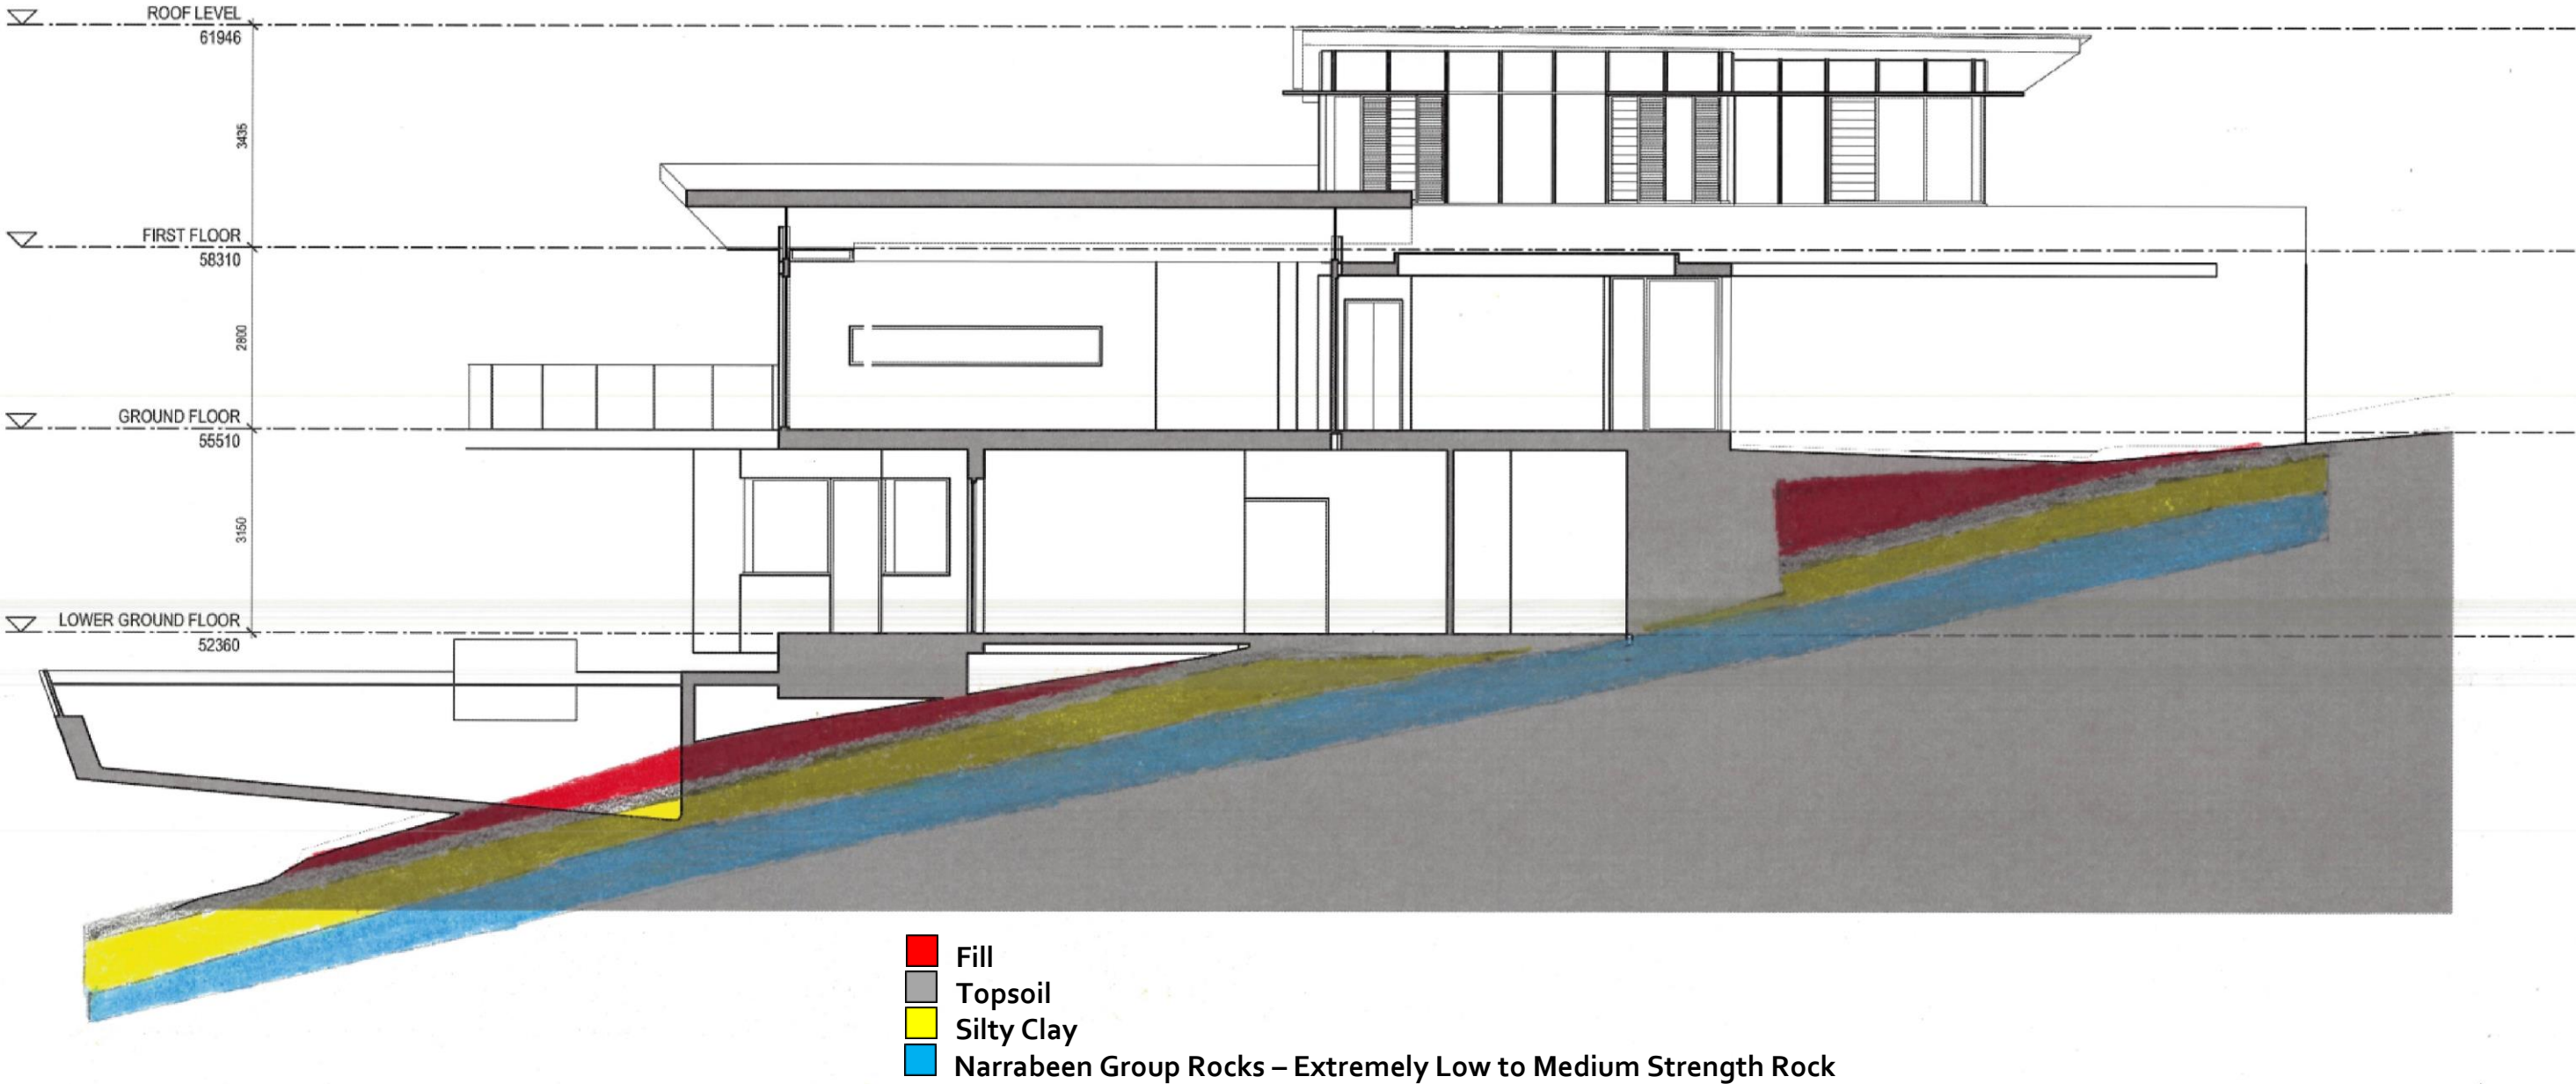
TYPE SECTION – Diagrammatical Interpretation of expected Ground Materials

The slope materials are colluvial at the near surface and residual at depth. In the test locations, the ground materials consist of fill and a thin sandy topsoil over firm to stiff silty clays. Fill provides a level lawn area on the uphill side of the house has been placed on the slope below the house. The clays merge into the weathered zone of the under lying rocks at depths of between ~0.2m to ~1.5m below the current surface, being shallower at the location of an existing cut (DCP3). The weathered zone of the underlying rock is interpreted as Extremely Low to Medium Strength Rock. See Type Section attached for a diagrammatical representation of the expected ground materials.
