Development Application for _____	Name of Applicant _____
Address of site 2a Allen Avenue, Bilgola Beach, NSW

REPORT ON GEOTECHNICAL SITE INVESTIGATION

The site is located within the H1 (highest category) landslip hazard zone as identified within Northern Beaches (Pittwater) Councils Geotechnical Risk Management Map (Map Sheet GTH_016). The site is also designated as Acid Sulfate Soils hazard Class 5 (Map-Sheet ASS_016).

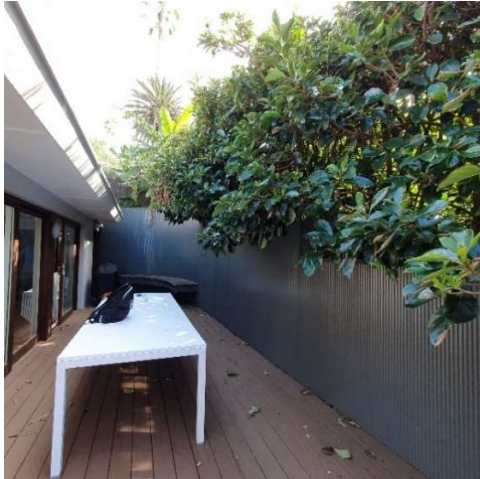
continue to the north-west corner of the site, although this is unconfirmed as the wall is covered by a metal sheet wall (Photograph-6). The retaining wall along the north boundary comprises rendered brick ($\leq 250\text{mm}$ wide, Photograph-7) and is up to $\leq 3.0\text{m}$ high adjacent to the tennis court and up to approximately 5.0m high at the north-west corner of the block.

Photograph-6: Retaining wall covered by metal sheet. View looking north-west.

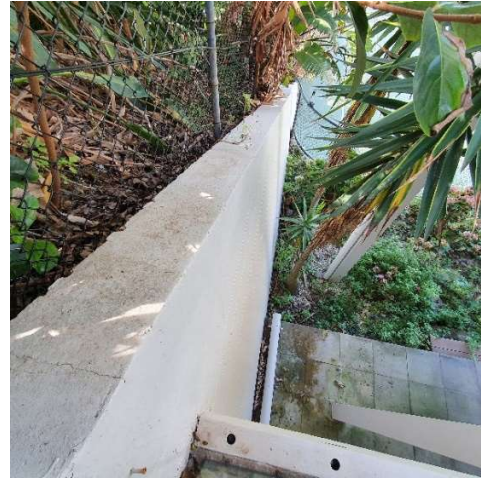
Photograph-7: Brick retaining wall along the north boundary. View looking down east.

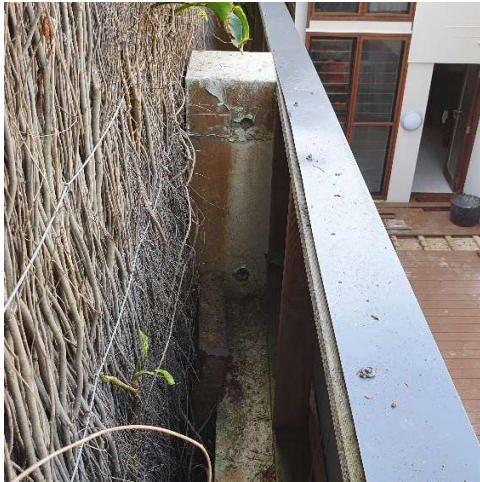
The site-dwelling is detached from the western boundary (approximately $\leq 1.0\text{m}$ to $\leq 4.0\text{m}$). Along the western boundary is an approximately 4.0m to 5.0m high retaining wall. The southern portion of the wall is rendered (Photograph-4), whilst the northern portion is stone veneer clad. Observations from the top of the wall identified what appears to be a concrete column/pier which is located on top of the wall (Photograph-8 and 9) (approx. $\leq 1.0\text{m}$ high and approximately 2.5m spaced along the western boundary). To the rear of the retaining wall (within south-east corner of No8 The Serpentine) a stormwater drainage pit which may be part of the water easement located along the south boundary of the site and a large tree (approximately $\leq 10\text{m}$ high) are located 1.0m from the retaining wall. The retaining wall contained a semi-vertical crack (up to $\leq 1\text{mm}$ wide and 3.0m long, Photograph-10), however it appeared stable with no signs of rotation, humidity, or underlying geotechnical issues and appeared in good condition.

Photograph-8: Brick retaining wall along the north boundary. View looking down east.

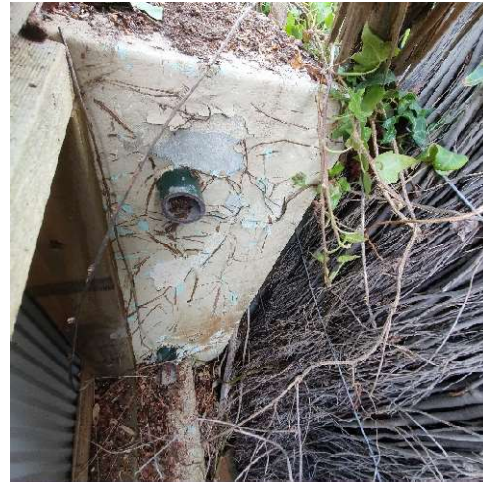
Photograph-9: Closer look to concrete pier. View looking south.

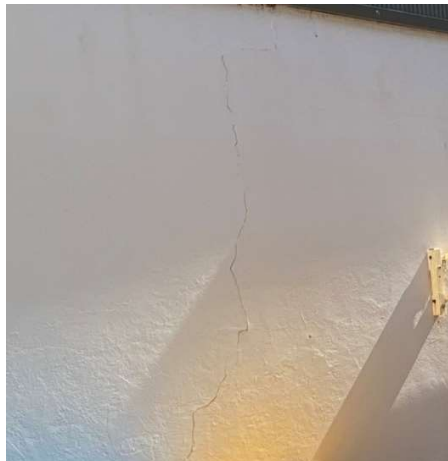
Photograph-10: Cracking within the retaining wall. View looking west.

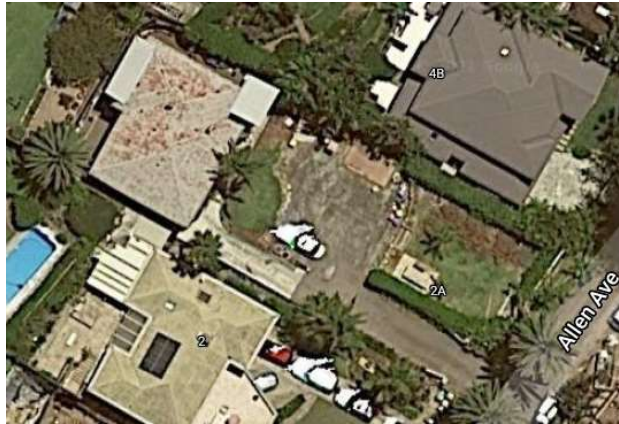
Based on available google maps satellite view it appears that the centre of the site previously contained a concrete surface with a platform adjacent to the north boundary, whilst the eastern side contained a grass lawn (Photograph-11).

Photograph-11: Previous site plan. Extract from available Google Maps satellite view.

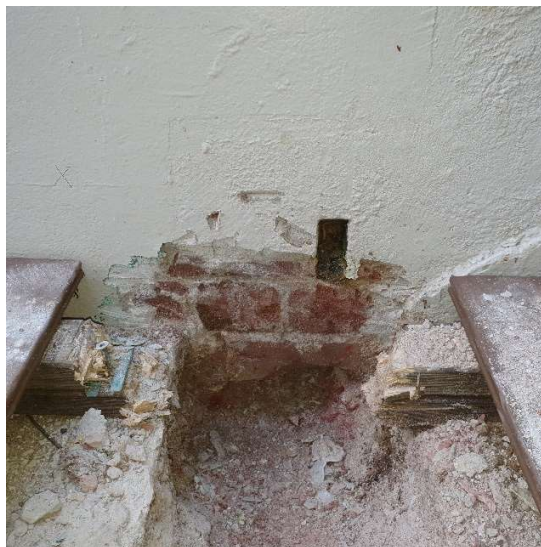
TP1 (Photograph-12) was excavated below the existing retaining wall along the western boundary at the location as specified in Figure 1. TP1 was excavated to approximately 0.30m depth below the deck level and identified that the base of the retaining wall comprised of brick. TP1 is described in Figure 5.

The founding strata below the base of the wall comprised of very stiff clay, becoming hard below 0.50m depth (RL= 8.95m). The base of the retaining wall appeared in good condition, signs of soft soils or water accumulation were not encountered in the test pit.

Photograph-12: TP1 excavation. View looking down west.
