# **REPORT ON GEOTECHNICAL INVESTIGATION**

## **PROPOSED RESIDENTIAL DEVELOPMENT**

**41 & 43 BEACH ROAD COLLAROY**

**PROJECT: TGE21914**

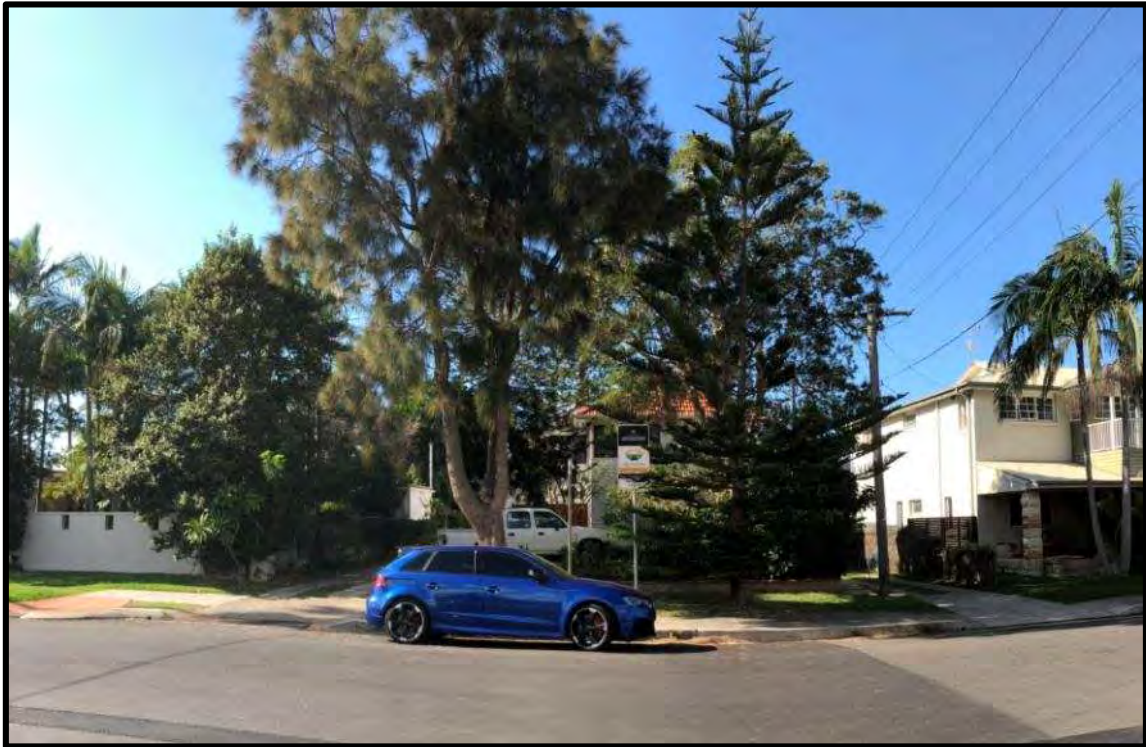
Photo 1 – Site viewed from Beach Road looking east.

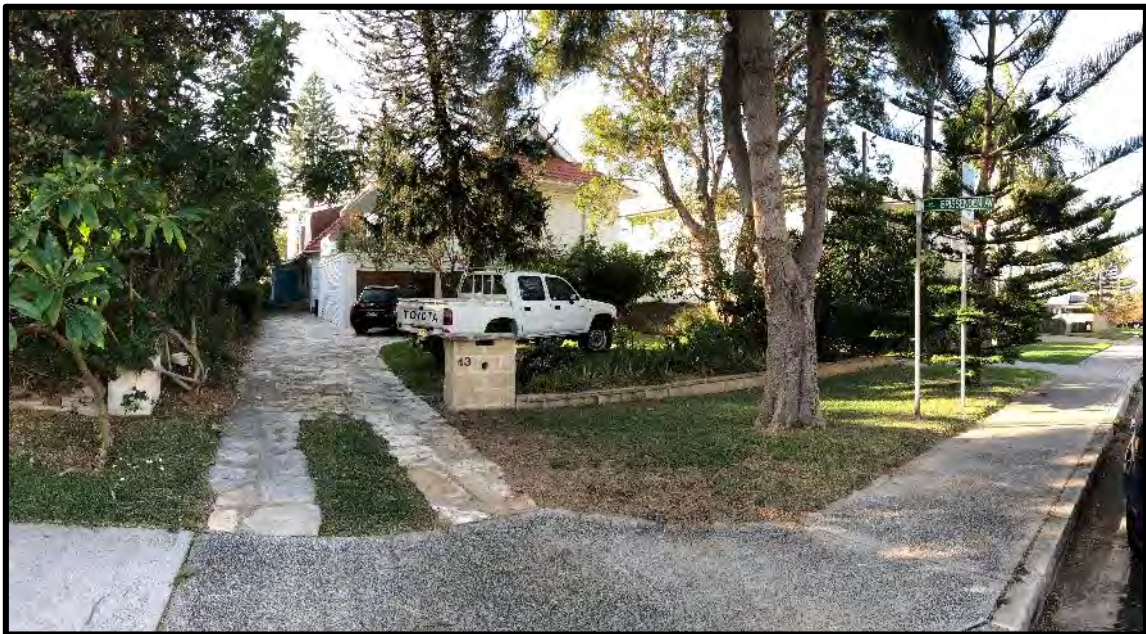
Photo 2 – View of site from north west corner, looking south east showing the front of No. 43.

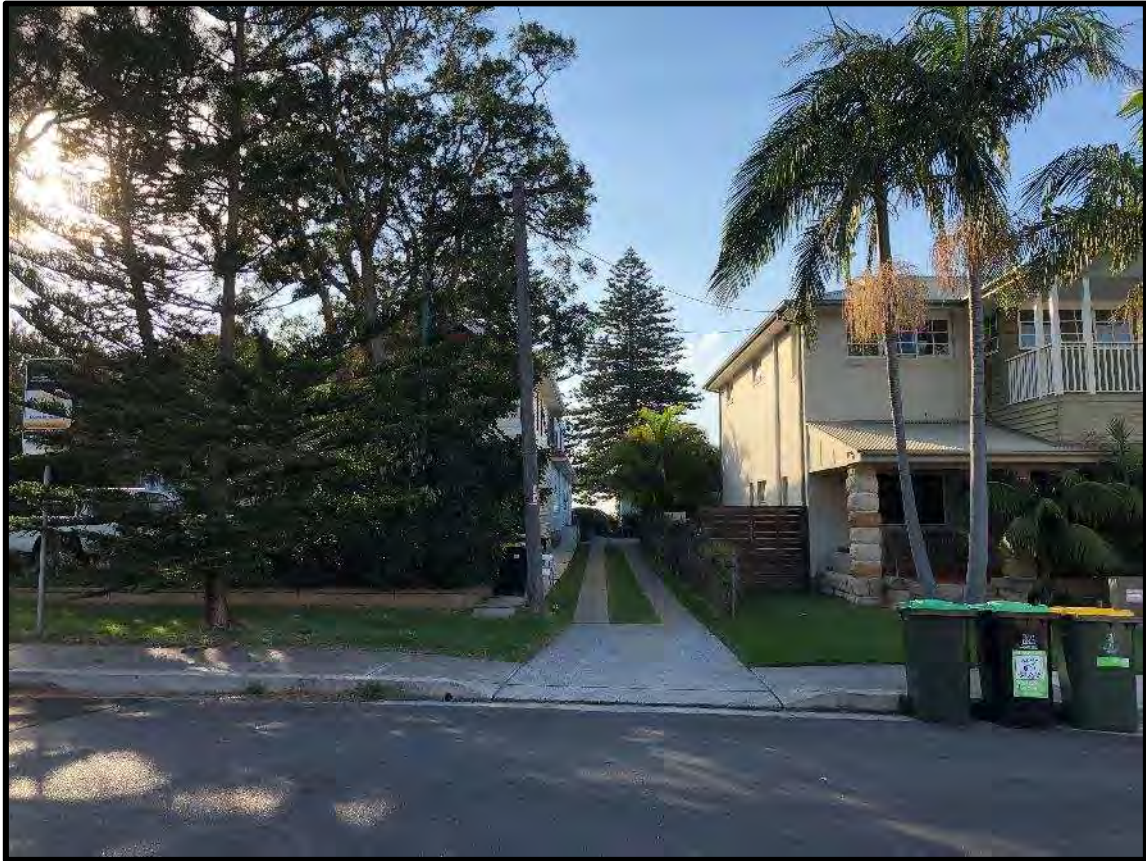
Photo 3 – View of drive accessing No. 41 with No. 43 to left (north).

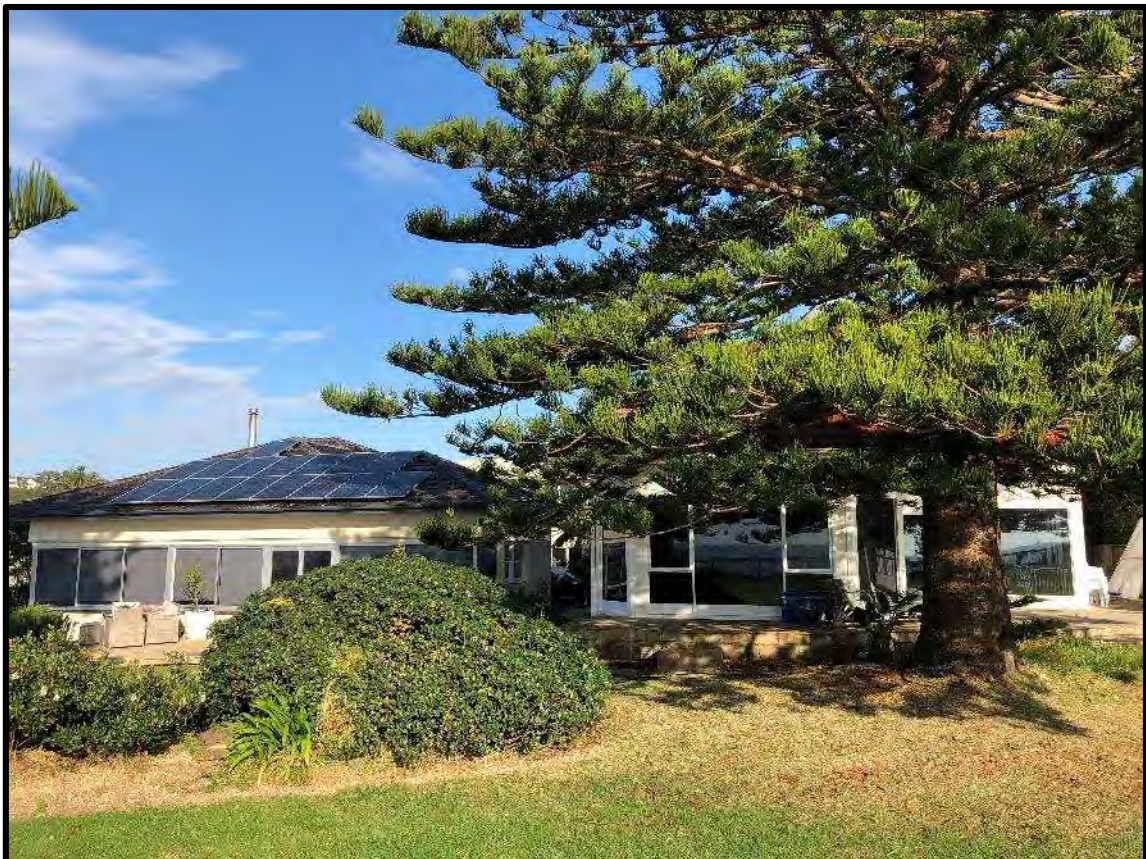
Photo 4 – View of site from beyond eastern boundary, looking west.

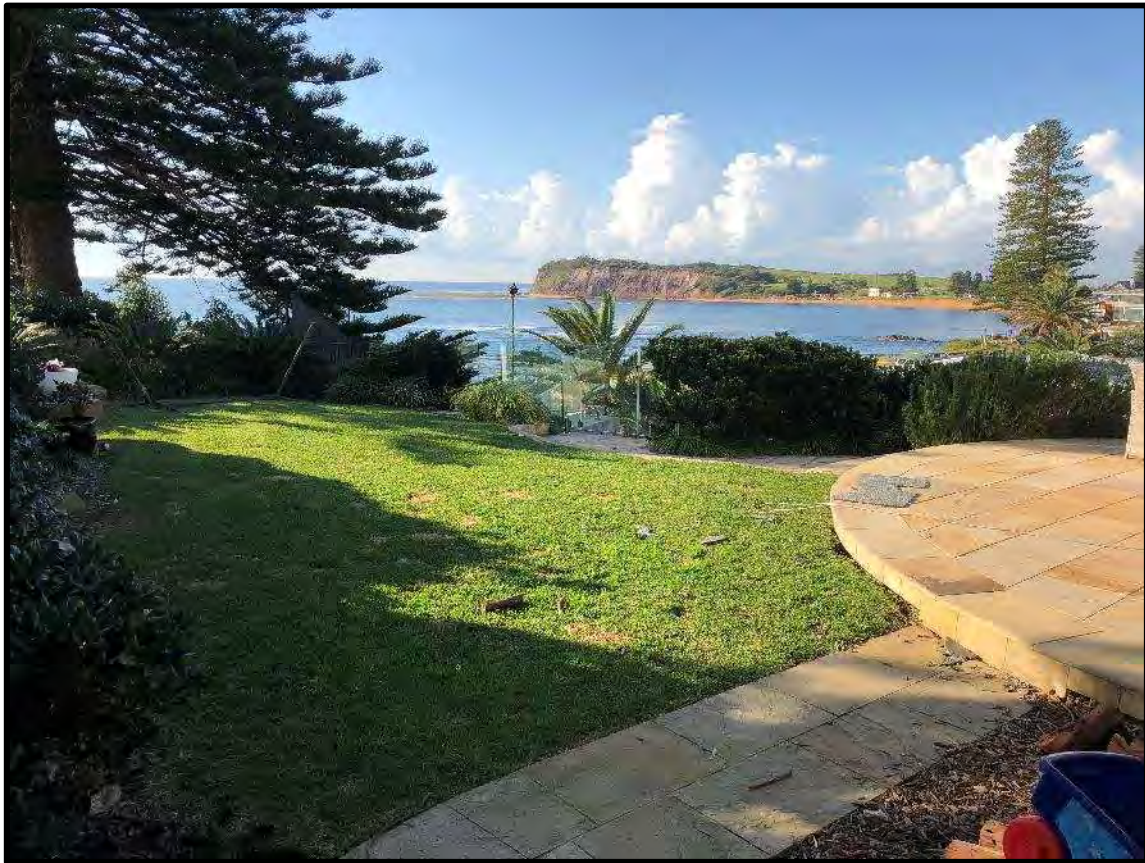
Photo 5 – View of rear section of No. 41, looking south east.

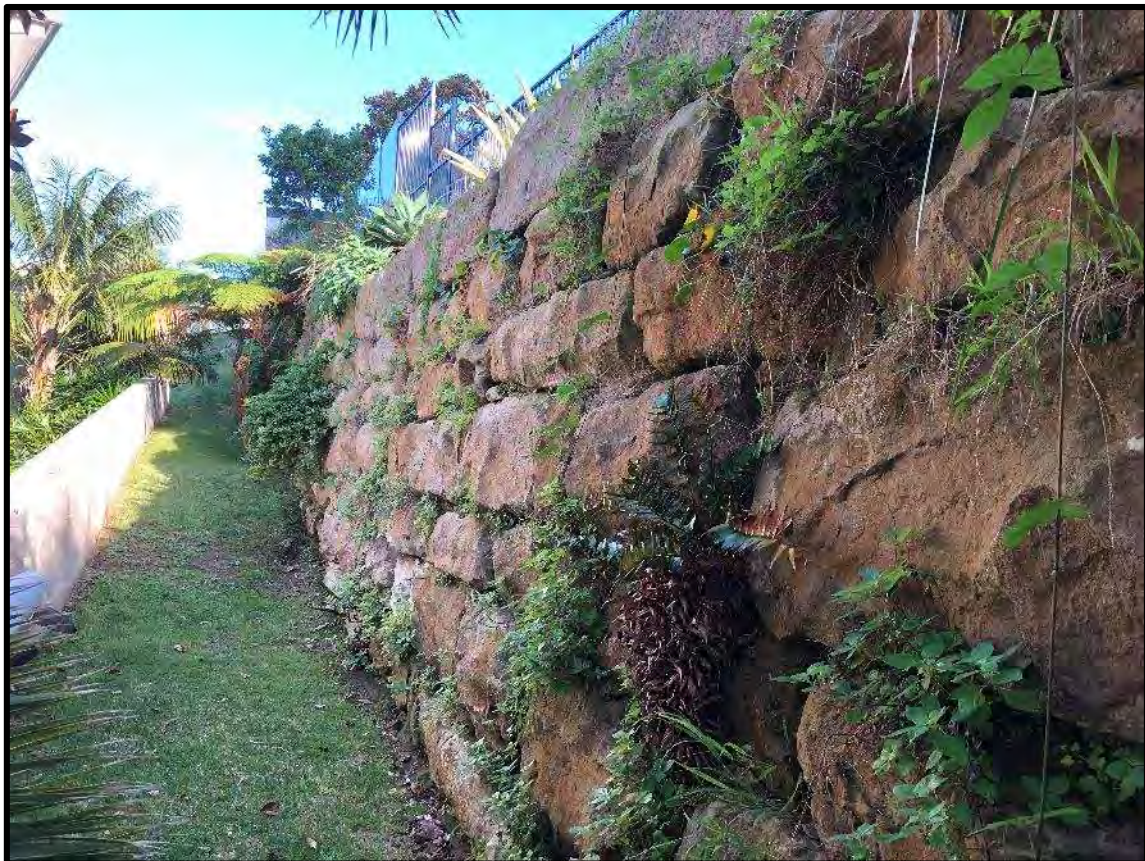
Photo 6 – View along southern boundary of No. 41, looking west.

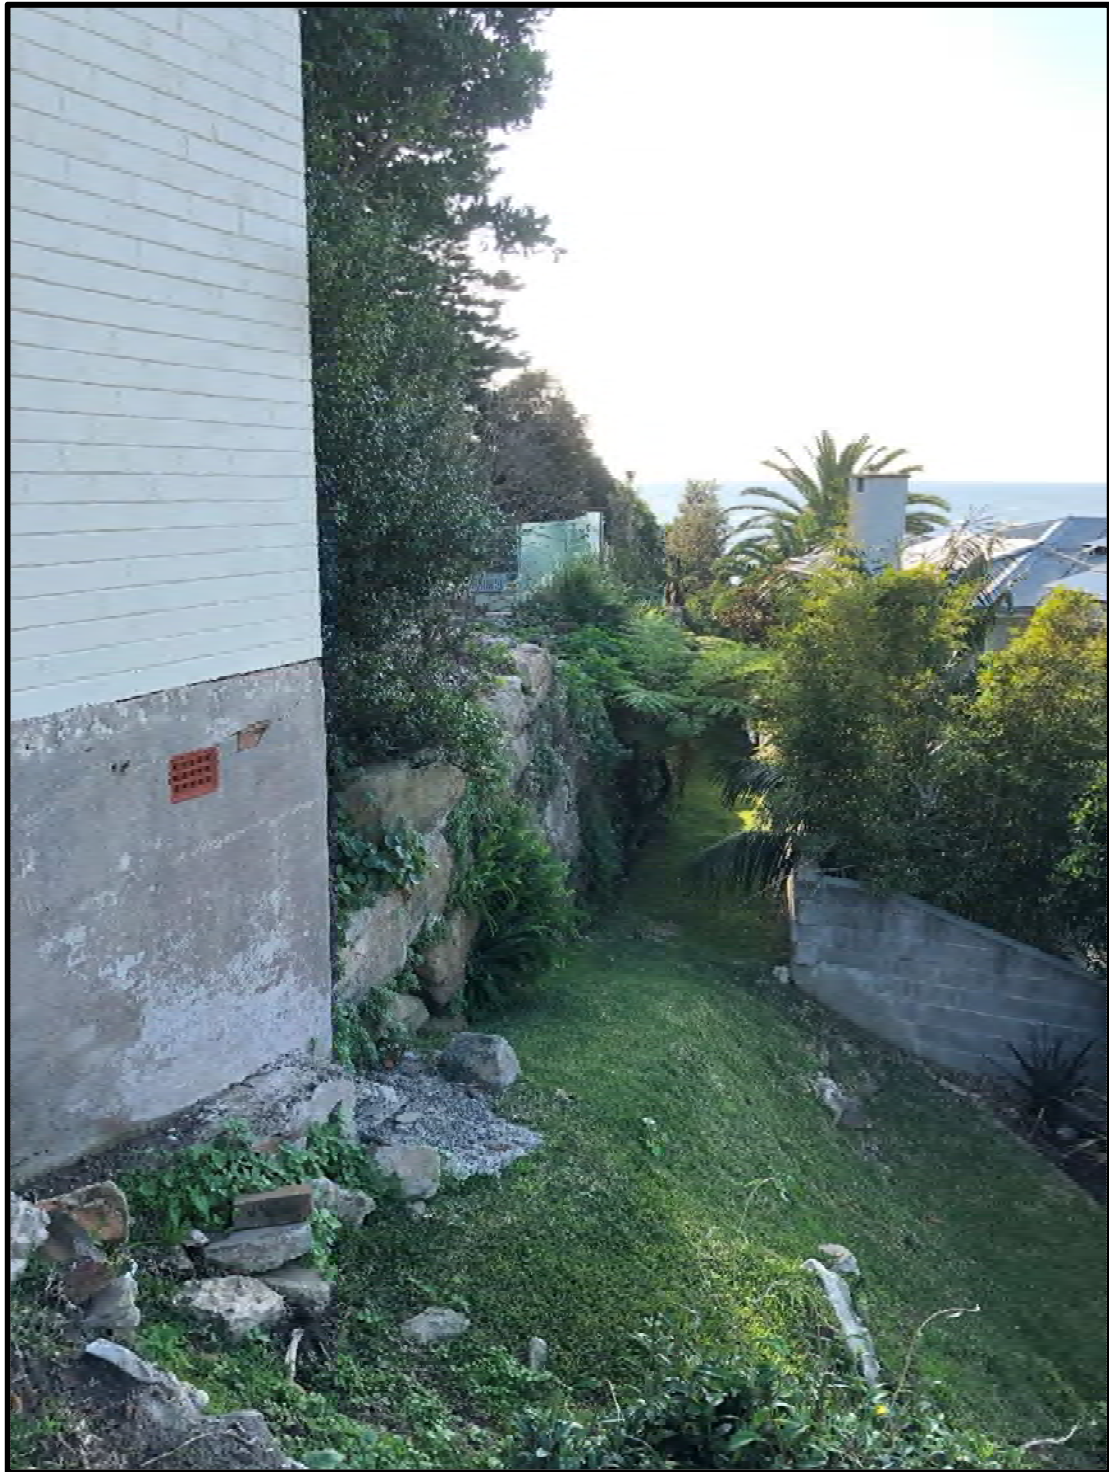
**Photo 7 – View along southern boundary of No 41, looking east.**
