## **Geotechnical Investigation Report**

**Proposed New Residence**

**Lot 04, 10 Fern Creek Road, Warriewood NSW**

**Report No. R22009.04.Rev0**

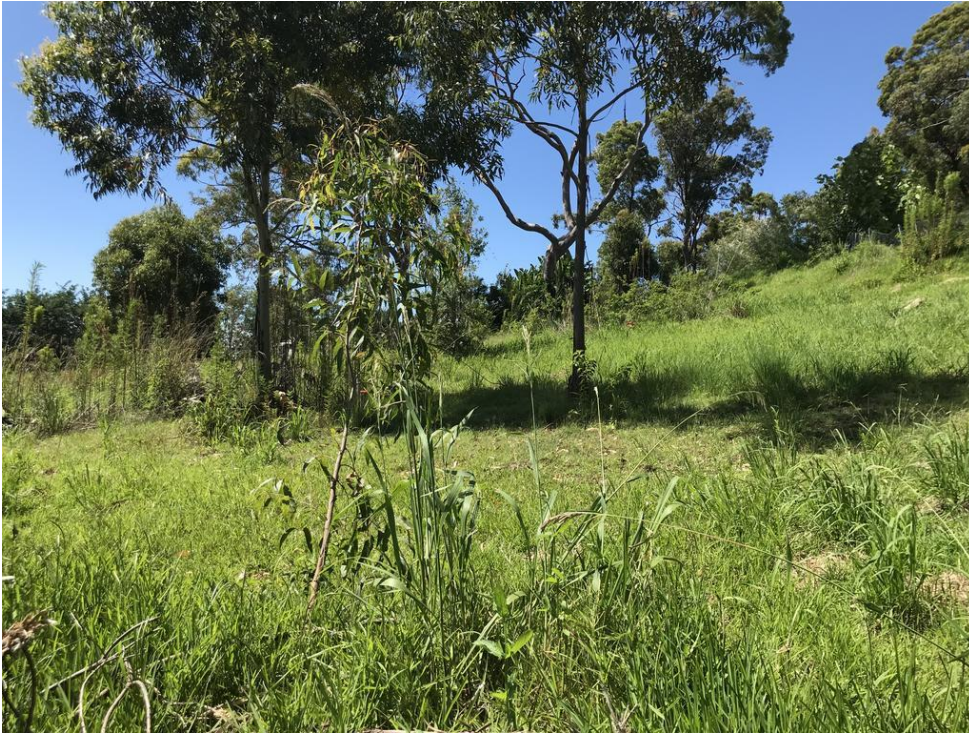
Site vegetation comprised grasses, weeds and scattered native trees. The trees were in upright position. The following site photographs show the general site conditions at the time of field work:

Photograph 1 – General site conditions, looking south
