Geotechnical Assessment

Project: New Dwelling
63 Gondola Road, North Narrabeen NSW

REF: AG 19241
16 October 2020

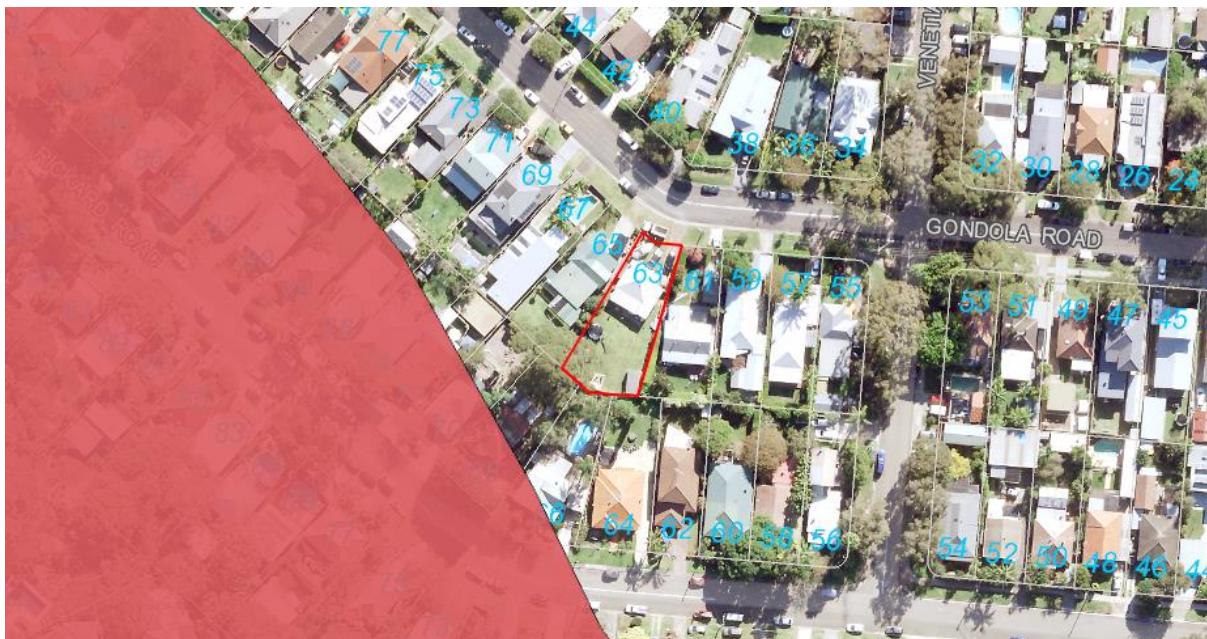
Image 2. 63 Gondola Road, North Narrabeen NSW
– **Geotechnical Hazard Map**– Red polygon (PLEP 2014)

- No evidence of significant soil creep, tension cracks or other indicators of slope instability were identified at the time of our inspection.
- The existing structure displayed no evidence of significant cracking or settlement that could be attributed to slope instability.
- The property is not mapped as a Geotechnical Hazard Zone in Northern Beaches Council PLEP Geotechnical Hazard Map (PLEP Geotechnical Hazard Map **Image 2** below).

No significant geotechnical hazards were identified above, beside or below the subject site.

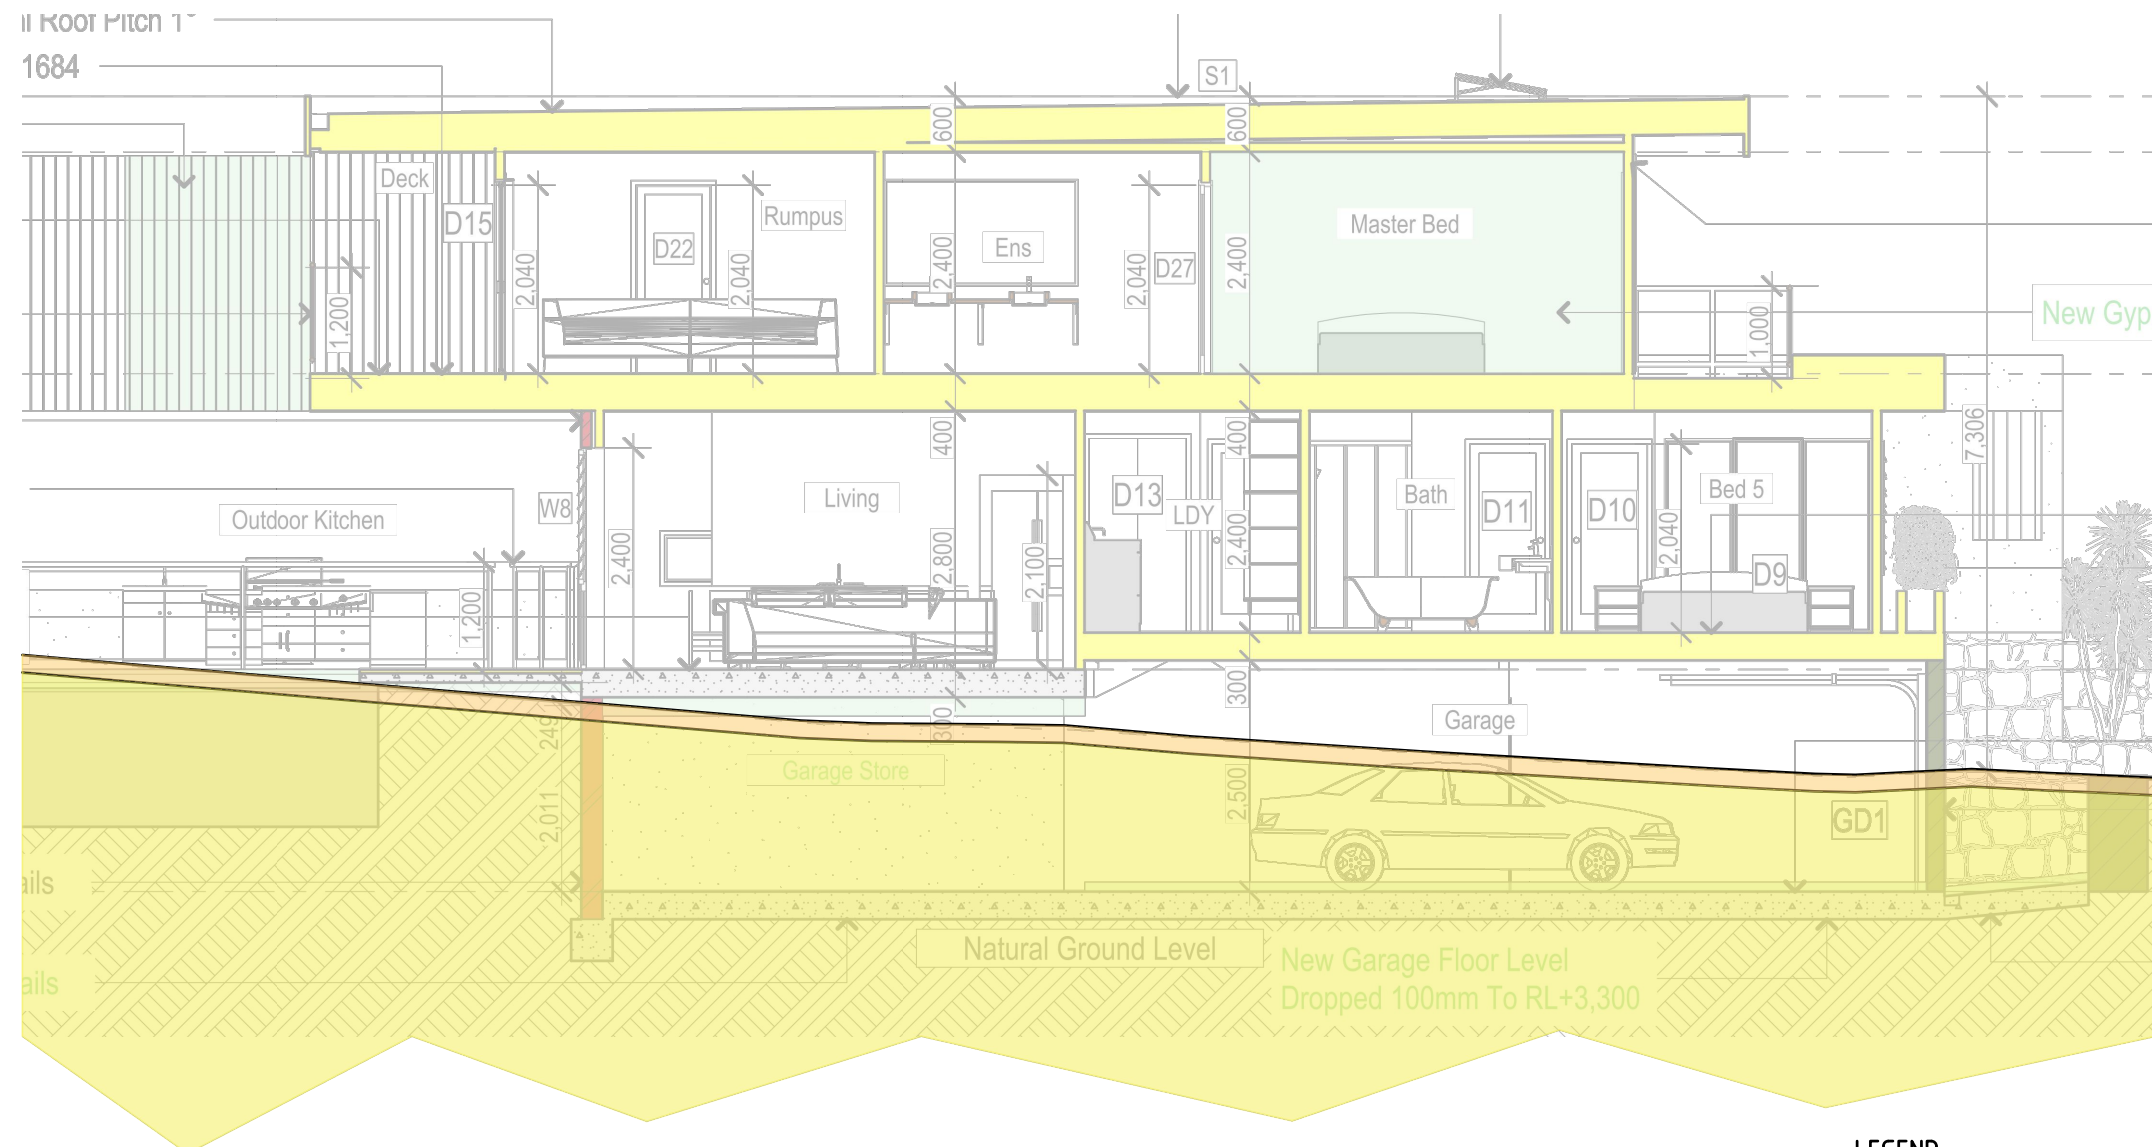
INFERRED GEOLOGICAL SECTION

The slope across the subject site has an average gradient of ~10 degrees. The soil profile is interpreted to be comprised of organic sandy top soils, with sand & clay overlying weathered bedrock at depths beyond 3300mm across the block. The likelihood of the slope failing is assessed as '**UNLIKELY**', the consequences of such a failure are assessed as '**MINOR**'. The risk to property is '**LOW**'. The existing conditions and proposed development are considered to constitute an '**ACCEPTABLE**' risk to life and a '**LOW**' risk to property provided that the recommendations outlined in **Section 3.6** are adhered to.

INTERPRETED SUBSURFACE SECTION ONLY.
ACTUAL GROUND CONDITIONS MAY VARY.
