Report Title: Geotechnical Report 141 Riverview Road, Avalon

Report Date: 23/2/21

GEOTECHNICAL INVESTIGATION:

New House at 141 Riverview Road, Avalon

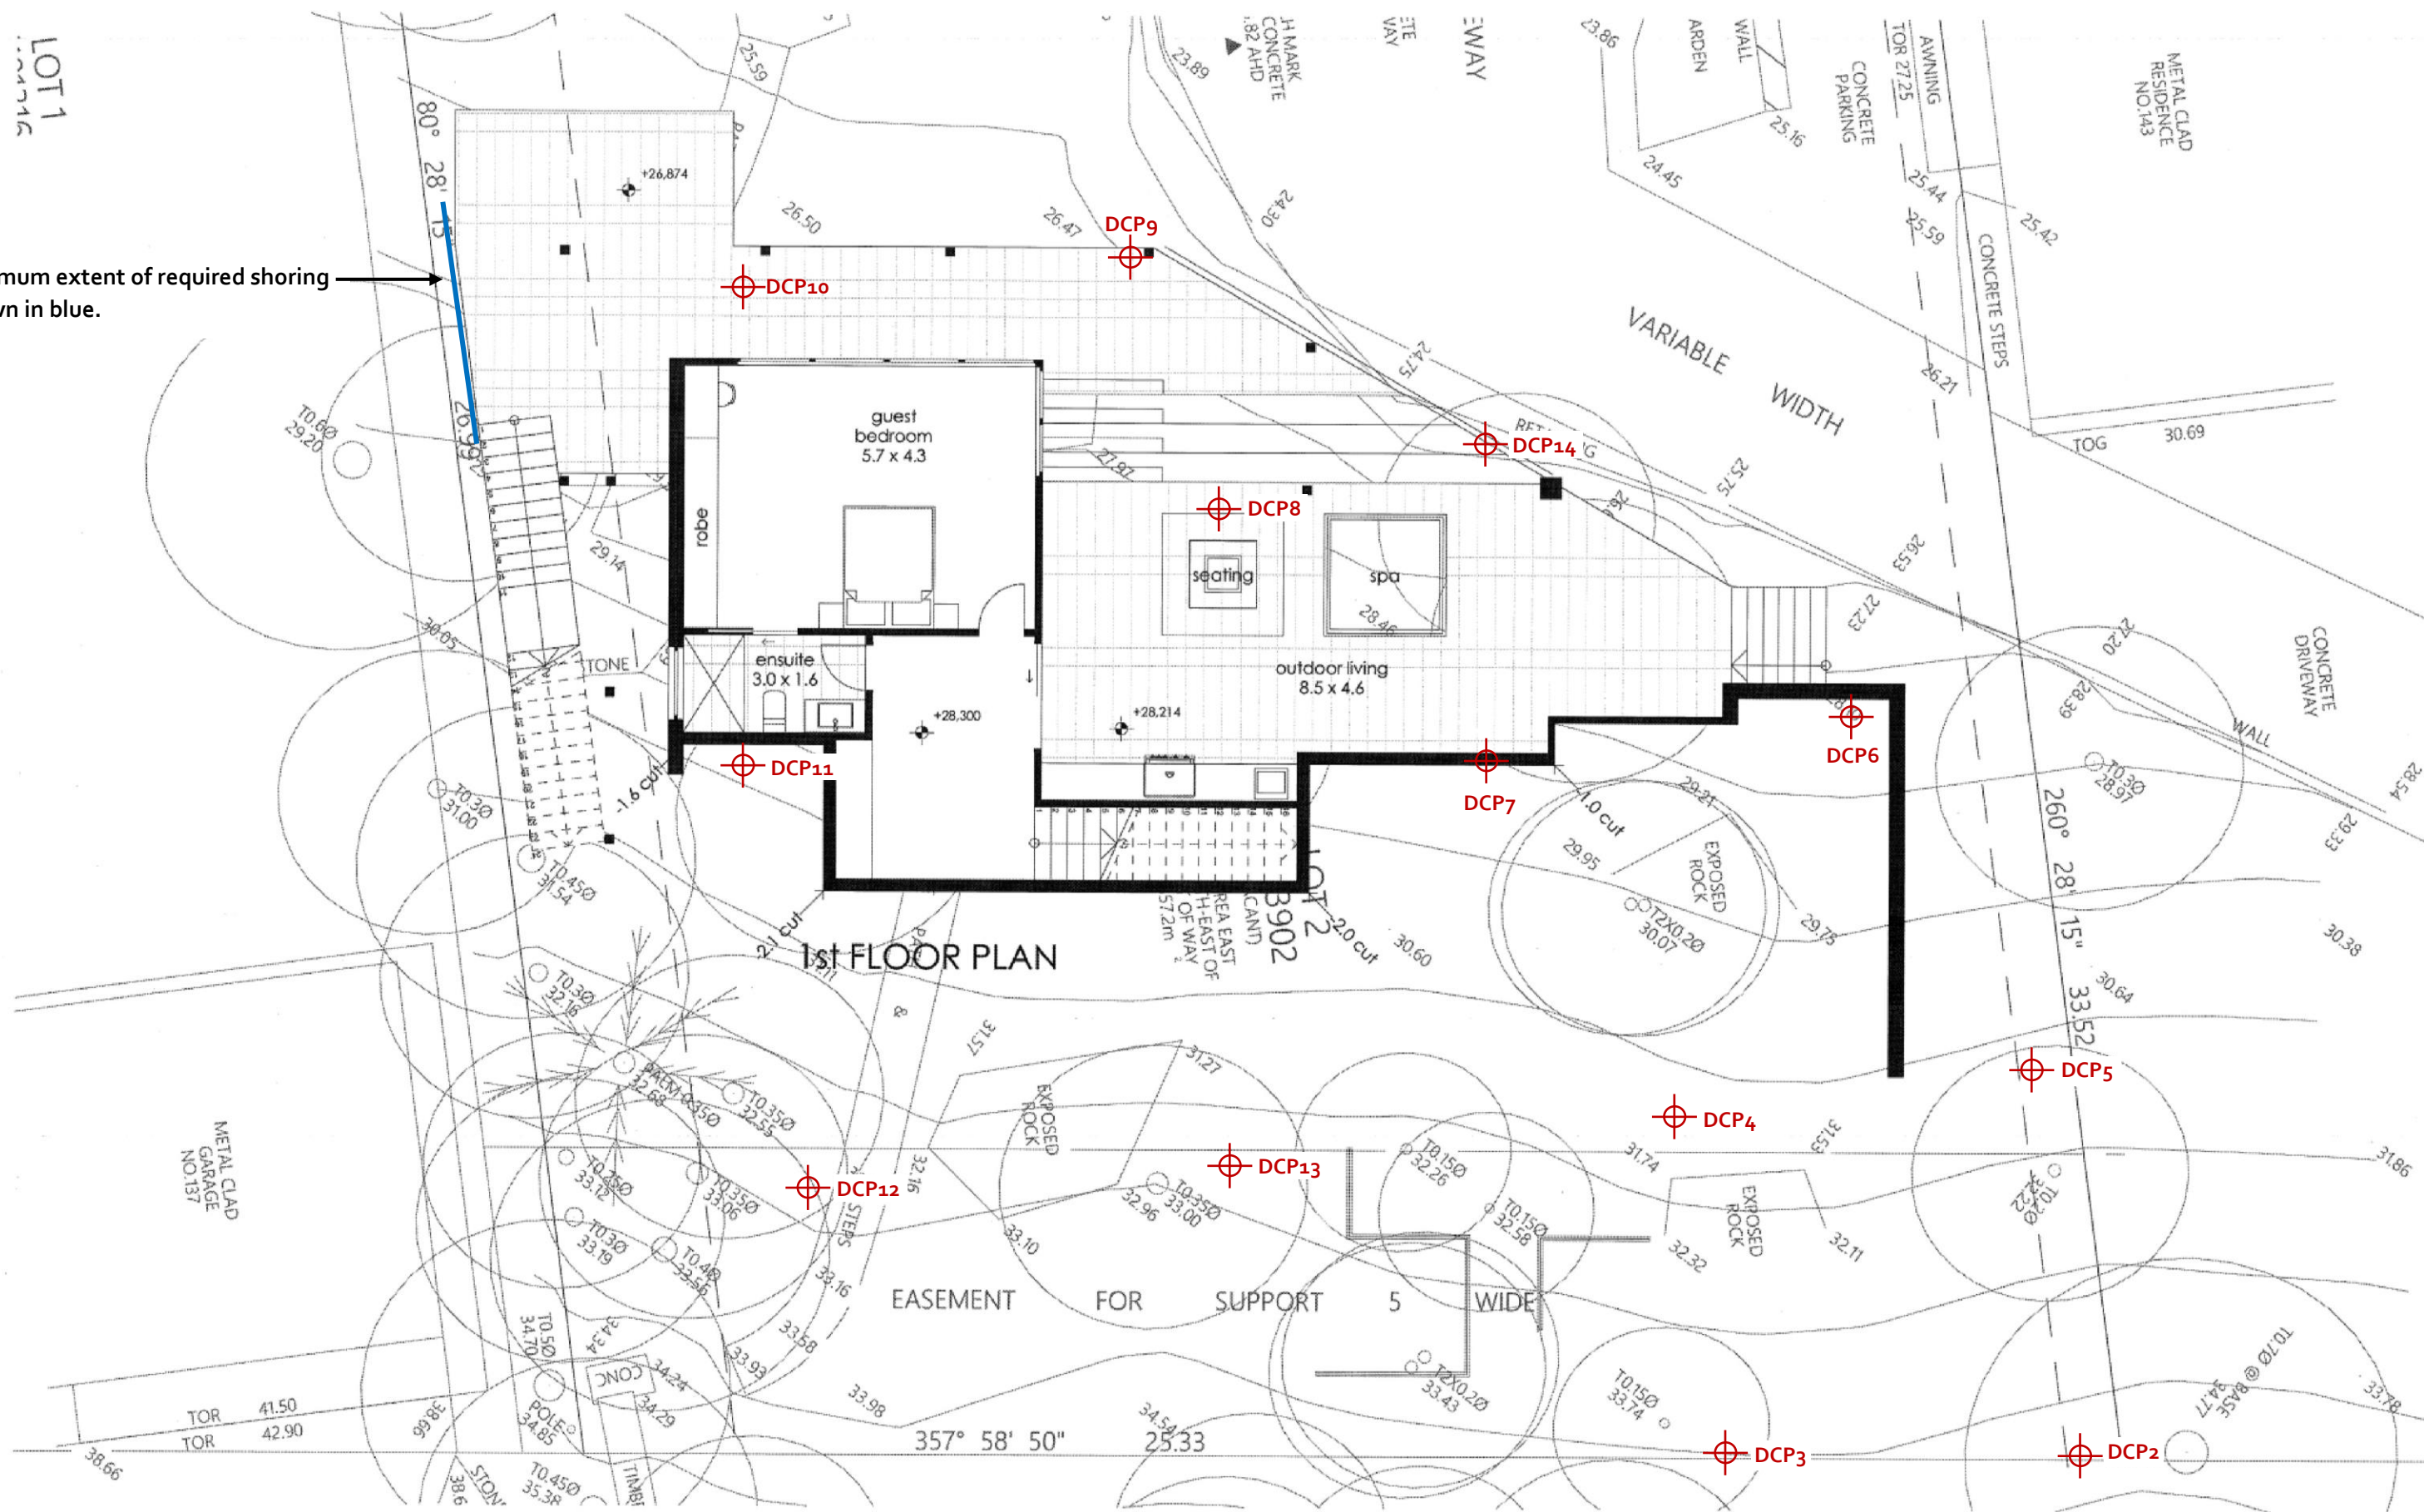
SITE PLAN – showing test locations

Three excavations are required to construct the proposed new house with terrace below. The excavations for the house are set back sufficiently from the property boundaries and adjoining structures to negate excavation induced instability. Allowing for backwall-drainage, the S portion of the terrace excavation (to a maximum depth of ~2.3m) comes flush with the S common boundary.

Minimum extent of required shoring shown in blue.

The S cut for the terrace excavation is to be permanently or temporarily supported before the excavation through Medium Strength Rock commences. The support is to be installed systematically as the excavation progresses to ensure the integrity of the neighbouring property. If the support is temporary, it is to remain in place until the retaining wall is built as a sacrificial-type system. See the site plan attached for the minimum required extent of the shoring shown in blue.
