REPORT ON GEOTECHNICAL SITE INVESTIGATION

# **NEW DEVELOPMENT**

# 321-331 CONDAMINE STREET, MANLY VALE

**Project No.: 2020-028**

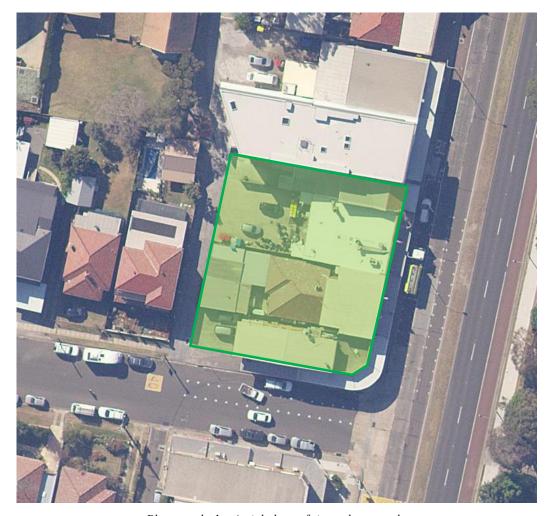
$Photograph: \ l-Aerial\ photo\ of\ site\ and\ surrounds.$

The existing buildings appear  $\times$  40 years of age and appear in reasonable condition with no signs of significant cracking or settlement on the external walls.
