Report Title: Geotechnical Report 67 Marine Parade, Avalon

Report Date: 20/8/19

GEOTECHNICAL INVESTIGATION:

Alterations and Additions at 67 Marine Parade, Avalon

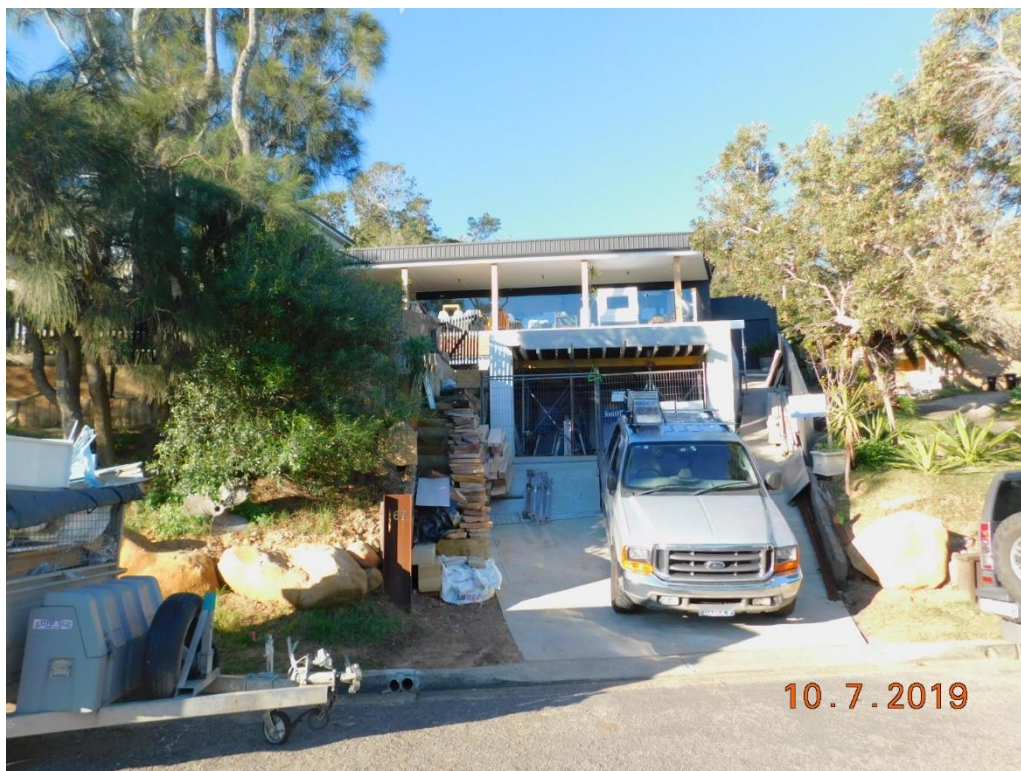
Photo 1

- 2.3** At the road frontage, a concrete driveway runs up the slope to a garage on the downhill side of the house (Photo 1). A dimensioned sandstone block wall up to 2.5m high runs E-W and retains a cut for the driveway (Photo 2). A shallow fill has been added for a lawn area above the cut and is supported by a ~0.6m dimensioned sandstone block wall on its downhill side (Photo 3). Both walls appear well-constructed. The single-storey brick and clad house is supported on brick walls and brick piers (Photo 4). No significant signs of movement were observed in its supporting brick walls or brick piers. A cut has been made into the slope on the uphill side of the

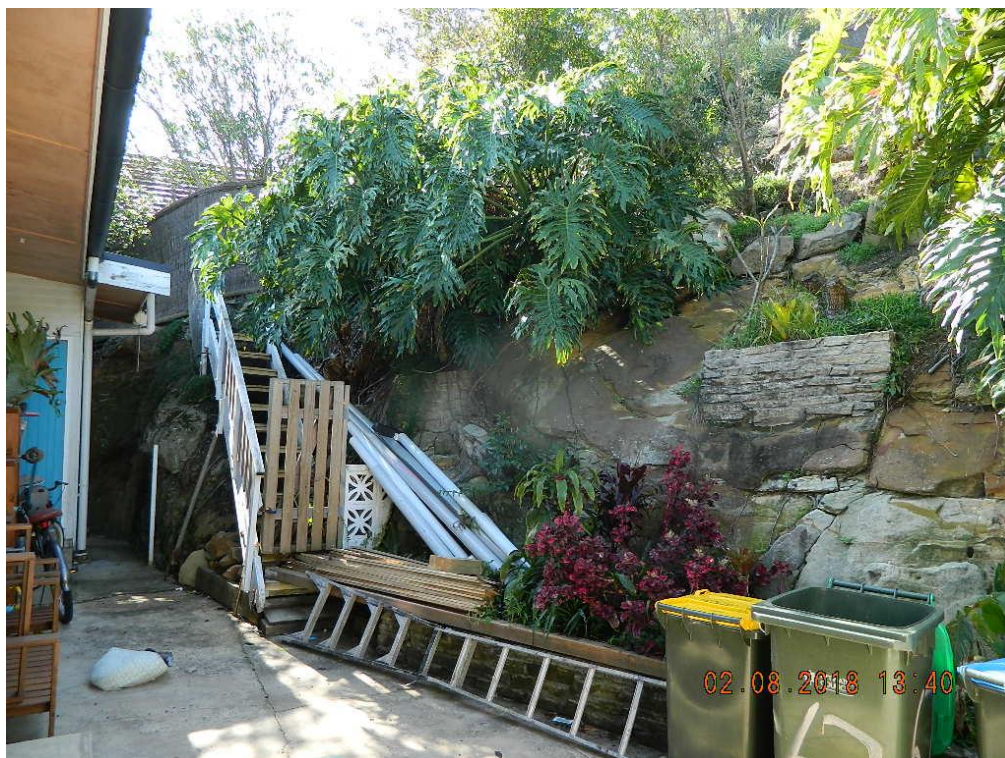
Photo 5

house (Photo 5). The ~3.0m high cut face is through Medium Strength Sandstone that is jointed but considered stable. Small stone walls have been constructed in various locations about the vertical cut face as planter boxes (Photo 6). The slope above consists of outcropping sandstone bedrock that extends to the upper boundary and the cliff edge.

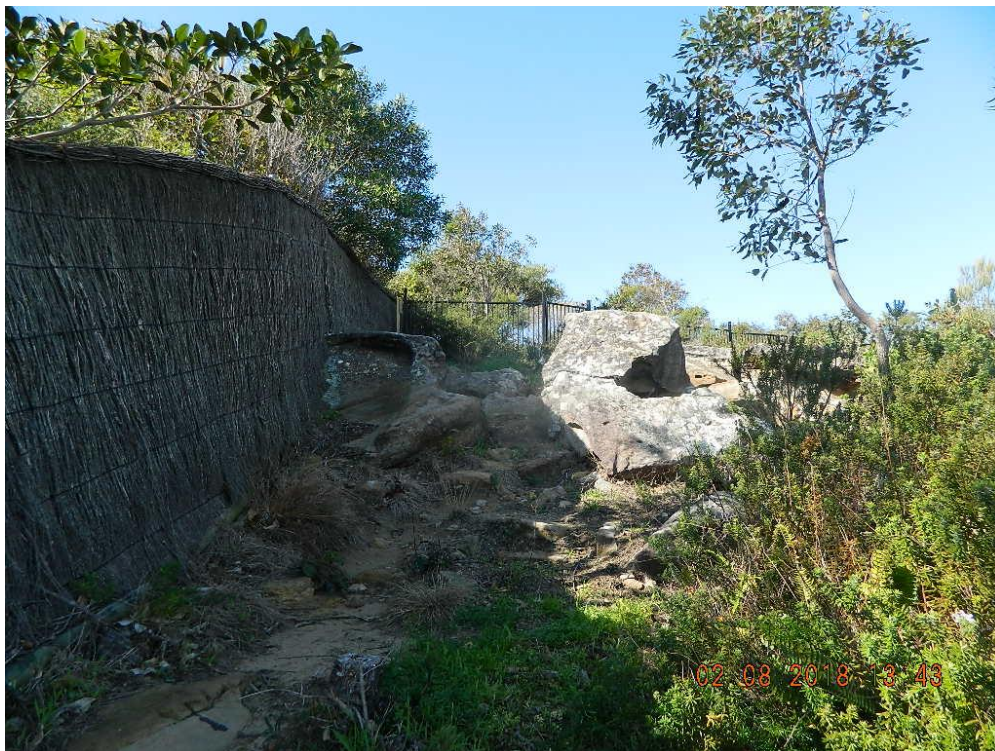
Photo 7

Sandstone bedrock outcrops at the sea cliff face to the E of the property and is visible outcropping down the slope to the house (Photo 7). This is an unusually thick sandstone bed

within the Narrabeen Group of rocks. The rock is overlain by natural sandy soils and sandy clays. In the test locations, rock was encountered at depths of between 0.3 to 3.3m due to the presence of fill (DCP1), but more so the variable and stepped nature of the rock. The bedrock underlying the area of the proposed development is expected to be variably ranging from very low strength to medium strength. See Type Section attached for a diagrammatical representation of the expected ground materials.

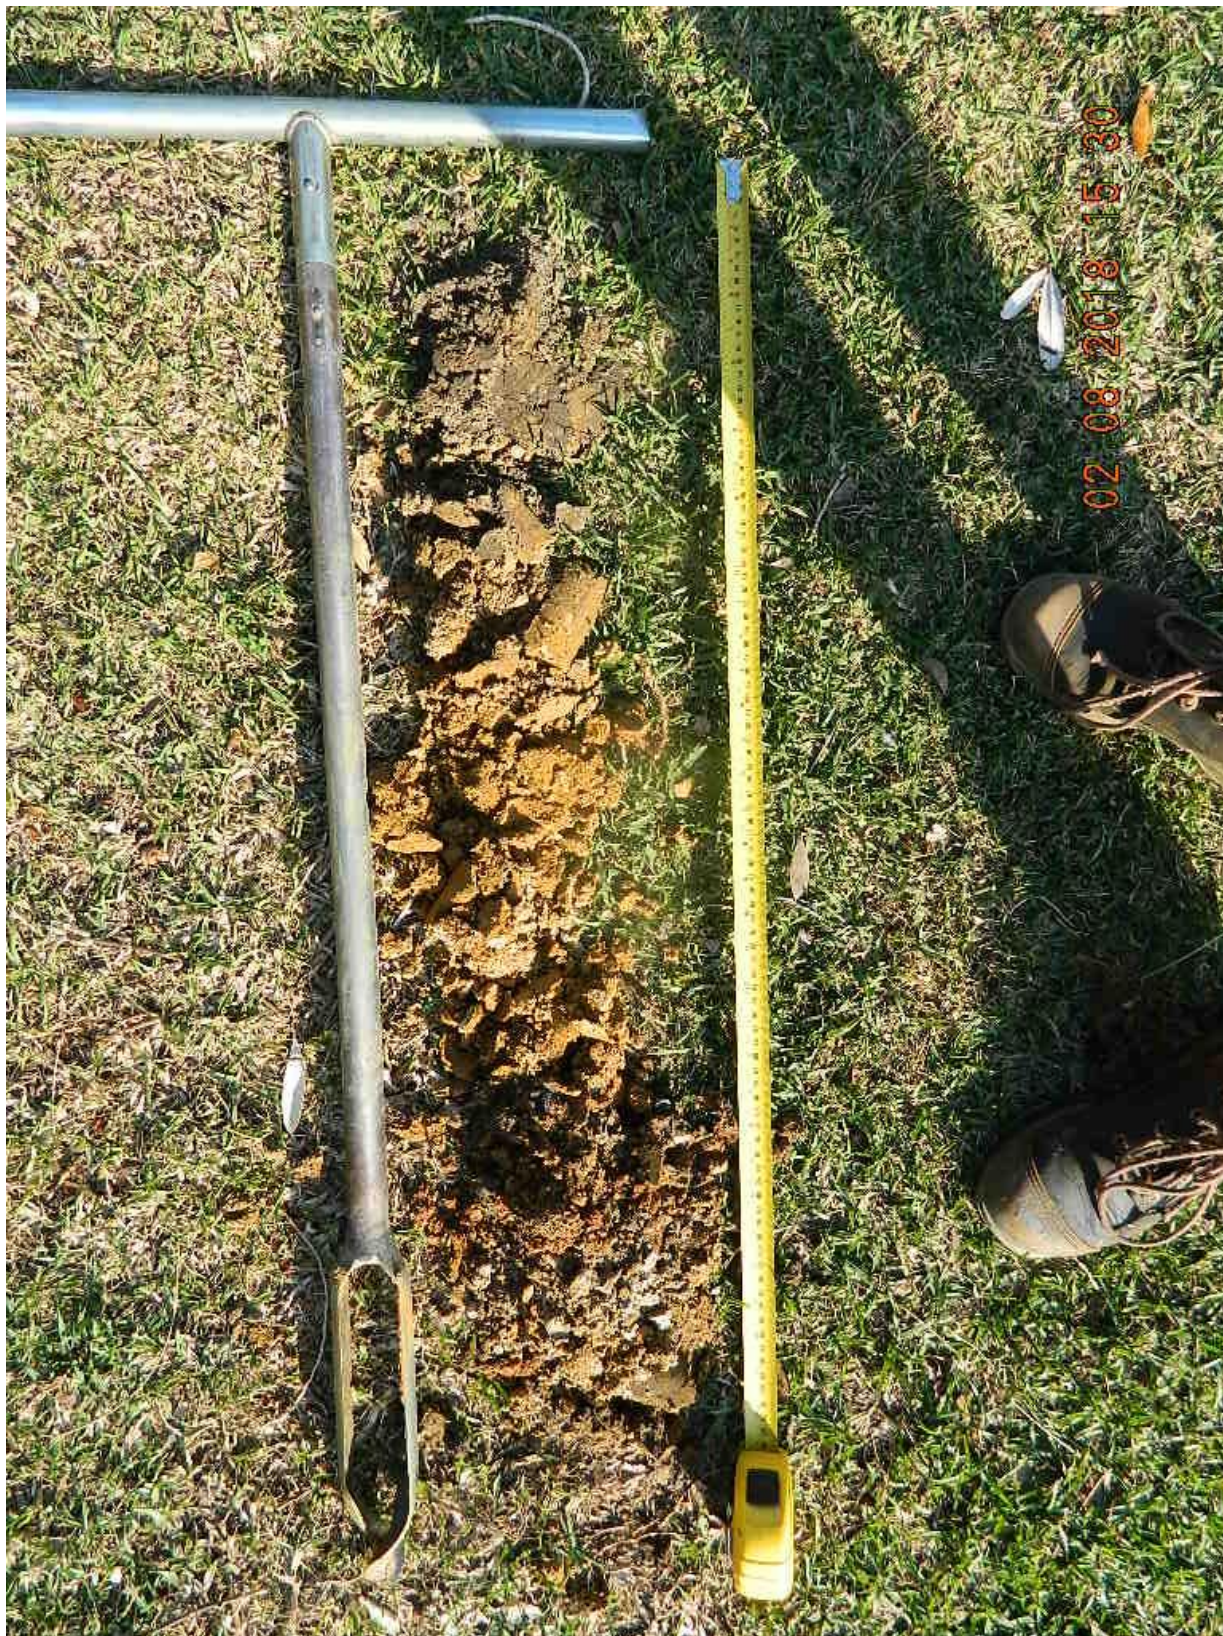
AUGER HOLE 1 (~RL36.71) – AH1 (Photo 9)

Depth (m)	Material Encountered
0.0 to 0.1	SANDY SOIL , brown, fine to coarse grained with fine trace organic matter, dry.
0.1 to 0.2	SANDY CLAY , orange/brown, fine to medium grained, trace organic matter, dry.
0.2 to 0.9	SANDY CLAY , orange, fine to medium grain, rock fragments with sandstone fragments from grinding auger at base.

End of hole @ 0.9m in weathered sandstone. No watertable encountered.

Photo 9: AH1 – Downhole is top to bottom

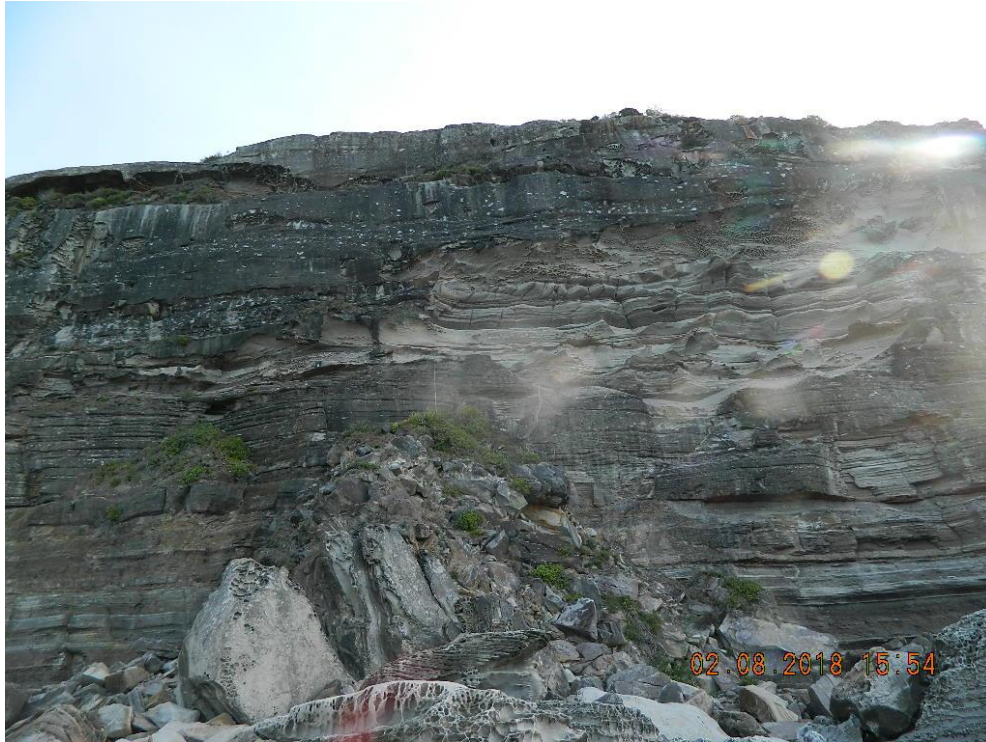
Photo 10

The vertical sea cliff on the upper boundary of the property falls from elevations of ~RL51.0 to ~RL5.0 to a rock platform below (Photos 10). The rock platform extends ~45m to the ocean line and has a covering of dislodged joint blocks. The proposed extension will be at a horizontal distance of ~27m from the base of the sea cliff. The lowest elevation of the piers for the proposed extension is expected to be ~RL38.0 so are some 33m above the base of the cliff.

Considering the large width of the rock platform, the large volume of armouring sandstone rubble at the cliff base, and distance and elevation to the proposed works, the current accepted predicted sea level rise for the next century is not expected to lead to significant undercutting that could impact the proposed works.
