## **GEOTECHNICAL INVESTIGATION:**

### **Proposed Secondary Dwelling at 2 Old Barrenjoey Road, Avalon**

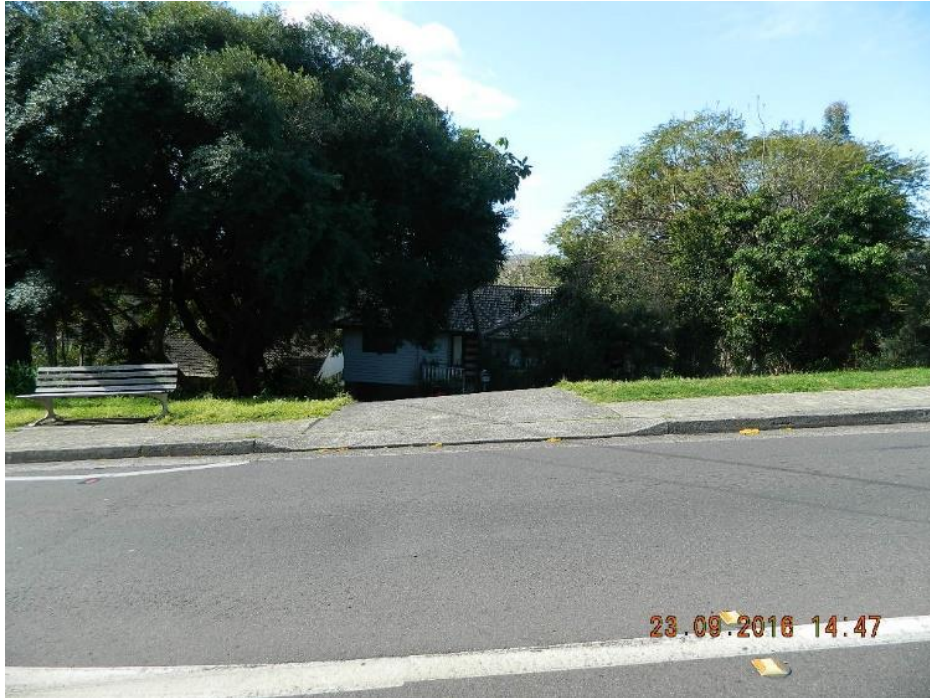
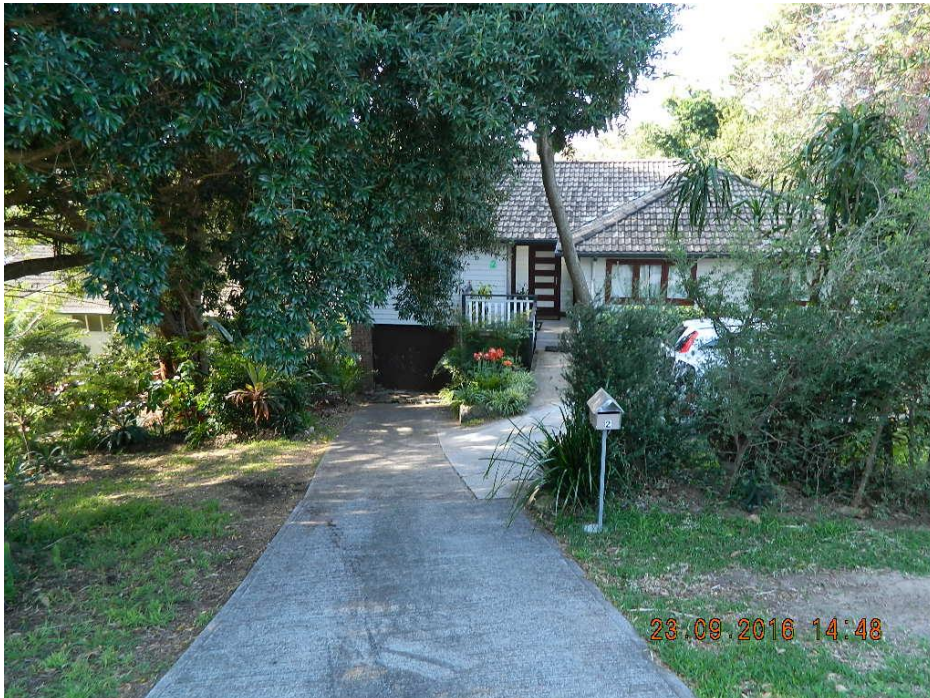
- 2.3 At the road frontage a concrete driveway runs downhill to a parking area above the house and a garage within the house (Photo 1 & 2). The fill batter for the road merges into the natural slope and no signs of movement were observed in this portion of the slope. The cut for the parking area and the E side of the house are supported by treated pine retaining walls that appear stable (Photo 3 & 4). The old, single storey brick and clad house displays significant cracking in its visible supporting brick walls. The most substantial cracking and movement surrounds the garage area on the lowest level of the house, on the NW corner and through the W and S wall (Photos 5, 6 & 7). It appears part of the W external wall has been rebuilt in the houses recent history but the brick work at the NW corner has since cracked and come apart to a maximum of ~30mm downslope (Photo 5). There was no lintel supporting an external window opening (Photo 8). The internal skin also appears to have been rebuilt and displays movement that has occurred since (Photo 7). Wide cracking is visible and the wall has settled and is not level

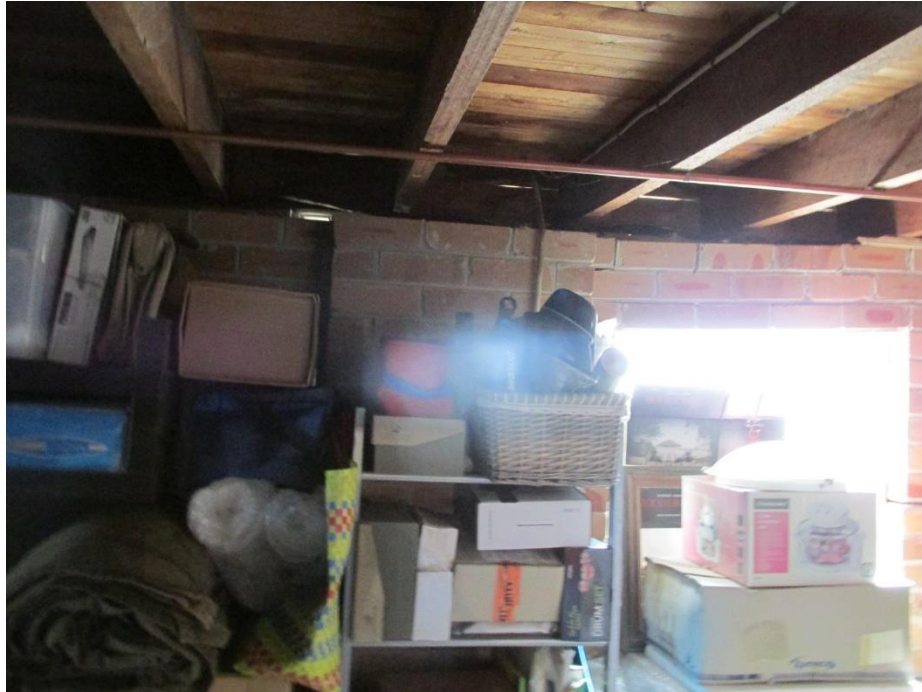
Photo 9

(Photo 9). The garage slab is also cracked to 20mm wide and shows heave up to 50mm towards the NW corner (Photos 10 & 11). Many of the brick piers in the foundation space have been replaced with steel posts (Photo 12). The owner informs us the brick piers were replaced as the piers were tilting so in some instances they were no longer supporting the bearers. The surrounding walls also have cracks that extend through the bricks and mortar but these are not as severe (Photo 13). The cracking appears to be the result of insufficient embedment of the footings but may also be due to the presence of fill that was not compacted during the initial construction of the house (around the NW corner to level the garage slab). Additionally the owner informs us the drainage above the garage is not sufficient and water flows through the garage during heavy downpours. We think it likely this water flow has exacerbated the movement around the garage significantly. Our recommendations to ensure the stability of the house into the future are outlined in **Section 14**.

The supporting brick walls of the house, concrete slab for the garage and the steel posts in the foundation space of the house are to be inspected by a structural engineer to assess their structural integrity and provide recommendations for remediation if necessary (Photos 5 to 13).

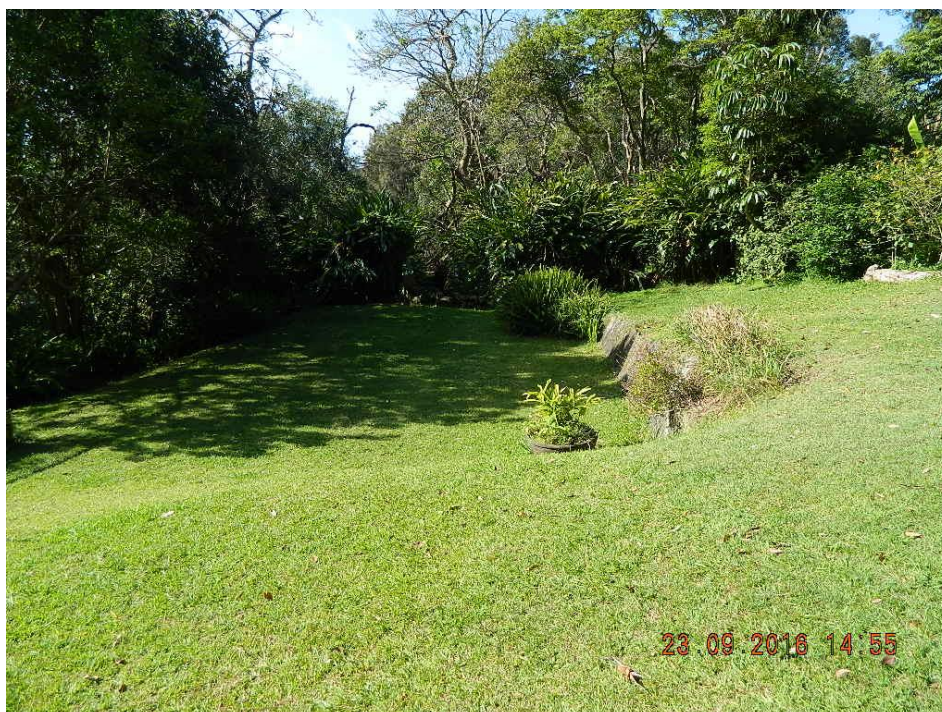
Photo 14

In the yard below the house a cut and fill has been made into the slope for a level area below the house (Photo 14). The cut is supported by an old, mortared rock retaining wall that is slightly bulging but is currently considered stable. The fill is battered to stable angles and is vegetated with small shrubs. Avalon golf course is located below the lower boundary of the property.

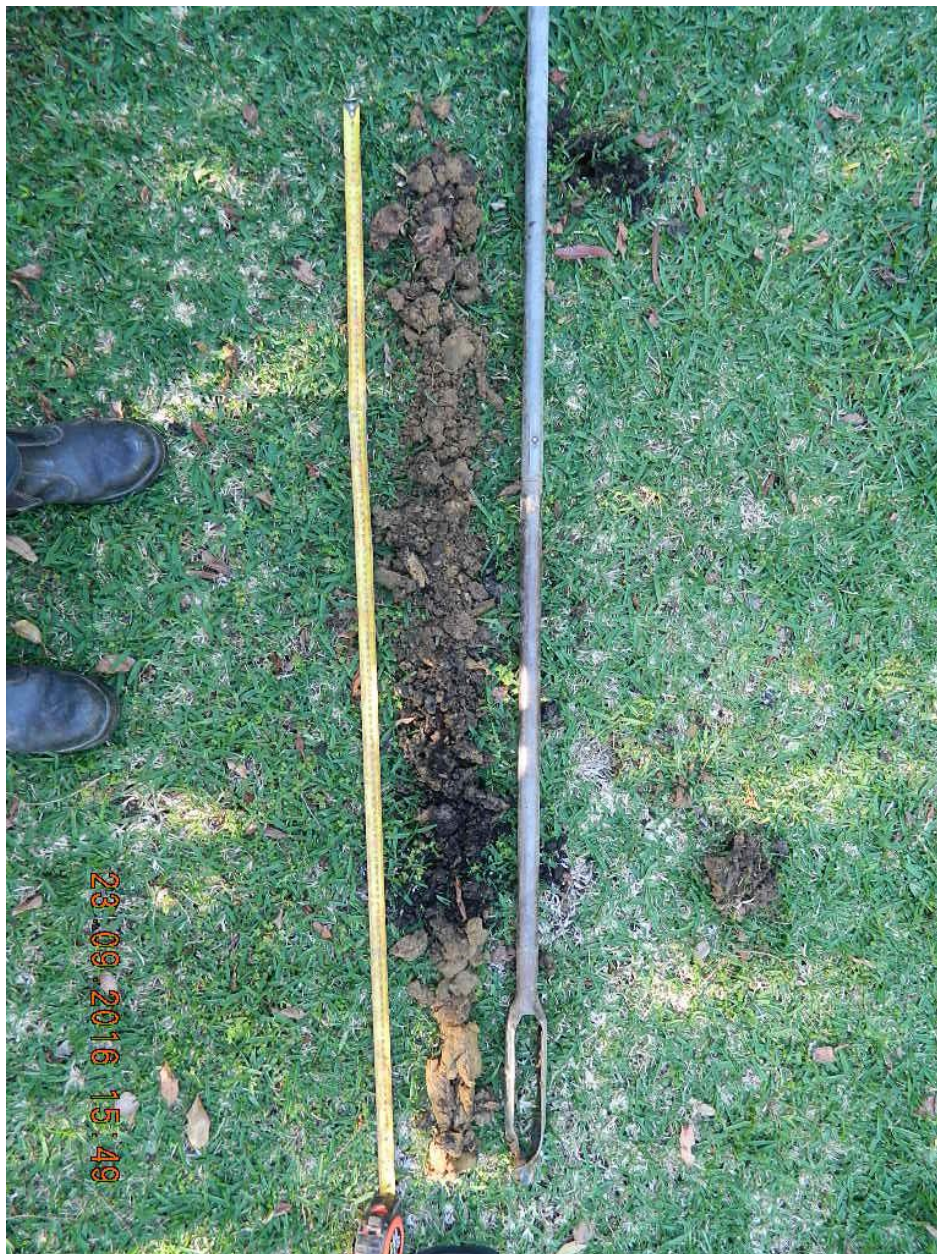
## AUGER HOLE 1 (~RL 36.4) – AH1 (Photo 15)

Depth (m)	Material Encountered
0.0 to 1.0	<b>FILL</b> , mixture of soil and clay, moist.
1.0 to 1.4	<b>CLAY</b> , yellow, firm to stiff, moist.

End of hole @ 1.4m in yellow, stiff clay.  
No watertable encountered.

*Photo 15 – base of the auger is at the bottom of the picture*

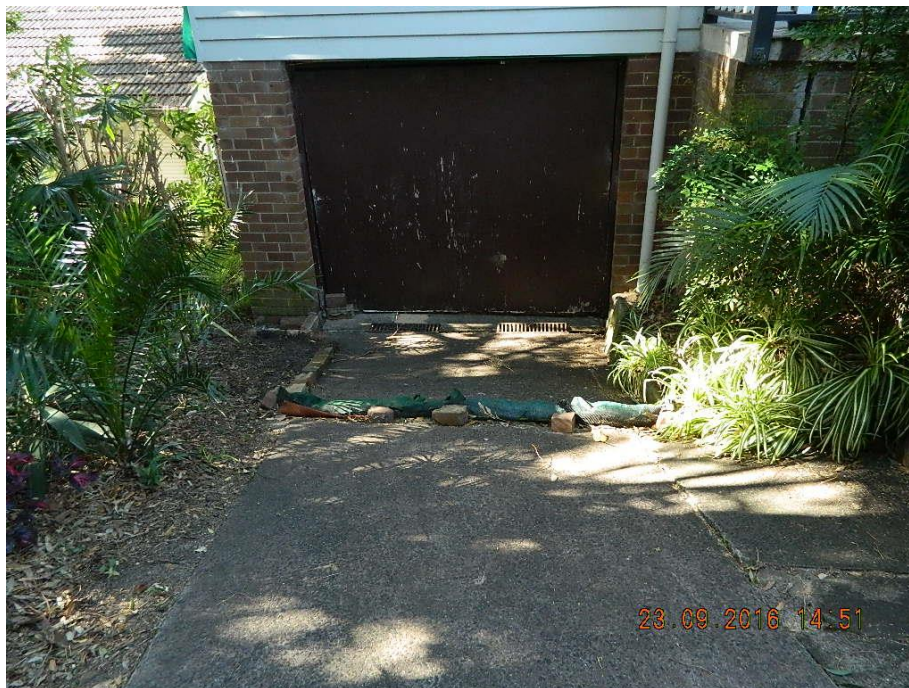
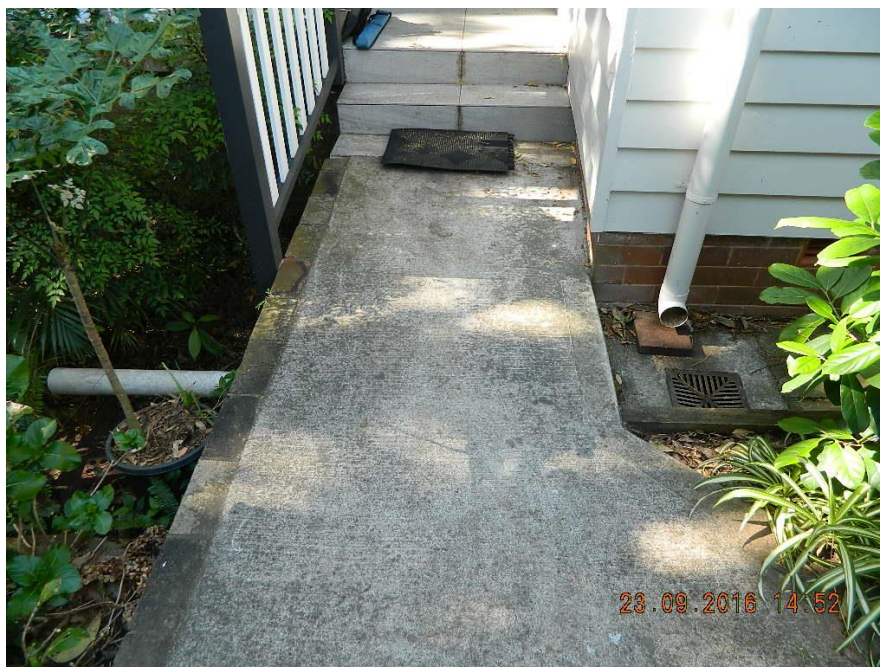
Roof water from two downpipes is currently directed to a grated drain that runs across the front of the garage (Photos 16 & 17). It appears during heavy downpours the grated drain overflows and water moves under and/or over the garage slab. We recommend this roof water be piped clear of the downhill side of the house and the proposed secondary dwelling to a spreader pipe.

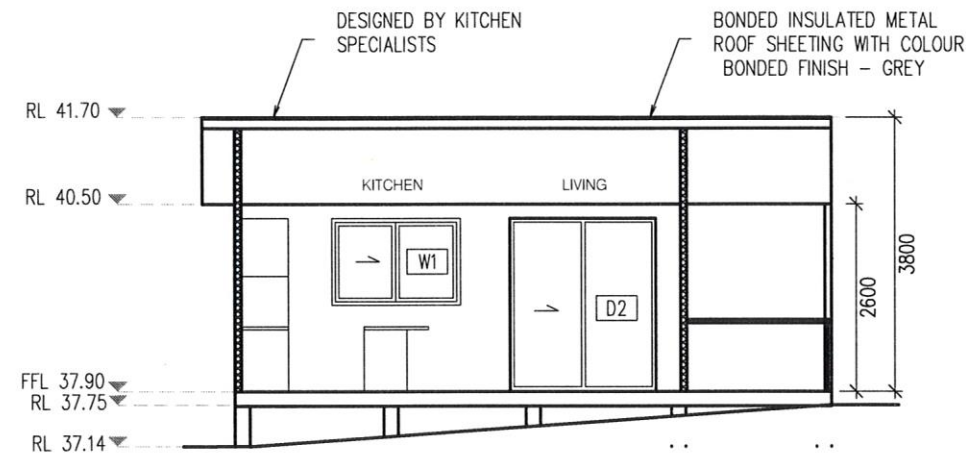
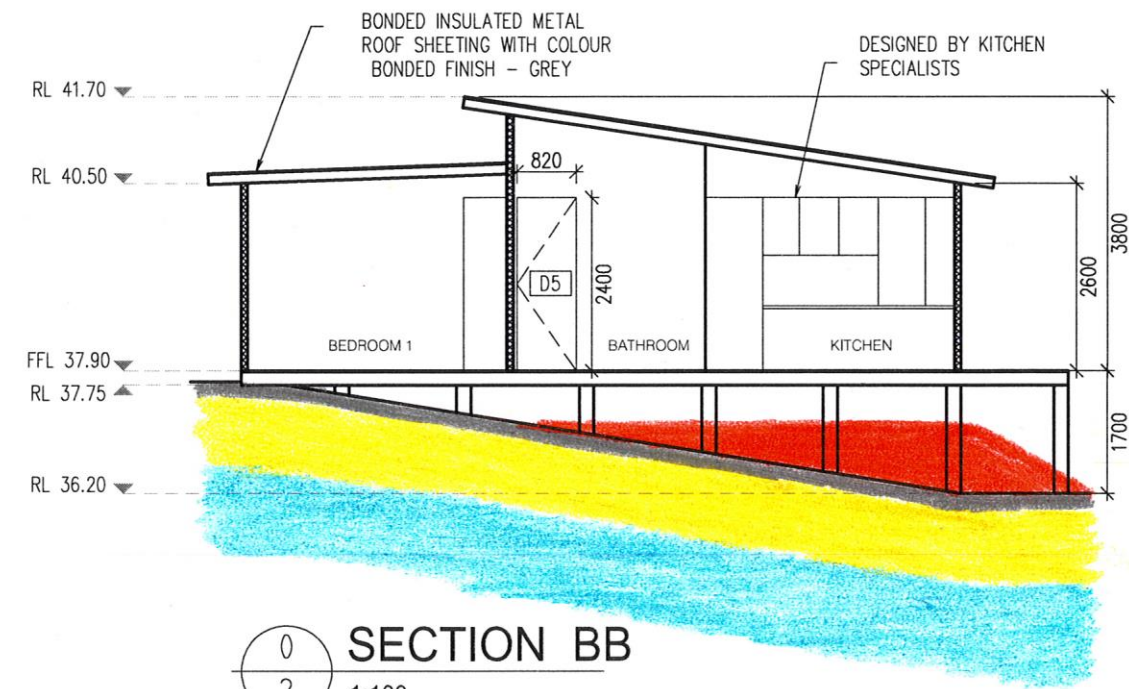
The slope materials are colluvial at the near surface and residual at depth. They consist of a thin sandy topsoil over sandy clays and clays with rock fragments throughout the profile. In the test locations the sandy clays and clays merge into the weathered zone of the under lying rocks at depths between 1.2 to 2.1m below the current surface, being variable due to cut and filling across the proposed works. The depth of the fill reaches a maximum depth of ~1.2m on the NW corner of the proposed secondary dwelling. The

weathered zone of the underlying rock is interpreted as extremely low strength shale. It is to be noted that this material is a soft rock and can appear as a mottled stiff clay when it is cut up by excavation equipment.
