205400.00  
9 July 2021  
NB:jb  
R.01.Rev1

**214 Hudson Parade, Clareville**  
**Proposed Alterations and Additions to Residential Property**

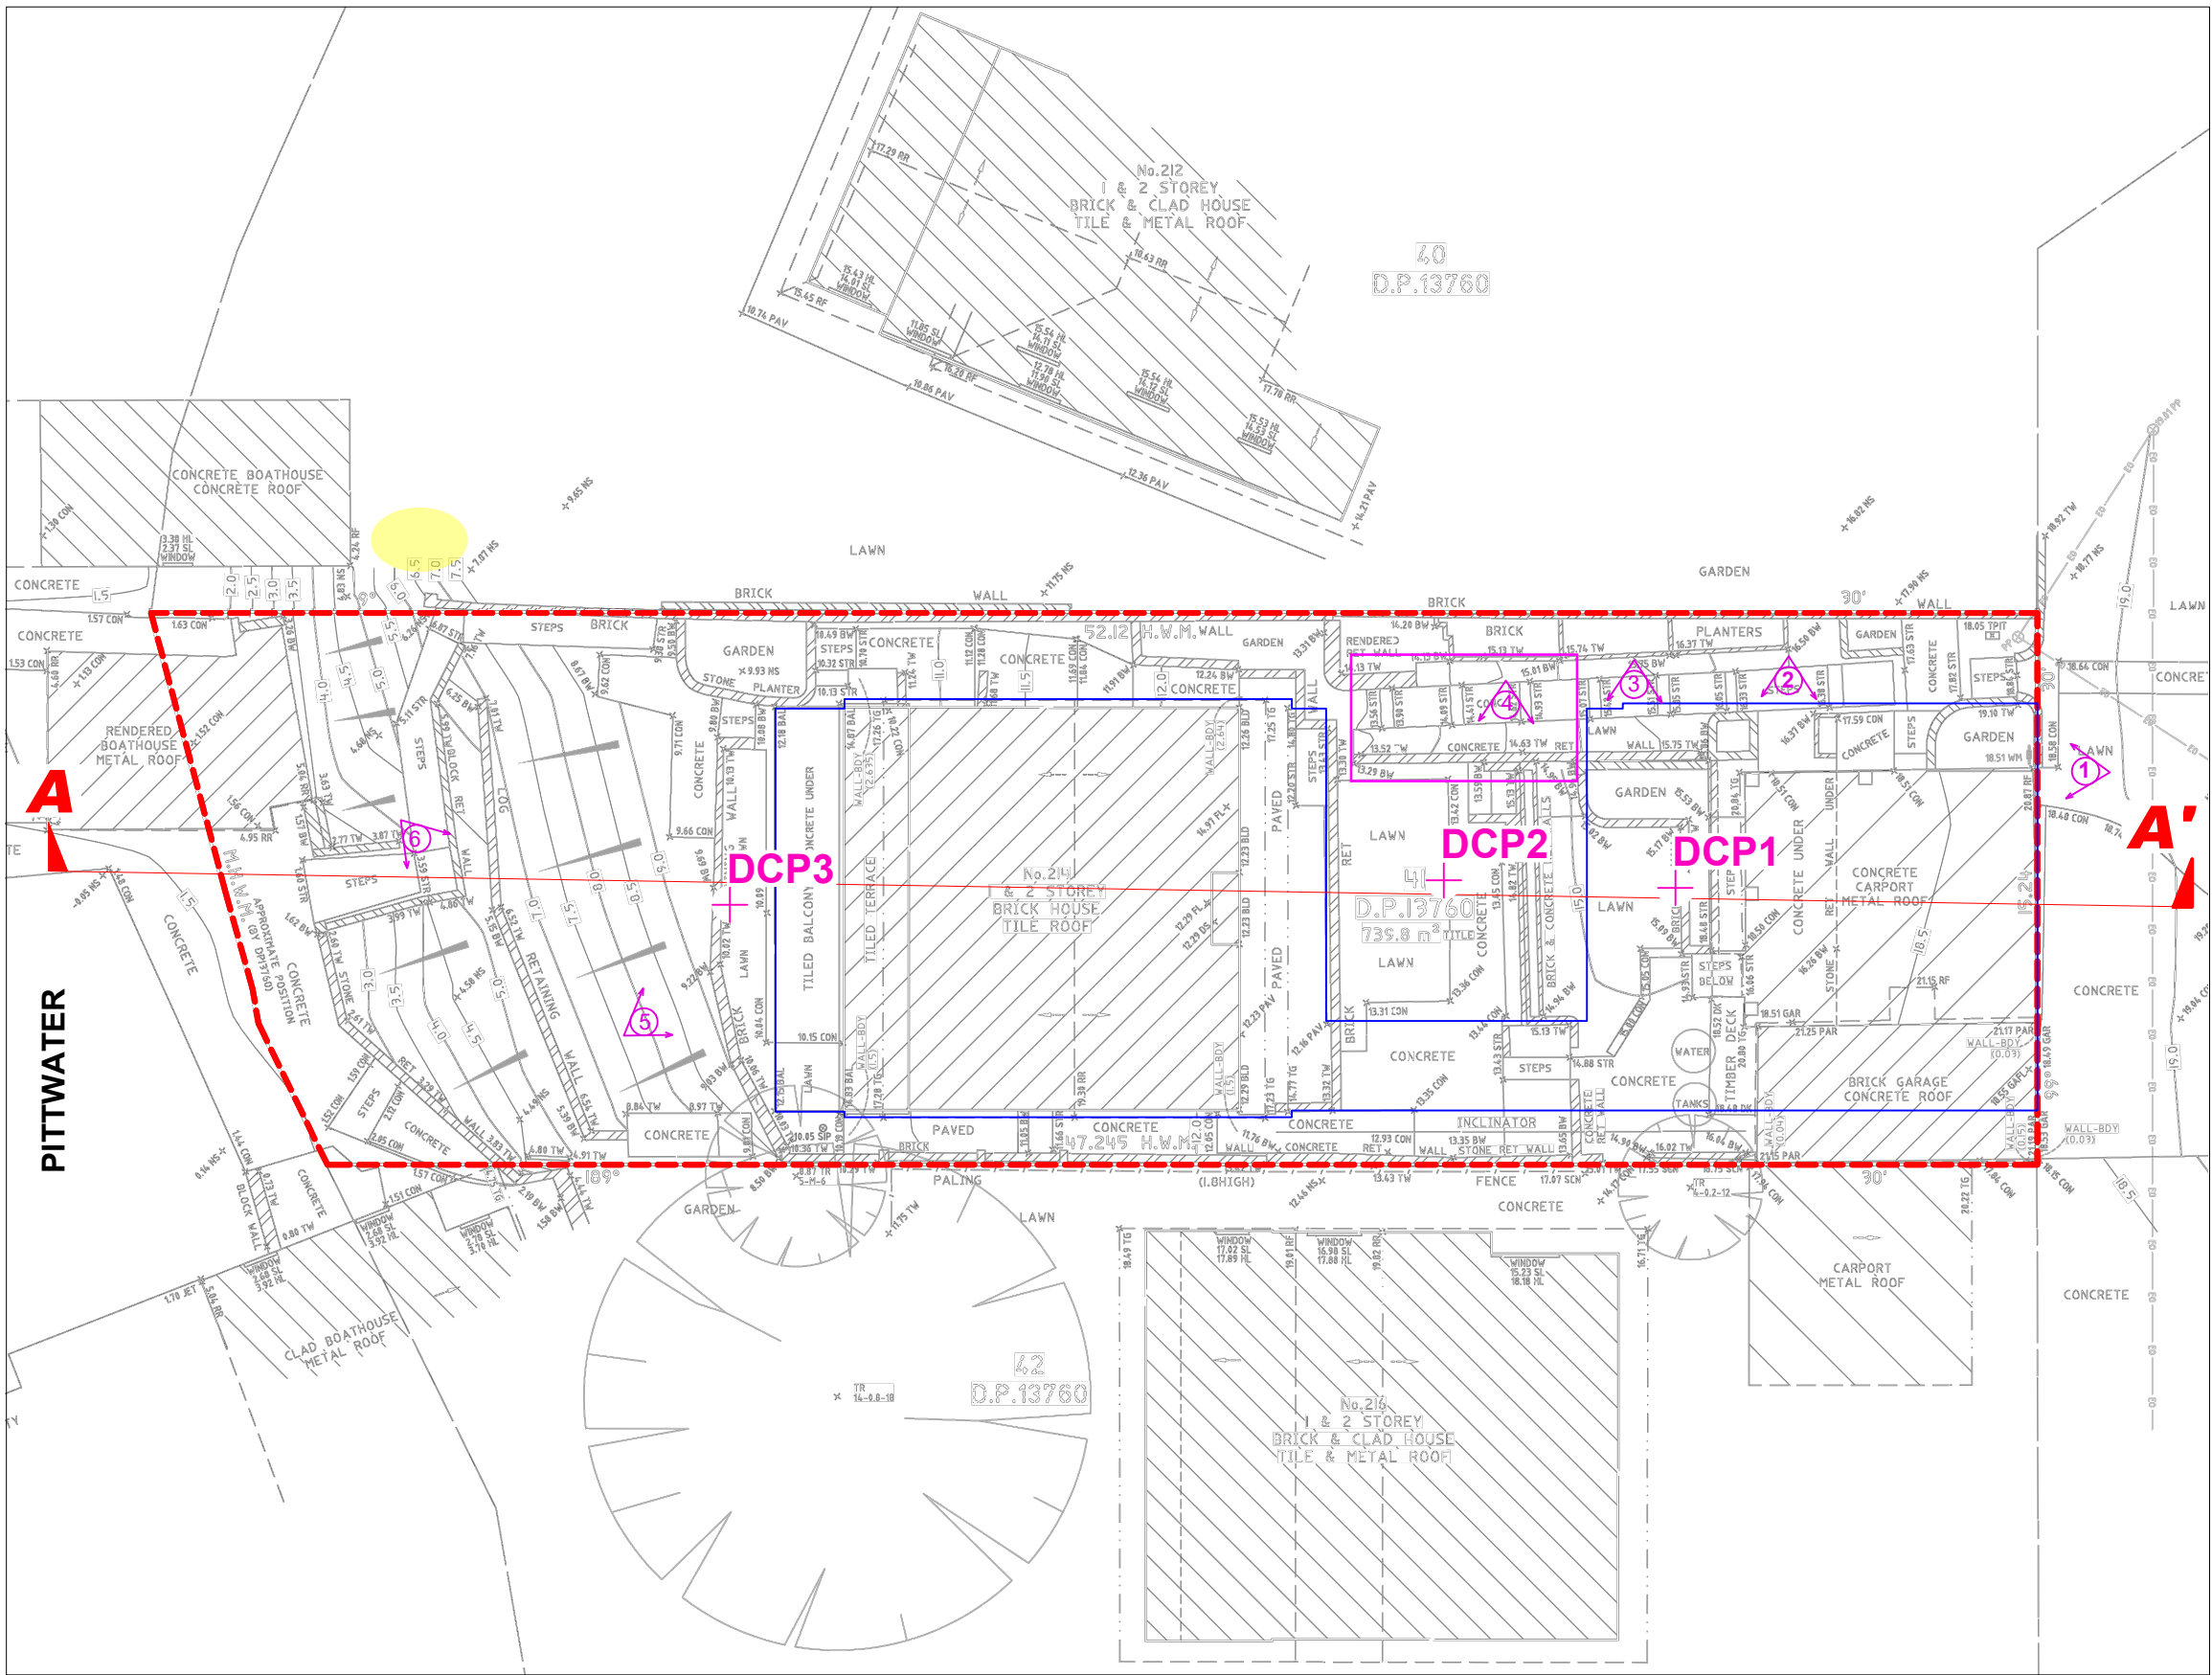
| | OFFICE: Sydney | DRAWN BY: MG | | | DRAWING No: 1 |

- sandstone outcrops are not present on site but can be seen at 216 Hudson Parade on the slope above Pittwater, as indicated on Drawing 1.

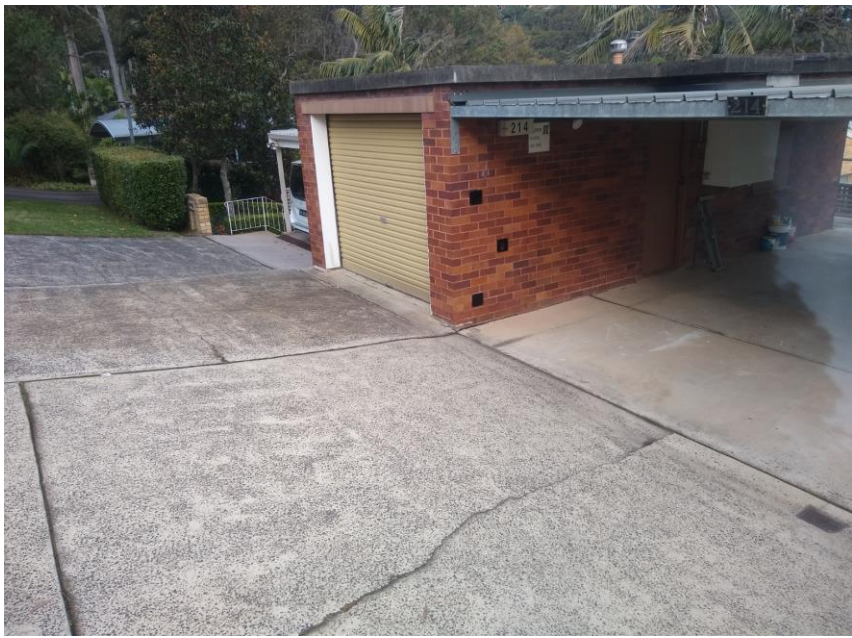
- the driveway at the top of the site appears to be in good condition with some minor cracking (Photo 1). Other areas of concrete pavement appear also to be in good condition with only minor cracking or settlement apparent;

Photo 1: View of garage and carport area

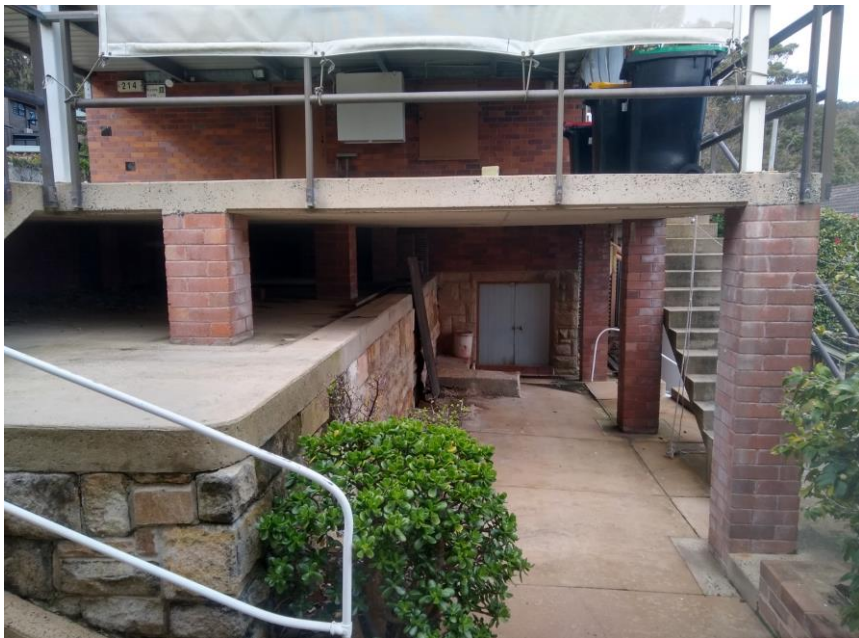
- the existing residences are of brick construction and appear externally, to be in reasonable condition with no major cracking noted (Photo 2);
- from a recent footing exposure by the client it appears that the main residence is founded on sandstone;

Photo 2: View underneath secondary residence

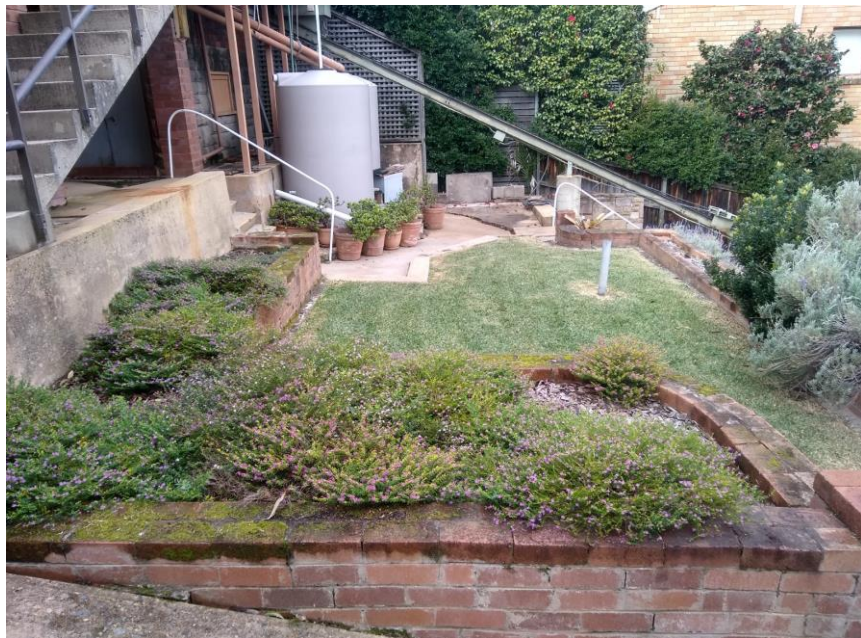
- brick retaining walls located between the main and secondary residence appear to be in good condition. They are standing upright and show no signs of cracking or tilting (Photo 3 and 4);

Photo 3: View looking at upper patio area (view east)

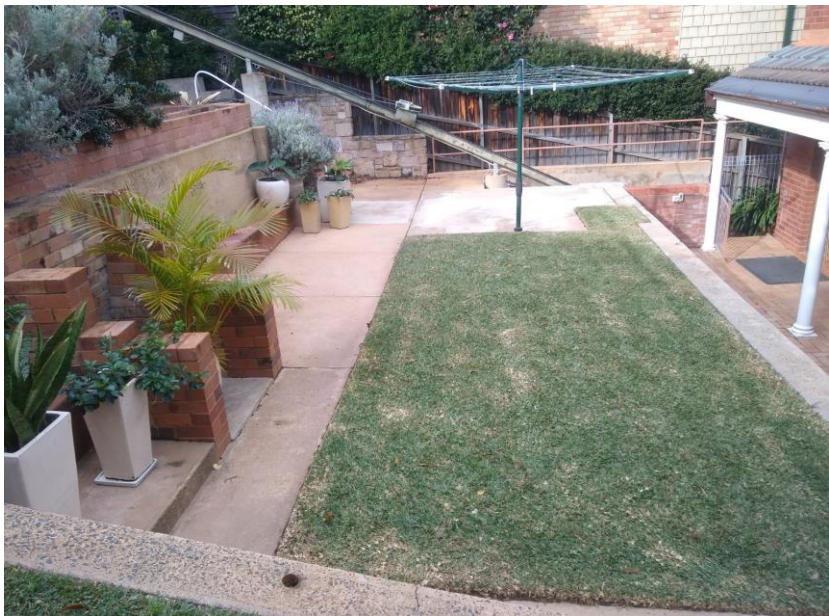
Photo 4: View looking at lower patio area (view east)

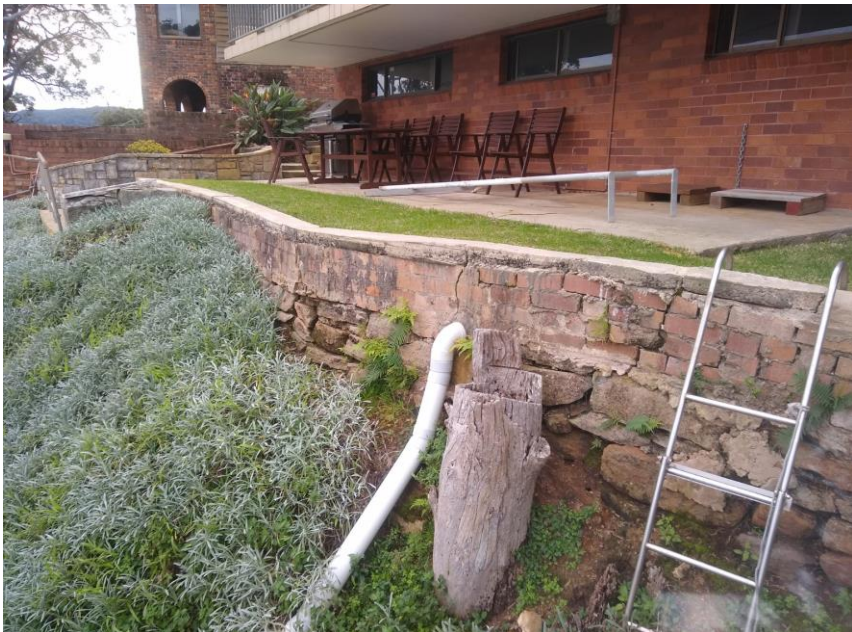
- a low height sandstone block wall is located below the main residence at the crest of the steep slope above Pittwater. There appears to be some cracking and movement of this block wall (Photo 5) ;

Photo 5: View looking at main residence and retaining wall below (view north)

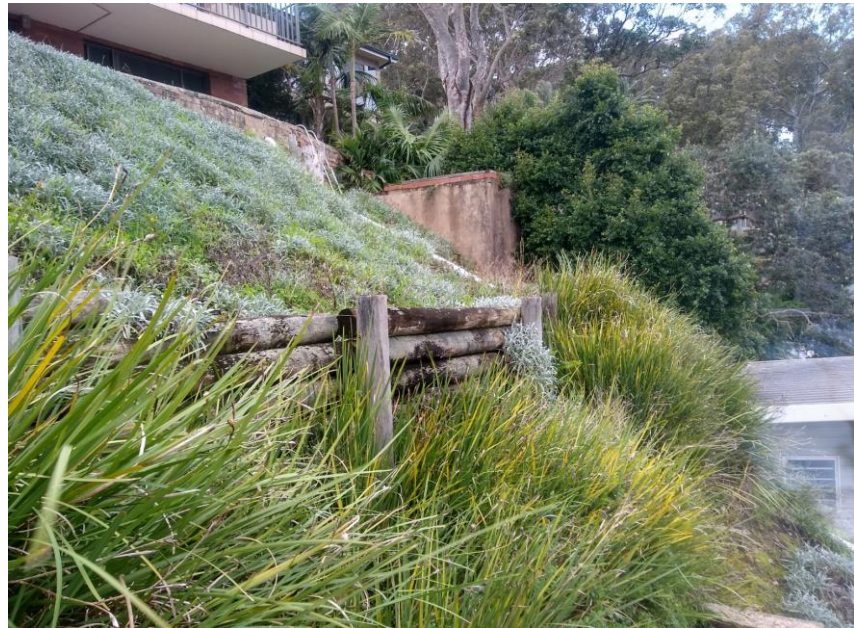
- the slope beyond the main residence is very steep with a timber retaining wall supporting garden beds. The wall has been creep-affected with some tilting of the wall observed (Photo 6); and

Inspection of the general slope on the subject and adjoining lots indicated no evidence of gross, large scale slope instability in the recent past. However, there is evidence of minor settlement and creep movement affecting some areas of paving, pathways and landscaping walls, particularly in the lower southern slope where a small timber wall is tilting.

Photo 6: View of slope below main residence (view south)
