REPORT ON GEOTECHNICAL SITE INVESTIGATION

PROPOSED DEVELOPMENT

LOT 3, 1110 BARRENJOEY ROAD, PALM BEACH

Project No.: 2020-232

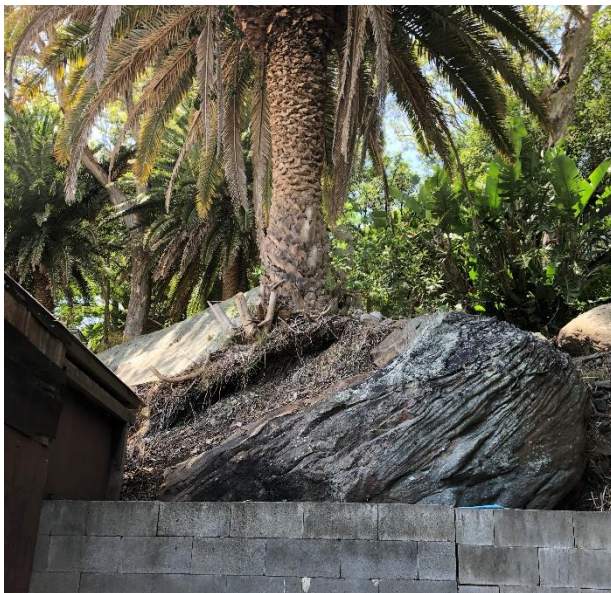
exposed. The tree appears to be positioned partially on top of a large sandstone boulder, this is shown in Photographs 3 and 4.

Photograph-3: Wash out under roots of palm tree, looking east

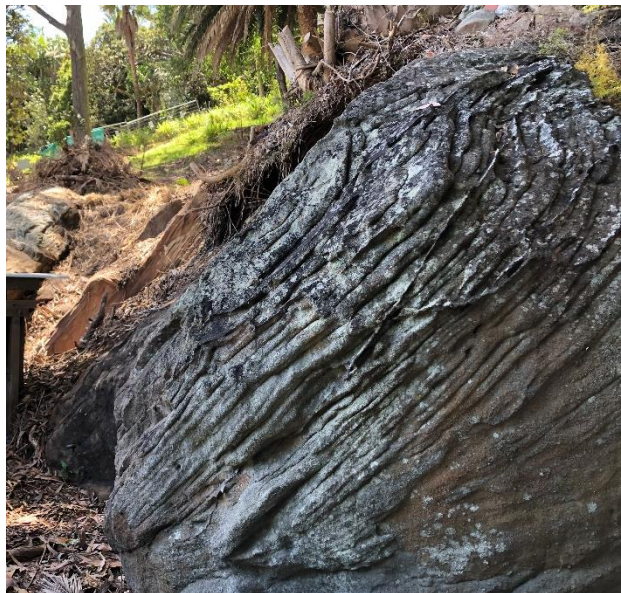
Photograph-4: Sandstone boulder and wash out under roots of palm tree, looking north east

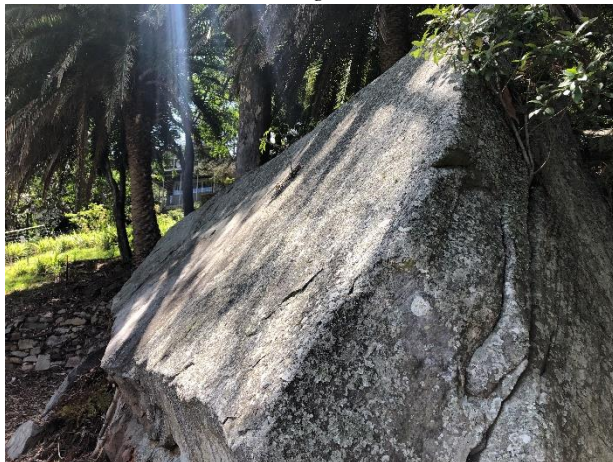
A middle-terraced level exists just to the east of the front terraced area at approximately R.L. 16.5m, this region is located between large sandstone boulders. A large ($\approx 48\text{m}^3$) angular, north east – south west striking, west north west dipping ($\approx 65^\circ$) sandstone boulder is located on the high east side of this middle-terraced level. A dry stack, subvertical sandstone rock retaining wall is located on the northern side of this boulder. This retaining wall appears to be stable, however it is not engineer designed and subject to poor construction methodology. The boulder and retaining wall are shown in Photograph 5 and 6.

Photograph-5: Massive, angular sandstone boulder within the middle-terraced region, looking north east

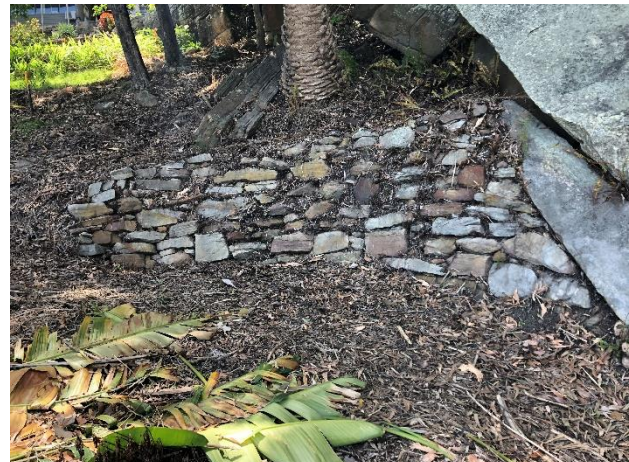
Photograph-6: Retaining wall to the north of sandstone boulder along the eastern edge of the middle-terraced region, looking east

The replacement and upgrade of the existing retaining wall within the eastern portion of the site will require careful consideration, as several boulders, including a very large boulder which continues into the neighbouring property to the north, are situated adjacent to the existing retaining wall.

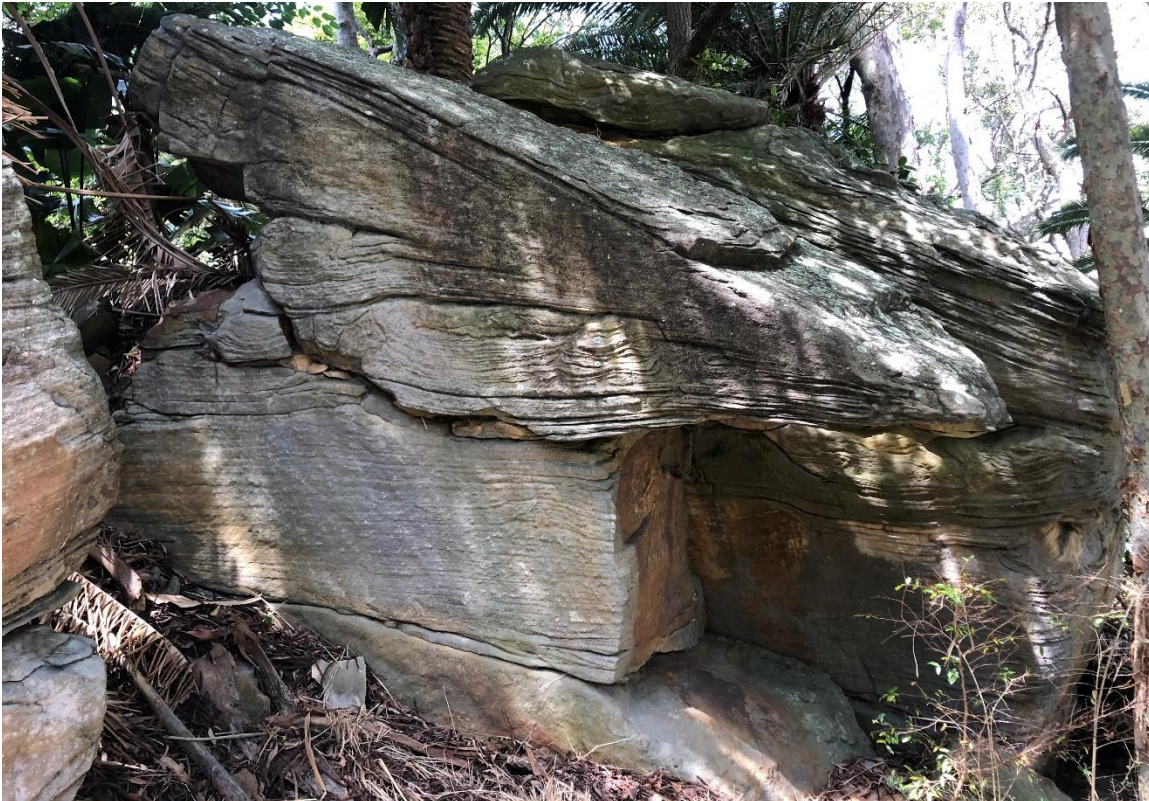
A series of large sandstone boulders are positioned within the north eastern corner of the site, with one large boulder extending an approximate 12m into the neighbouring property to the north east (No.140 Pacific Road). Within this series of boulders, a detached angular boulder was identified resting on top of another detached unit, both units are orientated down slope bearing onto a largely buried boulder. The upper and possibly lower detached units are interpreted as being susceptible to instability due to sliding or overturning failure. These boulders are shown in Photograph 7.

Photograph-7: Two detached units bearing onto a mostly buried sandstone boulder, looking south

The boulders buried across the soil slope are likely creeping with the soil. Excavation adjacent to or into these boulders is likely to disturb and cause instability. Some boulders directly overlie other boulders along unfavourable defects and are considered relatively unstable. Reference has been made (Drawing No.: DA2004) to boulder(s) within the eastern portion of the site; “rock cut back or retained as required”. It should be noted that for any rock fall hazards, the preference is removal however this may be difficult to achieve in the current conditions. If this cannot be completed, then stabilising systems are required (i.e. rock bolts/shotcrete). CGC must be consulted prior to any boulder removal or stabilisation works.

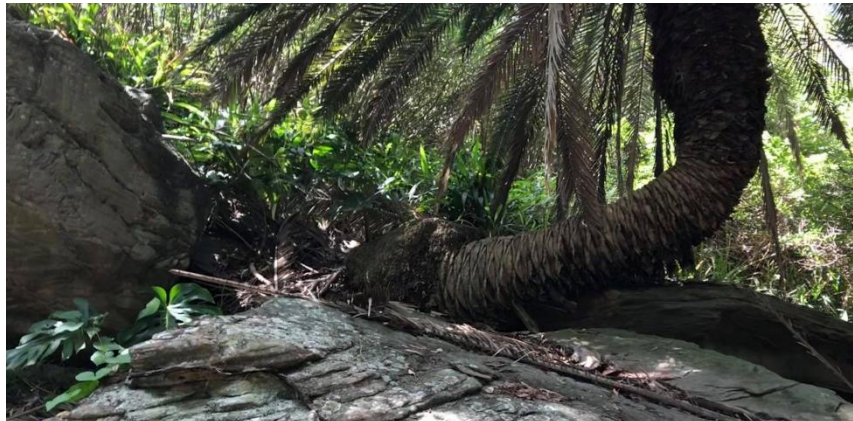
The neighbouring properties to the east (No. 138 – 140 Pacific Road) are located close to the crest of the ridge with their steeply west sloping backyards extending to the common boundaries with the site. The stepped backyards of these properties are densely vegetated and are retained by dry packed stone walls of variable heights. Only the site visible sections of the backyards of these neighbouring properties were inspected and there were no signs of excessive surface erosion or any tension crack/deformation over the soil slope or within the retaining walls to suggest any movement or underlying geotechnical issues. However, a palm tree orientated sideways and resting on sandstone boulders within No.138 appeared to show signs of previous instability, this is shown in Photograph 8.

Photograph-8: Palm tree within No.138 Pacific Road with horizontally orientated base, looking south east

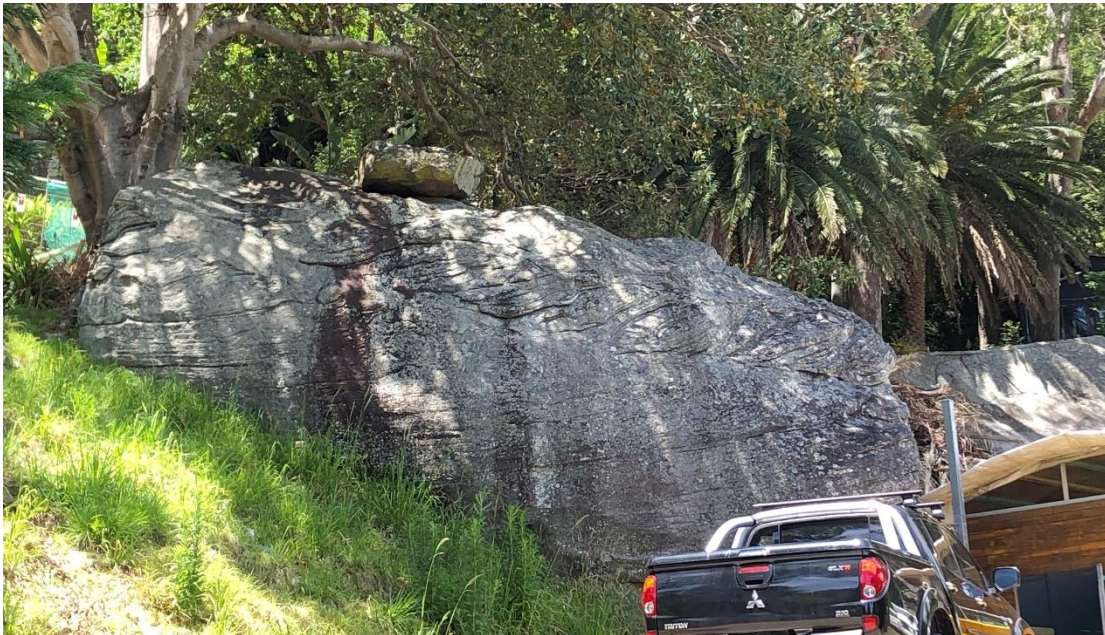
The neighbouring lot to the north (Lot 2, 1110 Barrenjoey Road) forms the middle portion of the vacant block and is situated within very similar topography. A very large sandstone boulder ($\approx 200\text{m}^3$) is located within the south western corner of the lot and extends into the site. Resting on top of this boulder is a smaller detached unit, which appears to be stable at present, this is shown in Photograph 9.

Photograph-9: Large sandstone boulder with smaller detached unit on top, within Lot 2, looking south east
