Lot 4, 7 Trentwood Park, Avalon

Comments on Updates to Plans

GEOTECHNICAL INVESTIGATION:

New Subdivision and Two New Houses at **7 Trentwood Park, Avalon.**

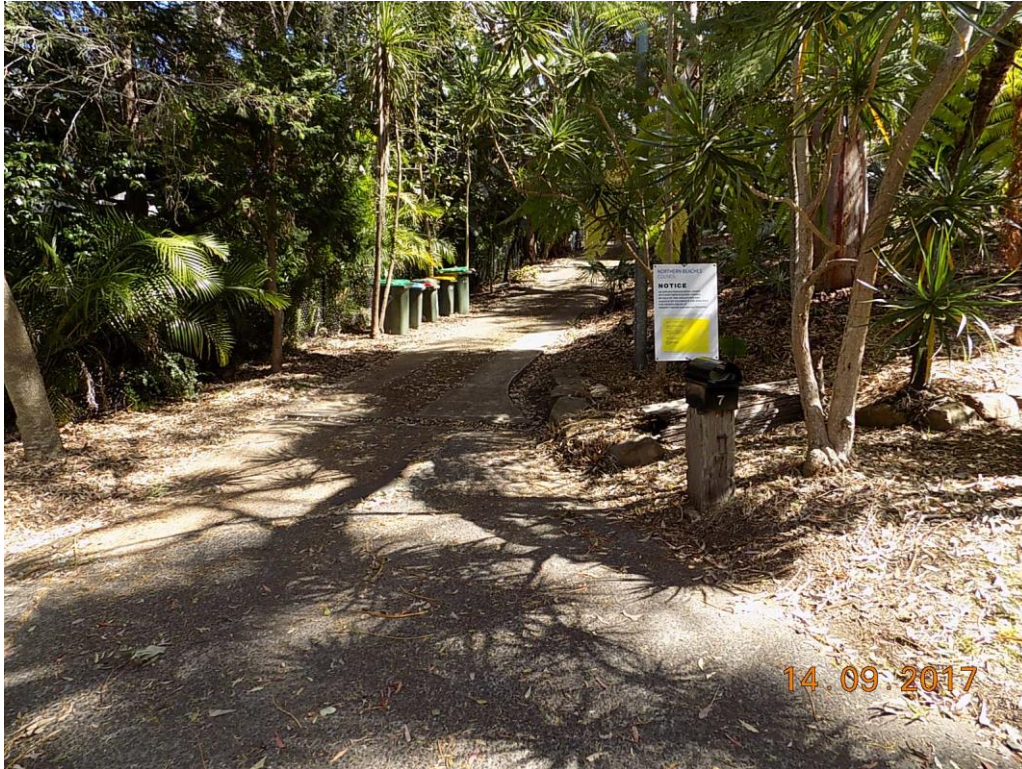
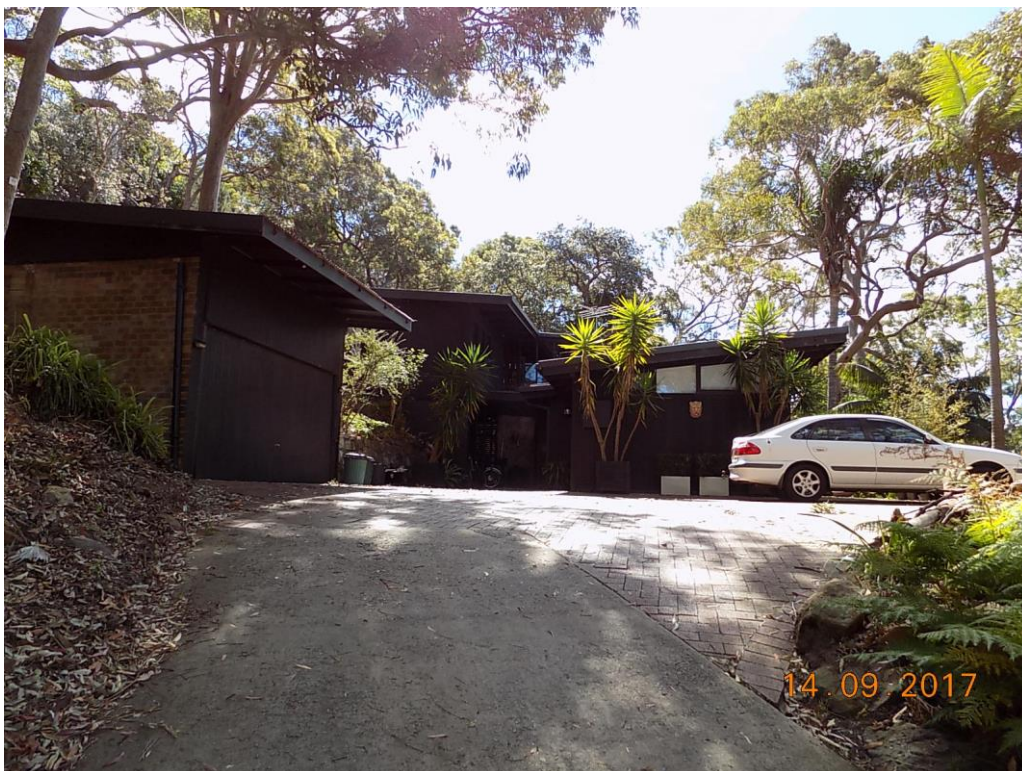
Photo 1

- 2.3** At the road frontage, a concrete driveway runs up the slope to a brick garage and brick-paved parking area on the S side of the house (Photos 1 & 2). The garage will be demolished as part of the proposed works. The driveway diverts to a lawn-covered parking area below the brick-paved parking area (Photo 3). The fill for the lawn-covered parking area is battered to stable angles and merges into the natural slope (Photo 4). Between the road frontage and the lawn-covered parking area, the slope is sparsely vegetated with native trees (Photo 5). The part two-storey timber framed and clad house will remain unchanged as part of the proposed works (Photo 6). An excavation has been made in the slope for the lower ground floor of the house. The cut was made through a

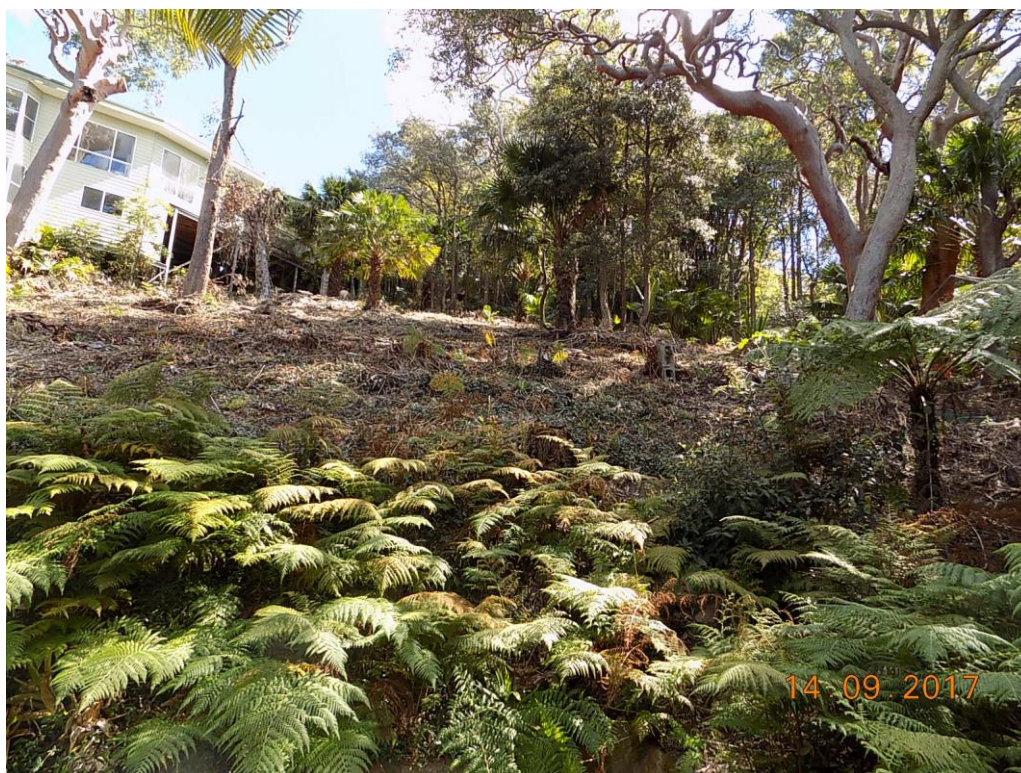
Photo 8

band of medium-strength sandstone (Photo 7). A fill has been placed on the slope above the cut for a level paved area. The fill is supported by a ~1.2m high stable sandstone block retaining wall that is supported directly off the exposed sandstone band. Another excavation has been made in the slope for the upper ground floor. The cut batter is well-vegetated and battered to stable angles. The slope that rises above the house to the upper boundary has been cleared of most of its vegetation (Photo 8).

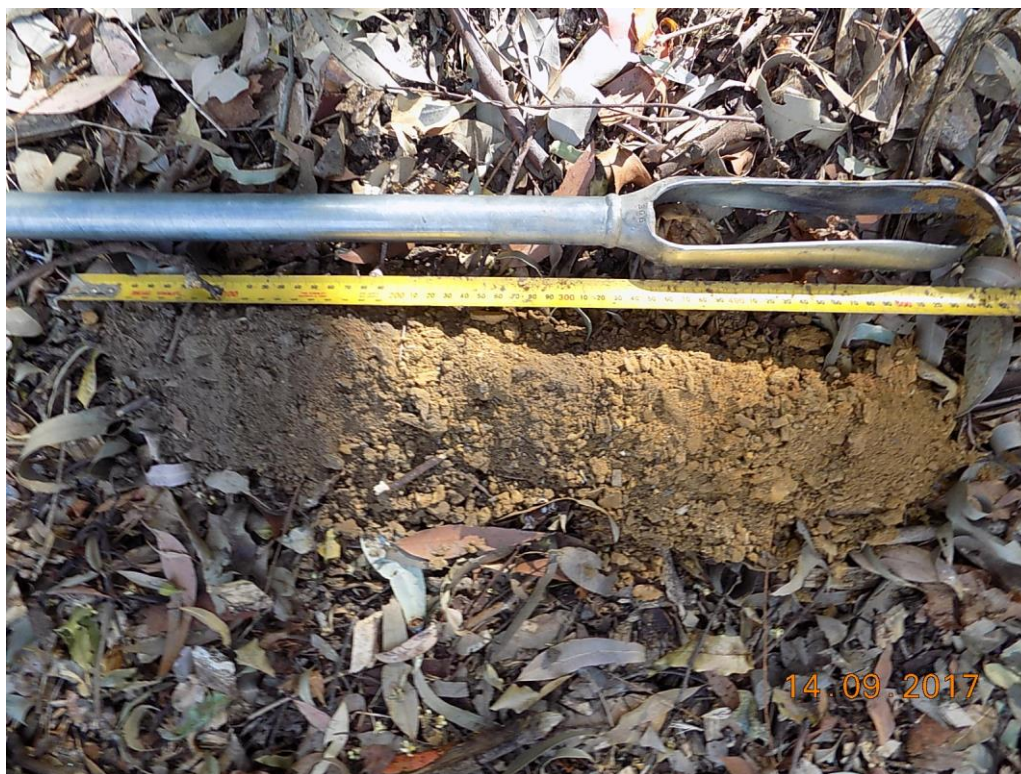
AUGER HOLE 1 (~RL46.1) – AH1 (Photo 9)

Depth (m)	Material Encountered
0.0 to 0.3	TOPSOIL , sandy soil, brown-grey, fine to medium grained with fine trace organic matter and trace silt.
0.3 to 0.6	CLAY , orange-brown, firm to stiff, fine grained.

End of hole @ 0.6m in firm to stiff clay. No watertable encountered.

Photo 9: AH1 – Downhole is from left to right.

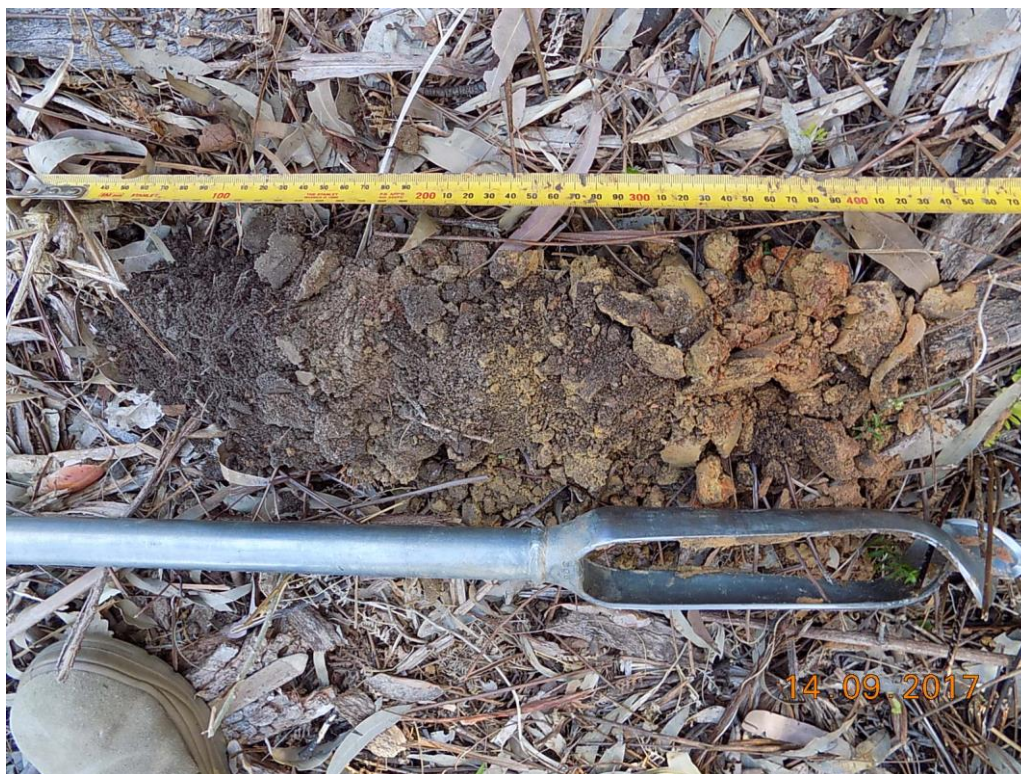
AUGER HOLE 2 (~RL69.8) – AH2 (Photo 10)

Depth (m)	Material Encountered
0.0 to 0.2	TOPSOIL , sandy soil, brown to dark brown, fine to medium grained with fine trace organic matter.
0.2 to 0.5	CLAY , weathered shale, orange-brown with mottled maroon, stiff, fine grained.

End of hole @ 0.5m in weathered shale. No watertable encountered.

Photo 10: AH2 – Downhole is from left to right.

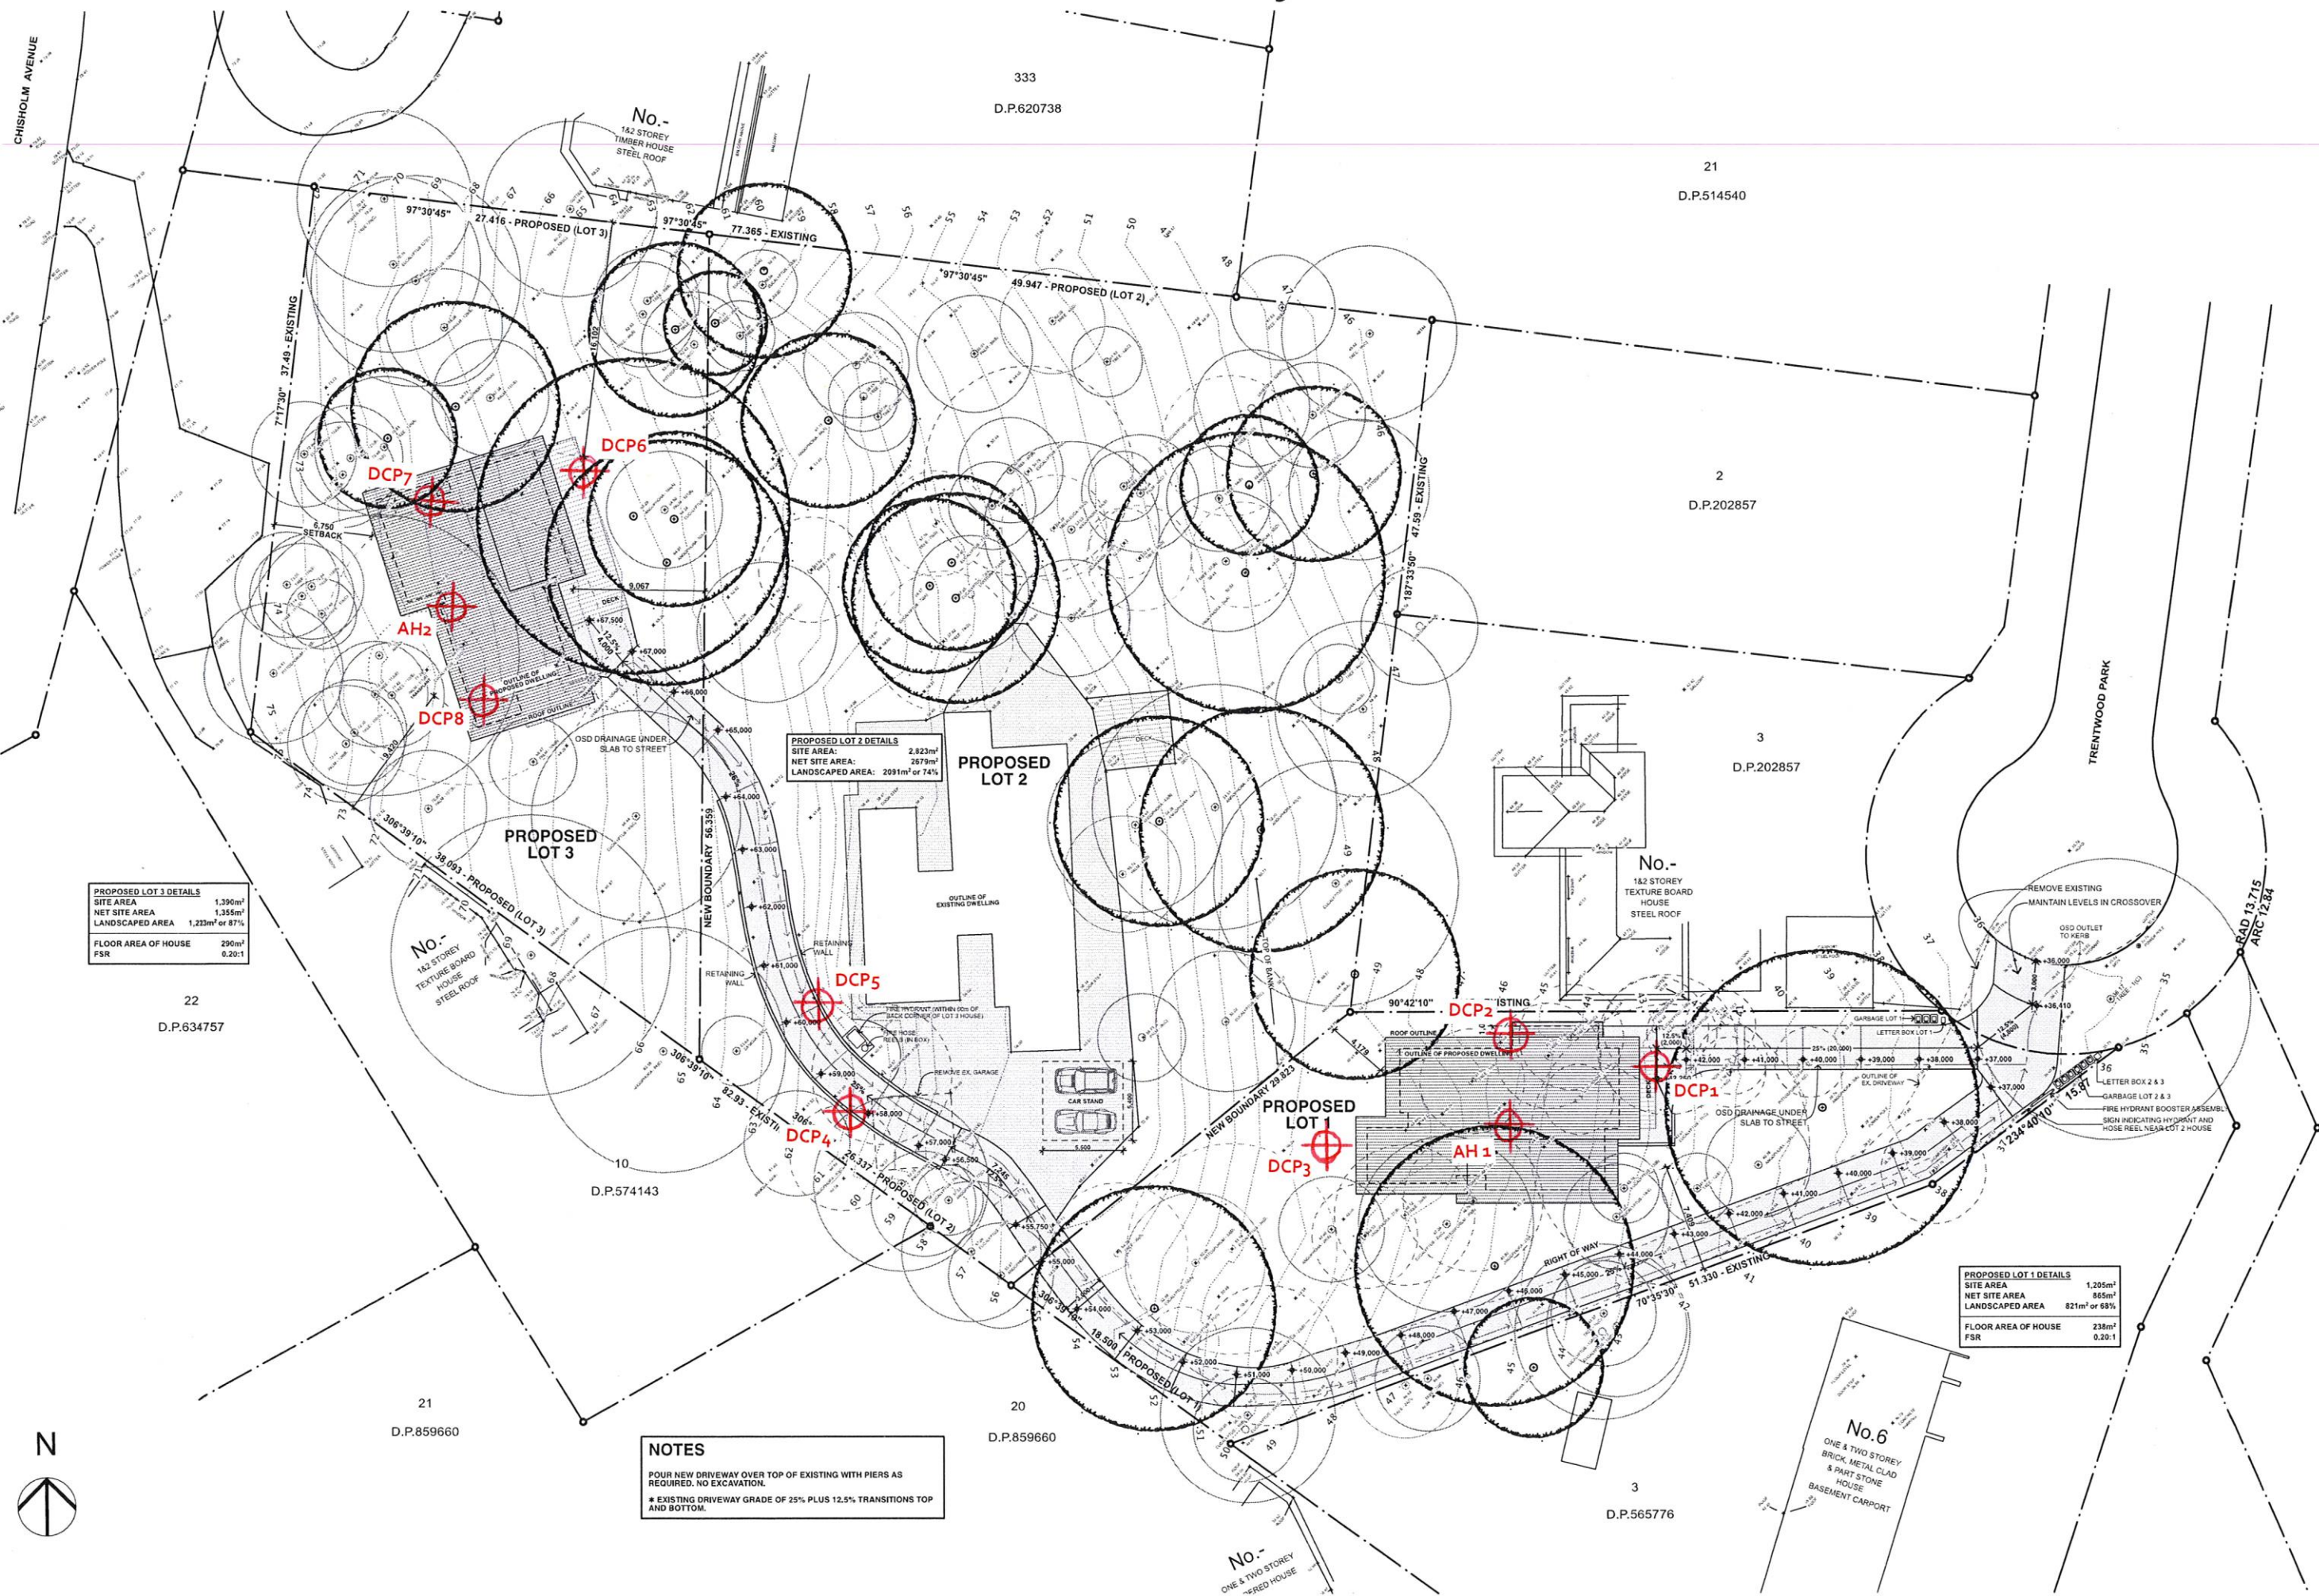
SITE PLAN – showing test locations

Two auger holes were put down to identify the soil materials. Eight Dynamic Cone Penetrometer (DCP) tests were put down to determine the relative density of the overlying soil and the depth to bedrock. The locations of the tests are shown on the site plan. It should be noted that a level of caution should be applied when interpreting DCP test results. The test will not pass through hard buried objects so in some instances it can be difficult to determine whether refusal has occurred on an obstruction in the profile or on the natural rock surface. This is not expected to be an issue for the testing on this site and the results are as follows:

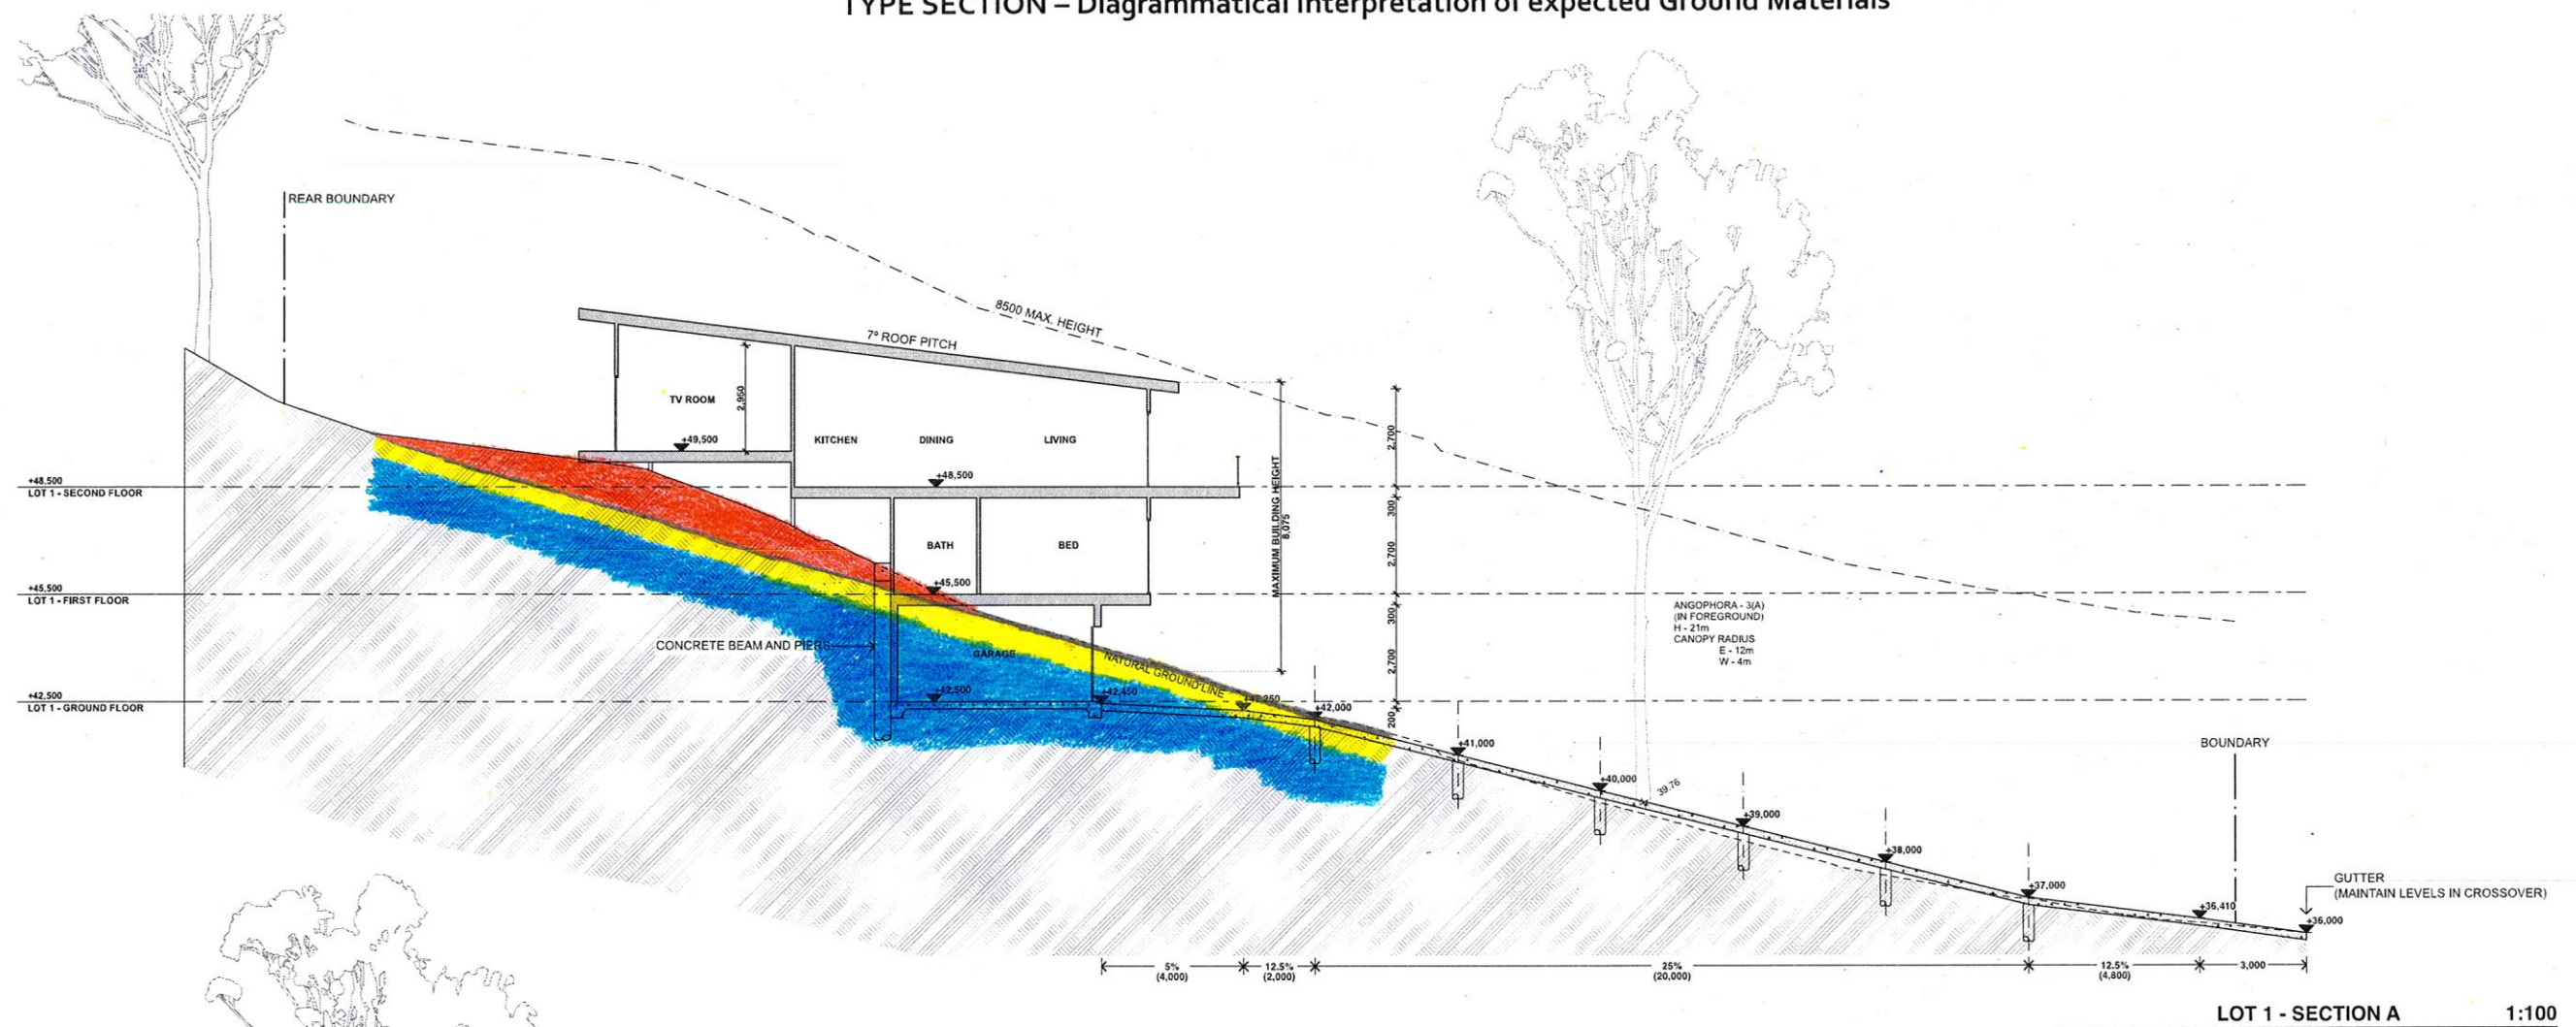
TYPE SECTION – Diagrammatical Interpretation of expected Ground Materials

The slope materials are colluvial at the near surface and residual at depth. They consist of a thin sandy topsoil over firm to stiff clays. In the test locations, the clays merge into the weathered zone of the underlying rocks at an average depth of ~0.6m below the current surface. The weathered zone of the underlying rock is interpreted as extremely low to very low strength shale. It is to be noted that this material is a soft rock and can appear as a mottled stiff clay when it is cut up by excavation equipment.

- Fill
- Topsoil
- Sandy Clay – Firm to Stiff
- Narrabeen Group Rocks – Extremely Low Strength Shale - after being cut up by excavation equipment can resemble a stiff to hard clay.
